# FACILITY CONDITION ASSESSMENT

**Shelby County Board of Education**  
160 South Hollywood Street  
Memphis, Tennessee 38112-4892  
Michelle Stuart

Douglass High School  
3200 Mt. Olive Road  
Memphis, Tennessee 38108

April 29, 2024

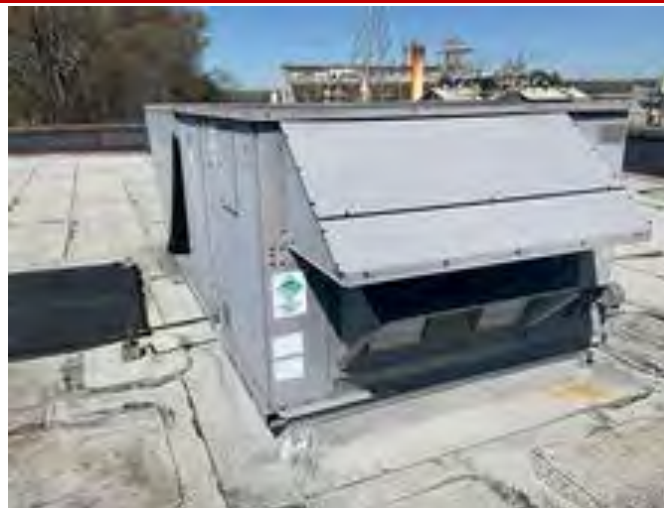
14 - ROOFTOP PACKAGED UNIT

Conditioned air for the building is by multiple 4-ton rooftop packaged units supplemented by a couple 25-ton units. All of the units were found to be original to construction (2008) and are in fair condition as they near the end of their useful life. Heated water to the plumbing fixture is possible by two commercial water heaters. Hot water to the kitchen area is through a water boiler and external storage tank system. One 2500-lb capacity passenger elevator provides service to both floors of the building. Electrical service is delivered to the property through overhead transmission lines to a main 3000-amp switchboard. Electricity is then spread throughout the building to smaller 600-amp subpanels and is backed up by an emergency generator. Fire suppression to the building is possible through a facility-wide sprinkler system in conjunction with a full fire alarm system.
