FACILITY CONDITION ASSESSMENT

Douglass K-8
1650 Ash Street
Memphis, Tennessee 38108

163745.23R000-012.354

April 25, 2024

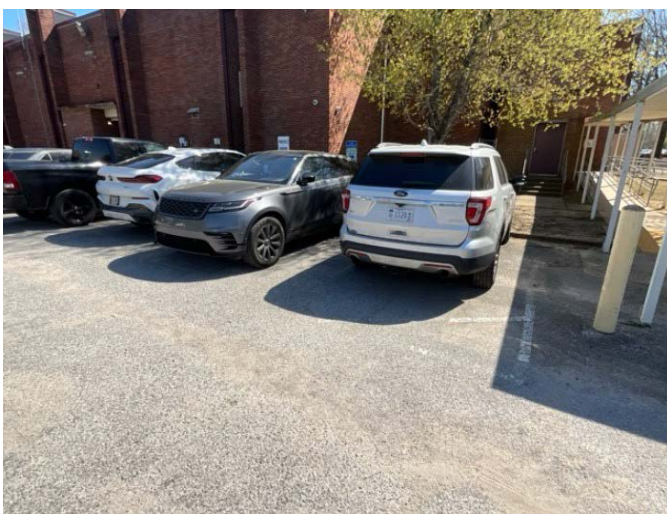
17 - PAVEMENT CONDITION

One asphalt parking lot is present on the north side of the property and connects to sidewalks which lead to the front and rear building elevations. Maintenance on the pavement appears to be past due with raveling and faded striping observed. One small playground is available on the SE corner of the building and is ADA accessible. Non irrigated lawns are present on each elevation with mature trees dotting the landscape.
