# FACILITY CONDITION ASSESSMENT

**Shelby County Board of Education**  
160 South Hollywood Street  
Memphis, Tennessee 38112-4892  
Michelle Stuart

Gardenvue Elementary  
4075 Hartz Drive  
Memphis, Tennessee 38116

*August 9, 2024*

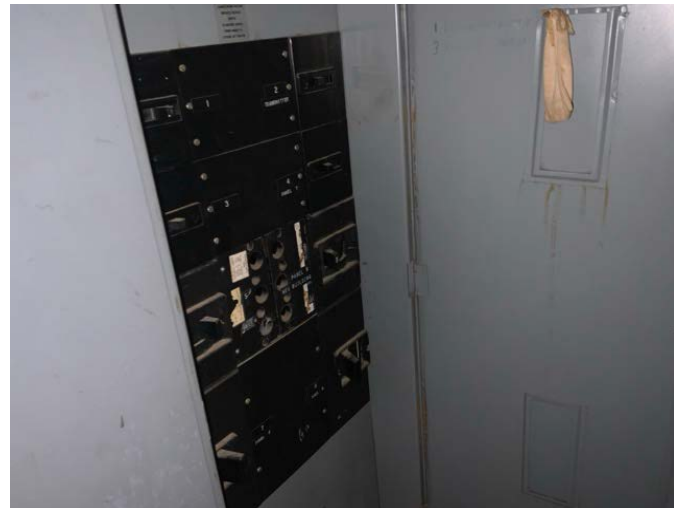
16 - DISTRIBUTION PANEL

The electrical distribution panels appear to be original to the building. The building distribution system should be upgraded, including the panels. The lighting has not been upgraded to LED. It is possible that the city lighting is provided by MGL&W. The plumbing is likely original, and replacement may be required. The urinals are installed up a step. The Round wings restrooms are not ADA compliant. The kitchen water heater is a storage tank that requires the boiler operational be to use. The water heaters and drinking fountains have been upgraded. Fire protection is limited to portable fire extinguishers and a commercial hood system. There is a complete fire alarm system and AED. The school is equipped with an intrusion system and surveillance system.

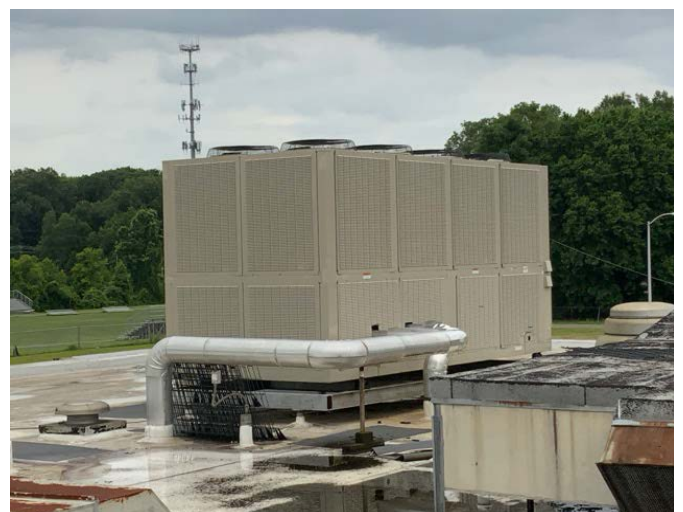
18 - CHILLER

Many classrooms had portable air conditioners. The chiller for the round wings and the chiller for the rectangular wing were just replaced. The air handlers for the round wings appeared to be original to the building. The exterior rooftop unit for the center of the building is near the end of life. Replacement of these units should be planned for the future. The boilers are end of life or nearing end of life and replacement with higher efficiency units should be planned in the near future.

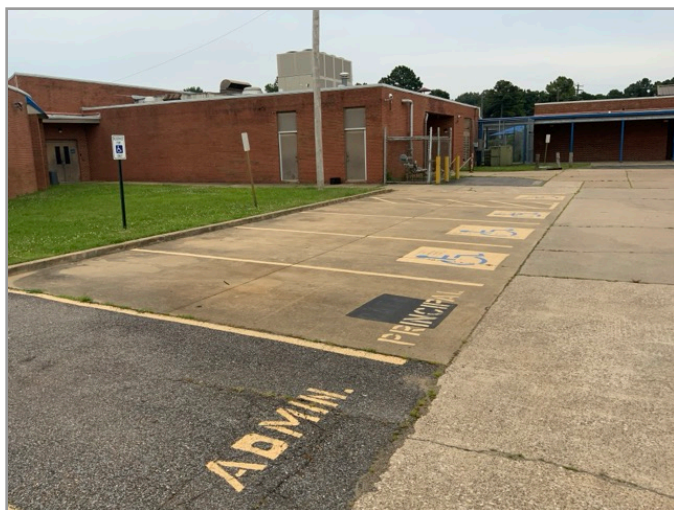
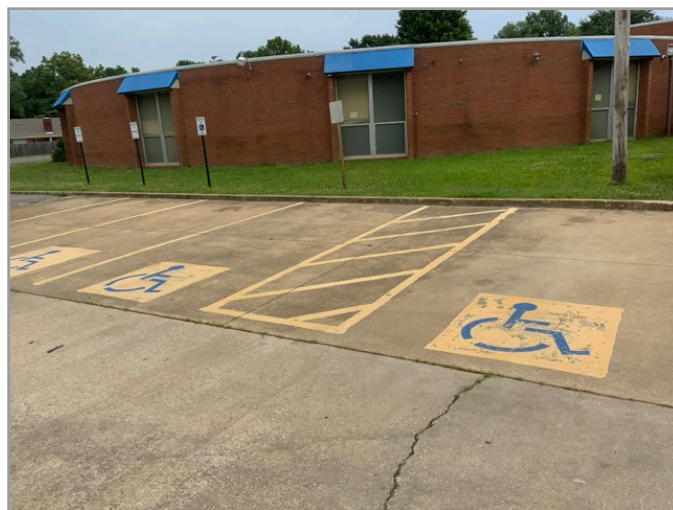
The asphalt paving has cracking with weeds and will require a mill and overlay. The ADA parking does not have a Van stall or wall lanes between stalls. The sidewalks are spalling, and future replacement should be planned. The tree overhanging the school should be trimmed back.

OVERVIEW OF ACCESSIBLE PARKING AREA

CLOSE-UP OF STALL
