FACILITY CONDITION ASSESSMENT

Shelby County Board of Education
160 South Hollywood Street
Memphis, TN 38112-4892
Michelle Stuart

Havenview Middle School
1481 Hester Road
Memphis, TN 38116

September 30, 2024

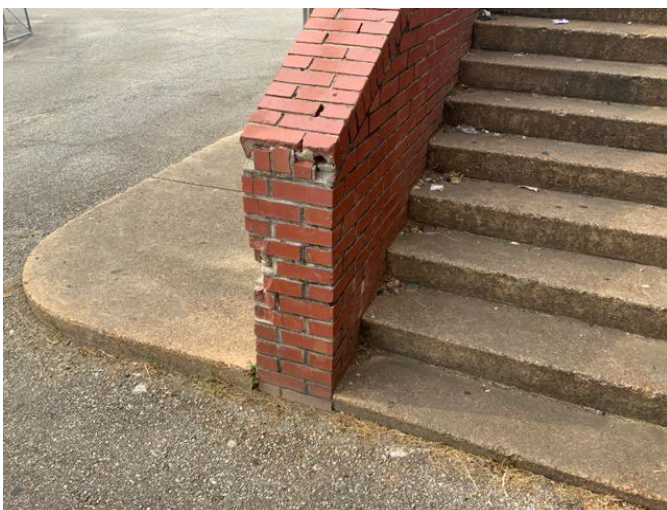
5 - EXTERIOR WALLS

Exterior Walls in Poor condition.

Recommendation: **Repair/Repoint in 2025**

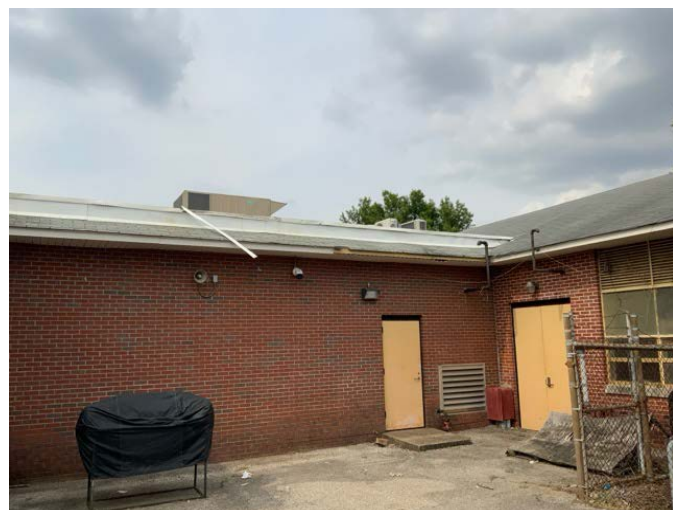
6 - SOFFIT/FASCIA

Soffit/Fascia in Poor condition.

Fascia and soffit damaged in multiple areas - AssetCALC ID: 8055438

Uniformat Code: B3080
Recommendation: **Repair in 2025**
