FACILITY CONDITION ASSESSMENT

Hawkins Mill Elementary School
4295 Mountain Trail
Memphis, Tennessee 38127

163745.23R000-047.354

January 16, 2024

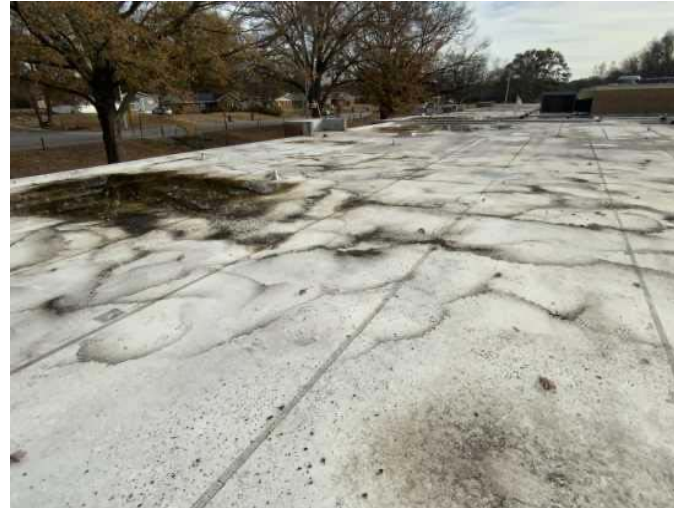
8 - PVC/TPO ROOFING

The main building was originally constructed in 1965 and is a one-story building with partial basement. Most building envelope components appear to be original and in fair condition. The PVC/TPO type roof covering the Main building and Annex are estimated to be installed in 2005 and appears in poor condition due to numerous large areas of ponding. The interior finishes such as vinyl tile flooring, acoustic tile ceiling and paint have been replaced over the years. Only typical lifecycle interior finish, exterior finish, and roof membrane replacements are budgeted and anticipated.

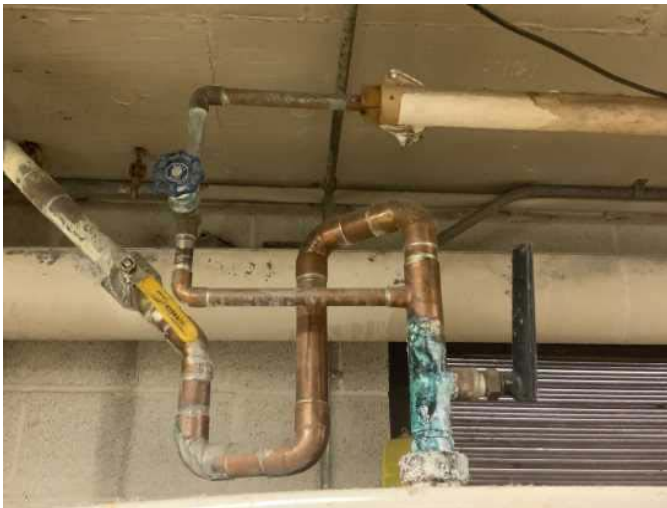
21 - PLUMBING SYSTEM PIPING

The plumbing system appears to be adequate to serve the facilities. The equipment and fixtures appear to have been upgraded over the years except for the trough style sinks in the common halls. The domestic water service within the school is well maintained, however, numerous faucets around the facility are leaking. POC reports that there have been incidents of clogging and drain line backups requiring calls for service. A 200-gallon water heater in the mechanical room is over ten years old and is approaching the end of its useful life. There is also a domestic water storage tank approximately 15 years old. Lifecycle replacement of original domestic water and sanitary sewer systems is anticipated in the mid-term.

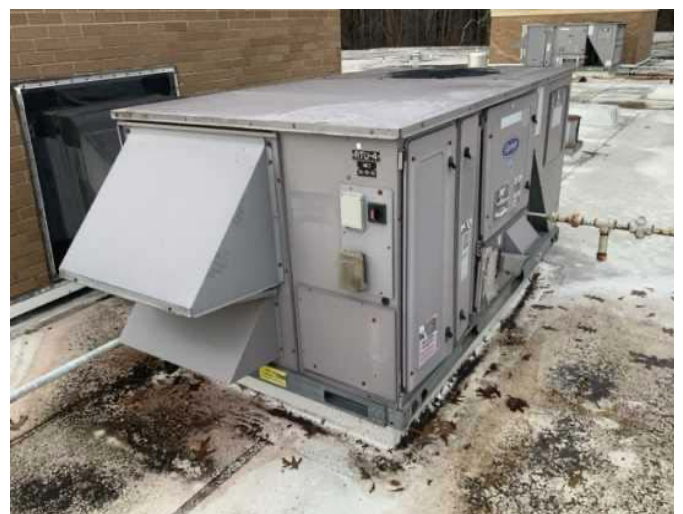
24 - TYPICAL PACKAGED UNIT

HVAC system for the Main building and Annex consists of packaged rooftop units. POC reports that units on the Main building are unreliable and require frequent calls for service. Also, POC reports that several areas including the plant manager office, some classrooms and cafeteria have inadequate heating. Auxiliary heating and cooling are provided by split systems around the building. A 14-year-old, 150-ton chiller in the basement mechanical room is currently decommissioned. Near term lifecycle replacement of many packaged units is anticipated.

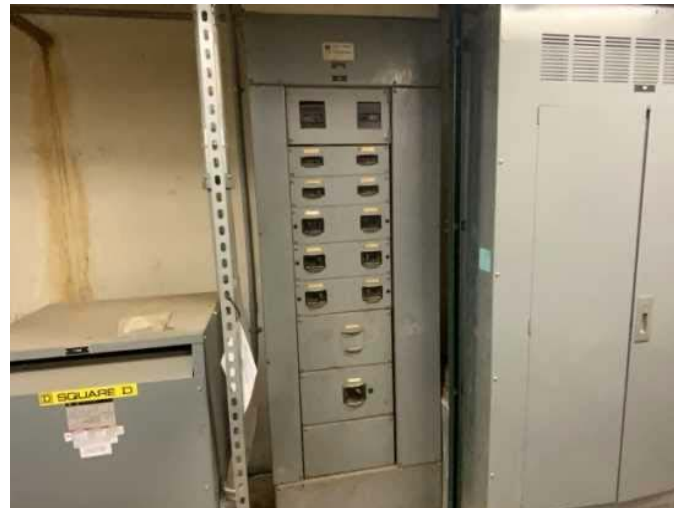
28 - SWITCHBOARD

Electrical infrastructure consists of 277/480V, 1200AMP 3 phase main distribution panel, one 150KVA transformer and a 120/208V 1600AMP switchboard in the main electrical. There are two 600 AMP panels on the stage area and circuit breaker panels throughout the facility with metal conduit and BX wiring. The electrical infrastructure is generally in good working condition having been upgraded in 2010 and no major expenditures are anticipated for the near term. Interior lighting consists mainly of 2 x 4 fluorescent fixtures with T-8 lamps.

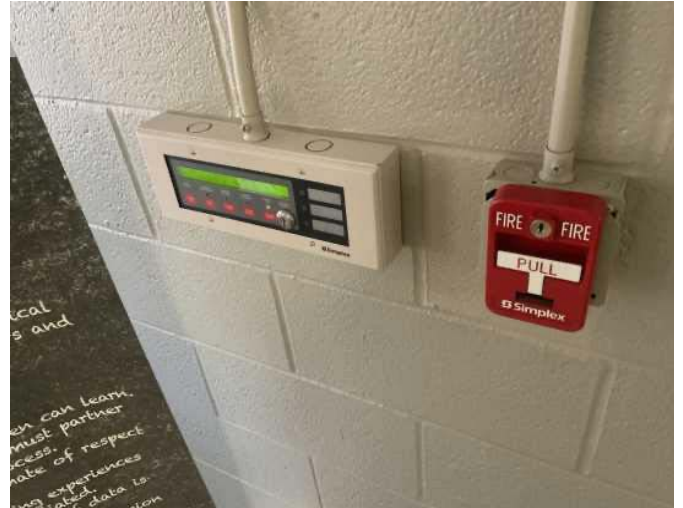
32 - FIRE ALARM SYSTEM COMPONENTS

Fire protection consists of a hard-wired fire alarm system estimated to be more than 20 years old and near-term lifecycle replacement is recommended. The alarm system consists of strobes, pull stations, illuminated exit signs, emergency lighting and other modern life safety devices. The building does not have an automatic sprinkler system.
