FACILITY CONDITION ASSESSMENT

Shelby County Board of Education
160 South Hollywood Street
Memphis, Tennessee 38112-4892
Michelle Stuart

Holmes Road Elementary
1083 East Holmes Road
Memphis, Tennessee 38116

DATE OF REPORT:
September 30, 2024

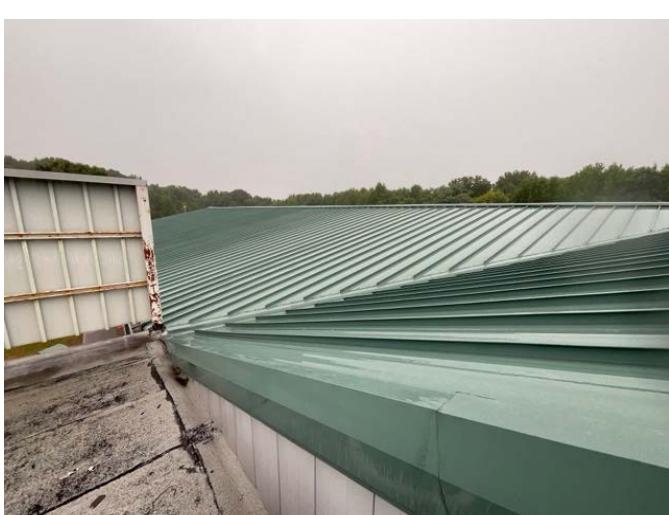
5 - ROOFING

This structure is comprised of brick clad CMU with a mixture of flat, gabled and domed roofs with typical school interiors and finishes. All materials appear to be from the original construction and are well maintained. No significant issues were found during the assessment except for the flat roof finishes appearing to be quite worn.

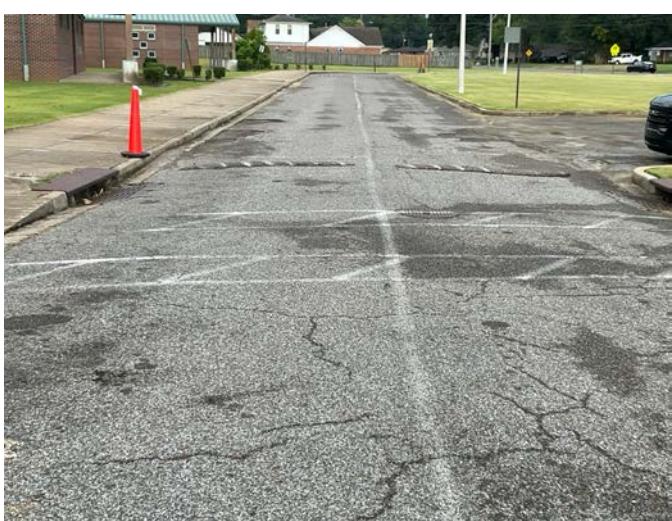
23 - PARKING LOT

Parking Lots in Poor condition.

Very worn and in some areas completely missing. - AssetCALC ID: 8000327

Uniformat Code: G2020
Recommendation: **Seal and Stripe in 2025**

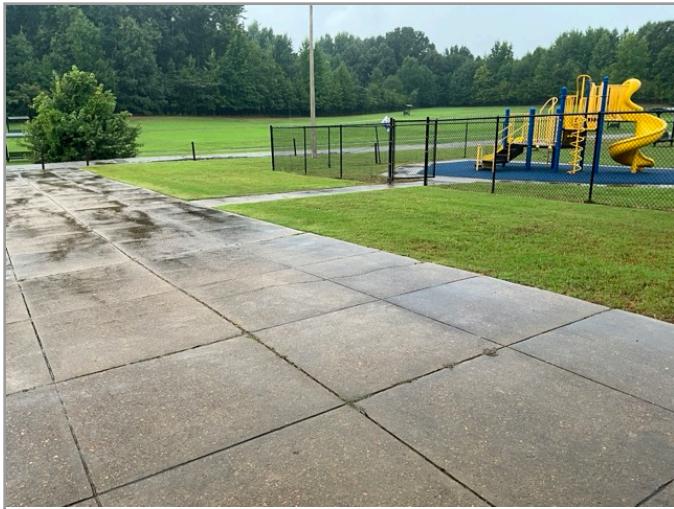
ACCESSIBLE ROUTE TO PLAYGROUND

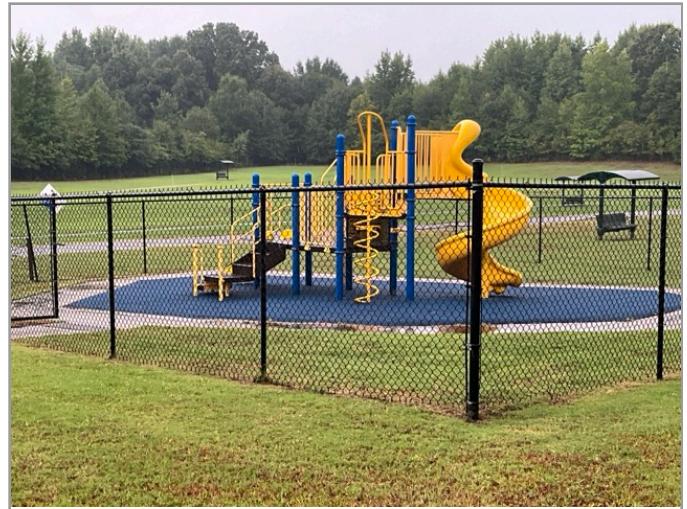
OVERVIEW OF PLAYGROUND
