# FACILITY CONDITION ASSESSMENT

Ida B. Wells Elementary School  
995 South Lauderdale Street  
Memphis, Tennessee 38126

*March 5, 2024*

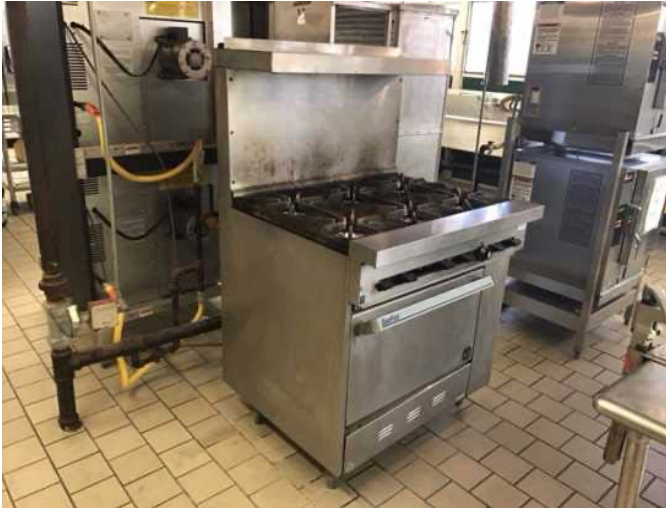
19 - FOODSERVICE EQUIPMENT

**Foodservice Equipment in Failed condition.**

Uniformat Code: E1030  
Recommendation: **Replace in 2024**

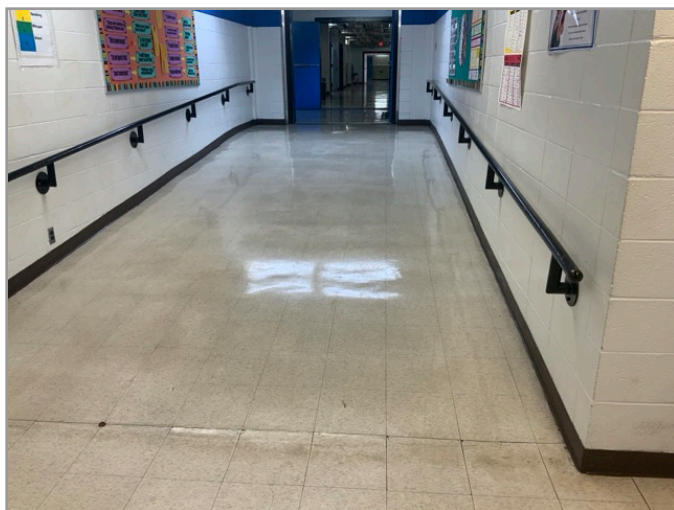
ACCESSIBLE INTERIOR RAMP

Question		Yes	No	NA	Comments
1	Does an accessible route appear to connect all public areas inside the building ?		✗		Second floor not accessible
2	Do accessible routes appear free of obstructions and/or protruding objects ?	✗			
3	Do ramps on accessible routes appear to have compliant slopes ?	✗			
4	Do ramp runs on an accessible route appear to have a compliant rise and width ?	✗			
5	Do ramps on accessible routes appear to have compliant end and intermediate landings ?	✗			
6	Do ramps on accessible routes appear to have compliant handrails ?	✗

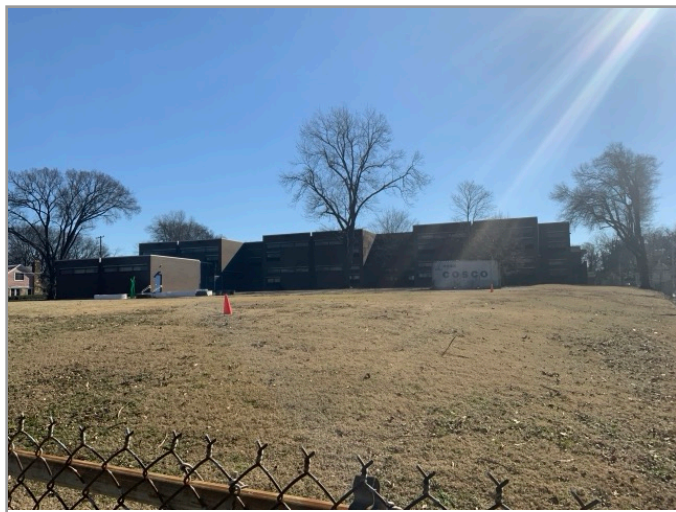
OVERVIEW OF PLAYGROUND

Question		Yes	No	NA	Comments
1	Is there an accessible route to the play area / s?		✗		Steps out multi-purpose room
2	Has the play area been reviewed for accessibility ?		✗		Unknown
3	Are publicly accessible swimming pools equipped with an entrance lift ?			✗
