FACILITY CONDITION ASSESSMENT

Shelby County Board of Education
160 South Hollywood Street
Memphis, Tennessee 38112-4892
Michelle Stuart

Idlewild Elementary School
1950 Linden Avenue
Memphis, Tennessee 38104

March 7, 2024

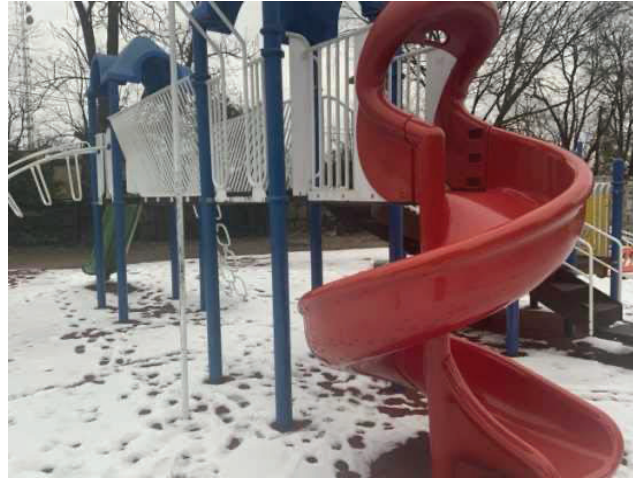
20 - PLAY STRUCTURE

Play Structure in Failed condition.

Uniformat Code: G2050
Recommendation: **Replace in 2024**

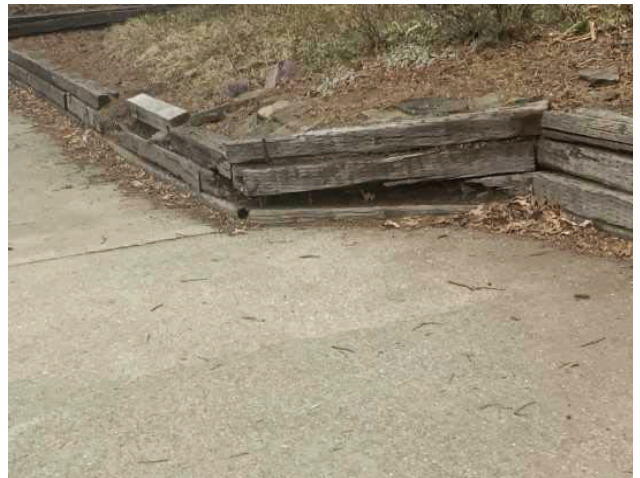
22 - RETAINING WALL

Retaining Wall in Poor condition.

Rotted out missing - AssetCALC ID: 7391871

Uniformat Code: G2060
Recommendation: **Replace in 2026**

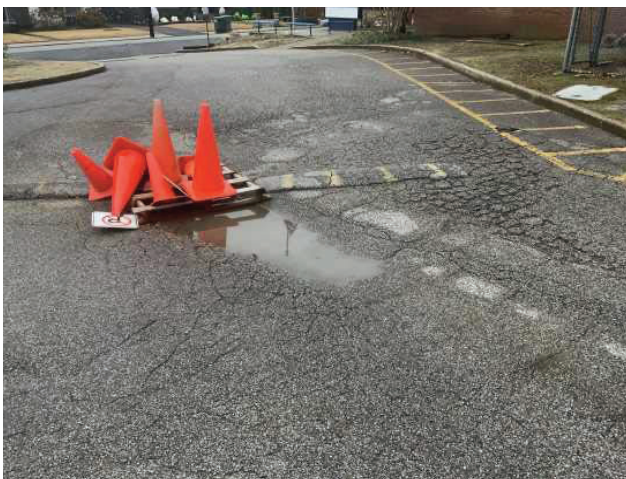
23 - PARKING LOTS

The asphalt paving in the parking area has potholes and extensive cracking and requires replacement. The sidewalk is starting to crack, and replacement will be required. The timber retaining wall has dry rot, requiring replacement. Some of the playground equipment is barricaded off. The exterior access courtyard has a tall step to exit the area.

Parking Lots in Poor condition.

Uniformat Code: G2020
Recommendation: **Mill and Overlay in 2026**

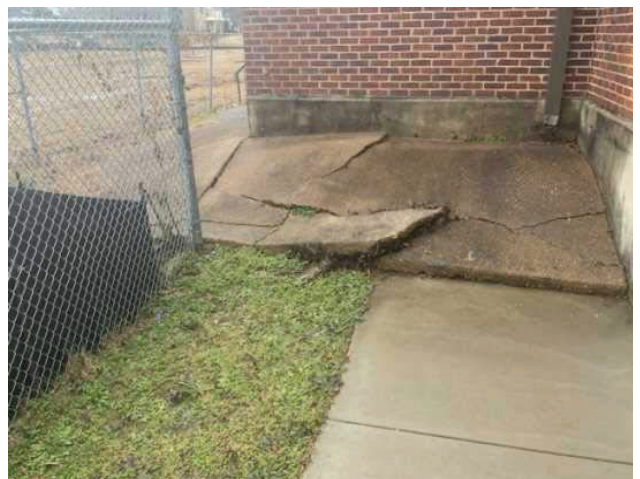
24 - SIDEWALK - GYMNASIUM

Sidewalk in Failed condition.

Broken up, steep slope - AssetCALC ID: 7389758

Uniformat Code: G2030
Recommendation: **Replace in 2025**

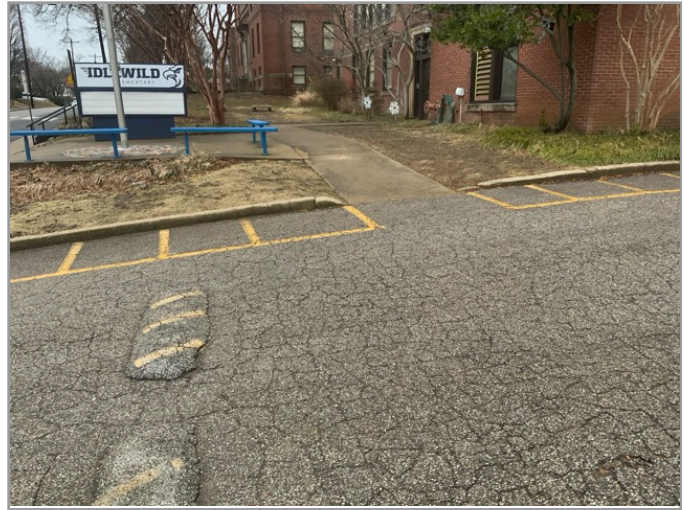
ACCESSIBLE PATH

Question		Yes	No	NA	Comments
1	Is an accessible route present from public transportation stops and municipal sidewalks on or immediately adjacent to the property ?		✗		Steps or steep driveway to accessible door
2	Does a minimum of one accessible route appear to connect all public areas on the exterior, such as parking and other outdoor amenities, to accessible building entrances ?		✗		Steps at most doors
3	Are curb ramps present at transitions through raised curbs on all accessible routes?			✗	
4	Do curb ramps appear to have compliant slopes for all components ?			✗	
5	Do ramp runs on an accessible route appear to have compliant slopes ?		✗		Steeper
6	Do ramp runs on an accessible route appear to have a compliant rise and width ?		✗		Narrower

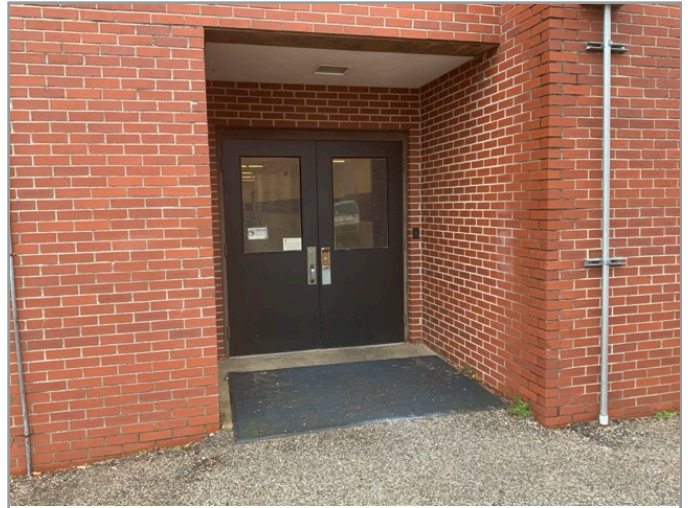
ACCESSIBLE ENTRANCE

Question		Yes	No	NA	Comments
1	Do a sufficient number of accessible entrances appear to be provided ?		✗		
2	If the main entrance is not accessible, is an alternate accessible entrance provided?			✗	
3	Is signage provided indicating the location of alternate accessible entrances ?			✗	
4	Do doors at accessible entrances appear to have compliant maneuvering clearance area on each side ?	✗			
5	Do doors at accessible entrances appear to have compliant hardware ?		✗		Push button on handle
6	Do doors at accessible entrances appear to have a compliant clear opening width ?	✗

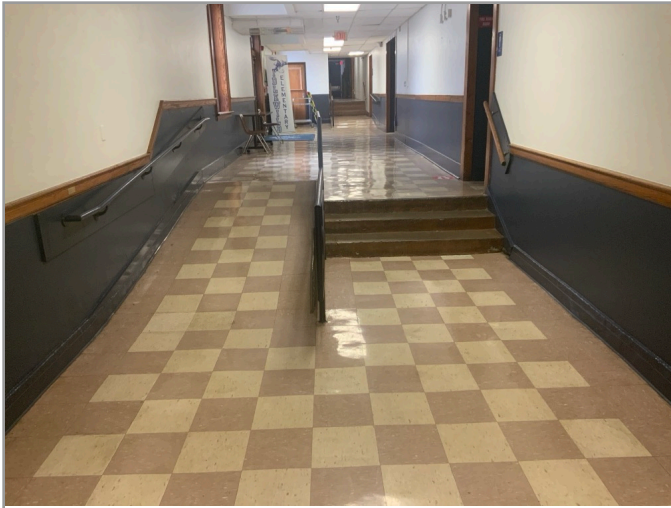
ACCESSIBLE INTERIOR RAMP

Question		Yes	No	NA	Comments
1	Does an accessible route appear to connect all public areas inside the building ?		✗		Most areas have stairs to access
2	Do accessible routes appear free of obstructions and/or protruding objects ?	✗			
3	Do ramps on accessible routes appear to have compliant slopes ?		✗		Hallway ramp steep
4	Do ramp runs on an accessible route appear to have a compliant rise and width ?	✗			Other than front hall
5	Do ramps on accessible routes appear to have compliant end and intermediate landings ?	✗			
6	Do ramps on accessible routes appear to have compliant handrails ?	✗

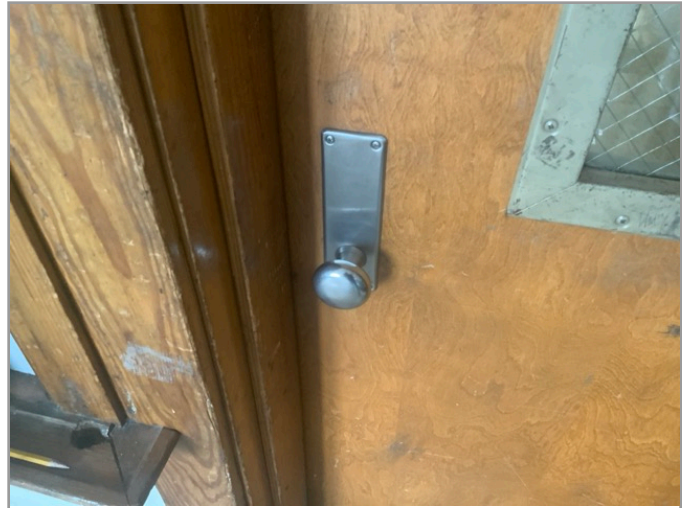
DOOR HARDWARE

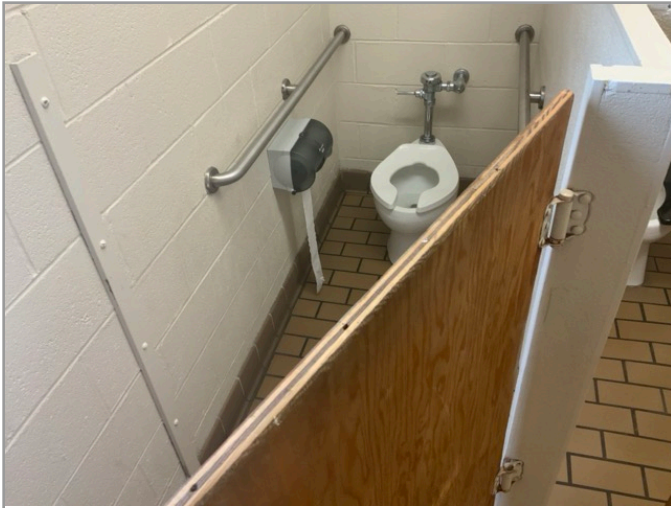
TOILET STALL OVERVIEW

Question		Yes	No	NA	Comments
1	Do publicly accessible toilet rooms appear to have a minimum compliant floor area ?	X			
2	Does the lavatory appear to be mounted at a compliant height and with compliant knee area ?	X			
3	Does the lavatory faucet have compliant handles ?	X			
4	Is the plumbing piping under lavatories configured to protect against contact ?		X		Not protected
5	Are grab bars provided at compliant locations around the toilet ?	X			
6	Do toilet stall doors appear to provide the minimum compliant clear width ?		X		Stall door swings into chair area

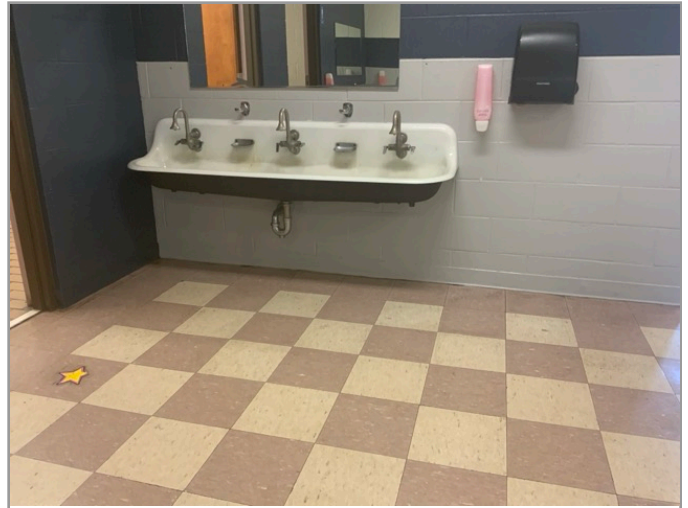
SINK, FAUCET HANDLES AND ACCESSORIES

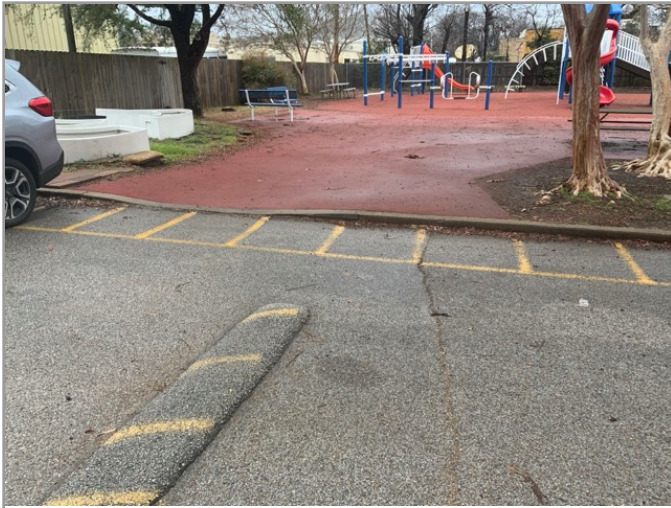
ACCESSIBLE ROUTE TO PLAYGROUND

Question		Yes	No	NA	Comments
1	Is there an accessible route to the play area / s?	X			
2	Has the play area been reviewed for accessibility ?			X	
3	Are publicly accessible swimming pools equipped with an entrance lift ?			X

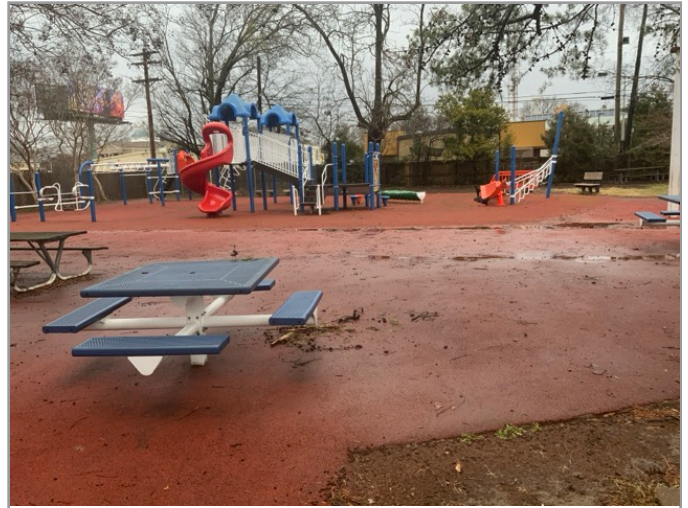
OVERVIEW OF PLAYGROUND
