# FACILITY CONDITION ASSESSMENT

**Shelby County Board of Education**  
160 South Hollywood Street  
Memphis, Tennessee 38112-4892  
Michelle Stuart

*September 30, 2024*

John P Freeman  
5250 Tulane Road  
Memphis, Tennessee 38109

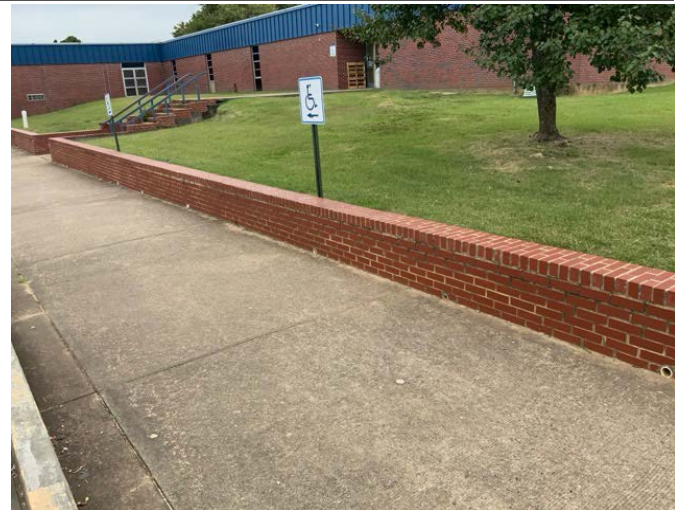
20 - RETAINING WALL

### Retaining Wall in Failed condition.

Uniformat Code: G2060  
Recommendation: **Replace in 2026**

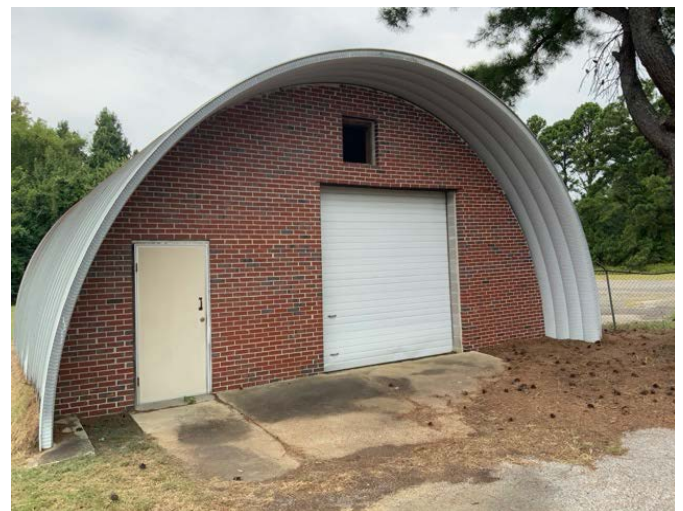
22 - STORAGE GARAGE

### Ancillary Building in Poor condition.

Excessive settling, cracked walls, not accessible trees - AssetCALC ID: 8079987

Uniformat Code: F1020  
Recommendation: **Replace in 2024**

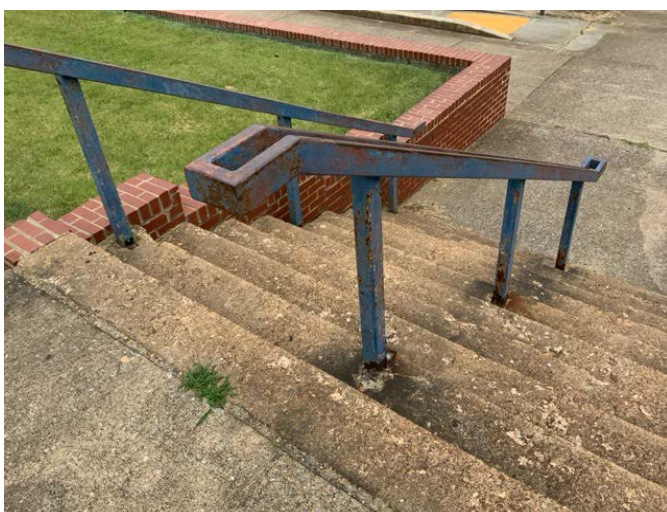
23 - STAIR/RAMP RAILS

### Stair/Ramp Rails in Poor condition.

Posts rusted out, held with tabs - AssetCALC ID: 8080037

Uniformat Code: B1080  
Recommendation: **Refinish in 2026**

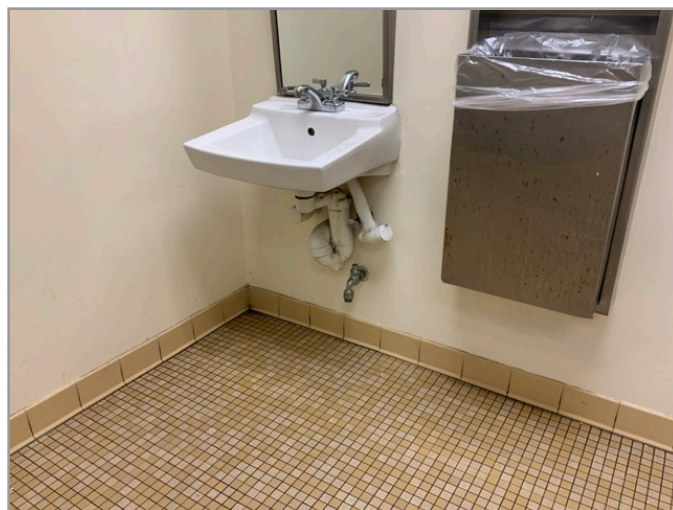
SINK, FAUCET HANDLES AND ACCESSORIES

Question		Yes	No	NA	Comments
1	Do publicly accessible toilet rooms appear to have a minimum compliant floor area ?	✗			
2	Does the lavatory appear to be mounted at a compliant height and with compliant knee area ?	✗			
3	Does the lavatory faucet have compliant handles ?	✗			
4	Is the plumbing piping under lavatories configured to protect against contact ?	✗			
5	Are grab bars provided at compliant locations around the toilet ?	✗			
6	Do toilet stall doors appear to provide the minimum compliant clear width ?	✗

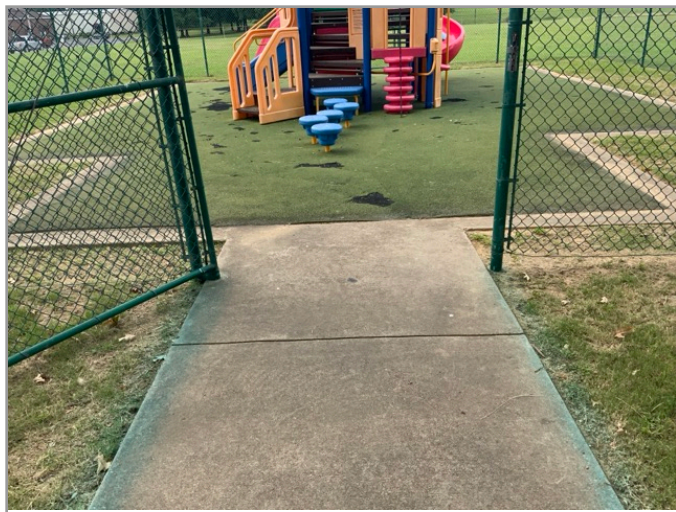
ACCESSIBLE ROUTE TO PLAYGROUND

Question		Yes	No	NA	Comments
1	Is there an accessible route to the play area / s?	✗			
2	Has the play area been reviewed for accessibility ?		✗		Unknown
3	Are publicly accessible swimming pools equipped with an entrance lift ?			✗

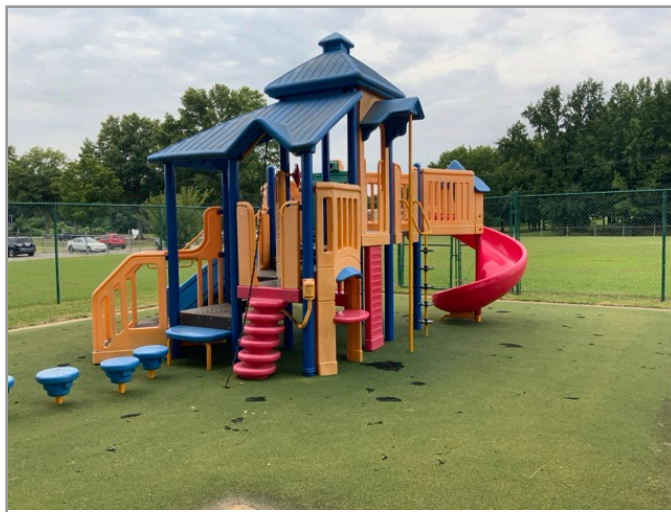
OVERVIEW OF PLAYGROUND
