FACILITY CONDITION ASSESSMENT

Shelby County Board of Education
160 South Hollywood Street
Memphis, Tennessee 38112-4892
Michelle Stuart

Kingsbury CTC
1328 North Graham Street
Memphis, Tennessee 38122

July 26, 2024

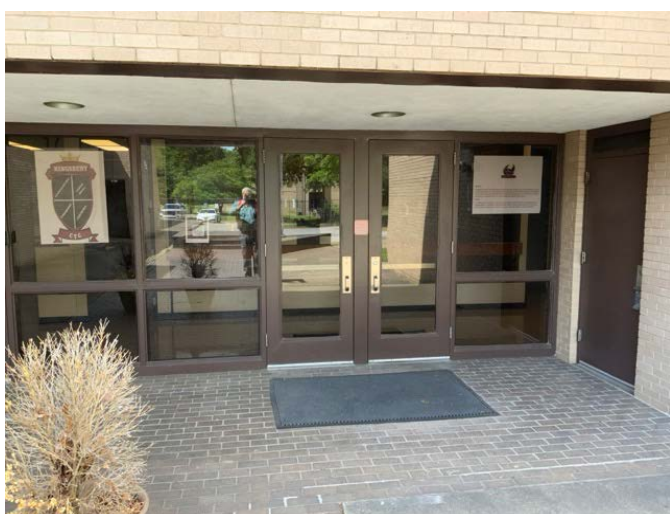
5 - FACADE

The building is a two story brick veneer facility with limited windows. The windows are protected with protective screening. There are areas in the brick that should be repointed to repair damage. The exterior steel door frames are starting to show signs of rust damage. The beam on the rear of the building that the bridge is attached to has rust damage and metal flaking off. The roof has been replaced with an EPDM membrane. There are no current identified roof leaks. The finishes are generally in fair condition and reworking of them will be required in the near future.

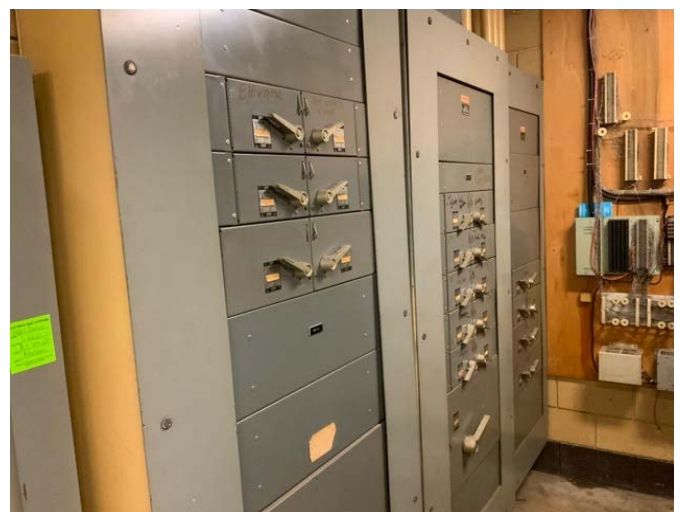
18 - MAIN DISTRIBUTION PANEL

The rooftop mechanical equipment has been recently upgraded. There are additional electric unit heaters and exhaust fans. The electrical system is near the end of life and upgrading of the lighting and distribution could be required. There are multiple rooms with a bus duct and tap switches in them. The electrical system was reported to not be undersized. The plumbing is original to the building and replacement could be required in the future. There are toilets, urinals and sinks in the restrooms. The hallways have upgraded drinking fountains that include bottle fillers. The water heater is past the halfway point in life. The fixtures could be upgraded to more efficient products. The classrooms include a fair quantity of sinks in the beauty salon and commercial kitchen. The building is protected with a wet sprinkler system and portable fire extinguishers. Within the kitchen exhaust hood is an automatic system. There is a fire alarm with pull stations, horns, and strobes. Additional protection is an AED.

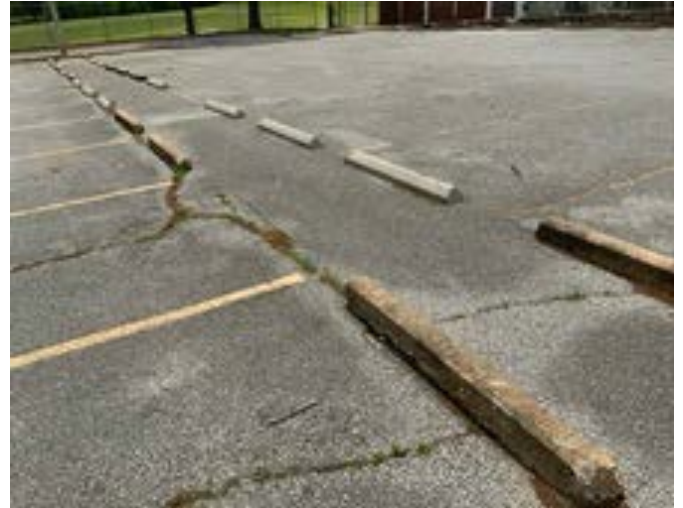
20 - PARKING LOT W/ WHEEL STOPS

The asphalt paving is cracked with weeds growing out of the cracks. The paving in front of the dumpster does not drain properly and the asphalt is broken up from the weight of the front axle of the waste hauling trucks. The concrete is spalling is happening on the bridge and other areas. The site lighting has not been upgraded to LED. Some of the walkways have been replaced with concrete and others with pavers.

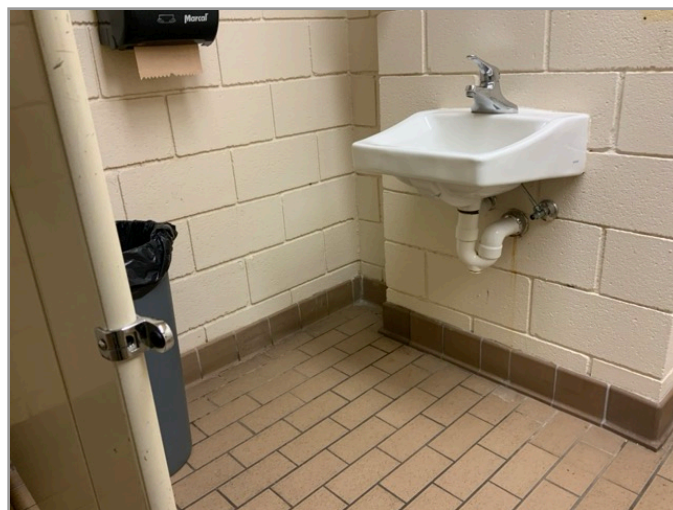
SINK, FAUCET HANDLES AND ACCESSORIES
