# FACILITY CONDITION ASSESSMENT

Kingsbury Elementary School  
4055 Bayliss Avenue  
Memphis, Tennessee 38108

*September 30, 2024*

*August 12, 2024*

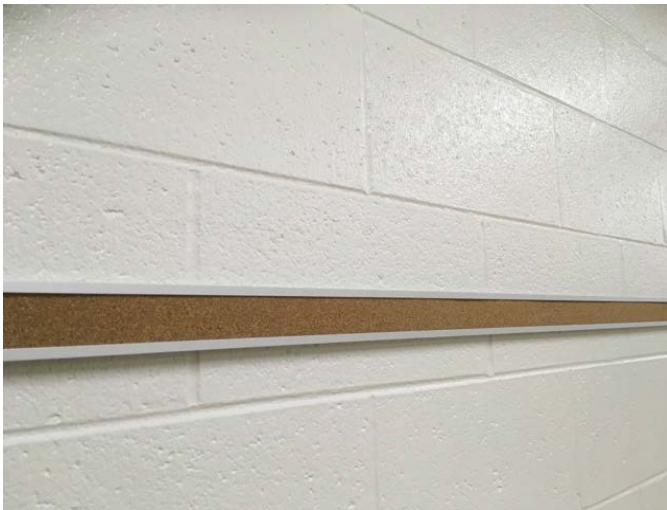
15 - WALL FINISHES

Multiple areas of cracking, tiles falling out - AssetCALC ID: 8026561

Uniformat Code: C2010  
Recommendation: **Replace in 2026**

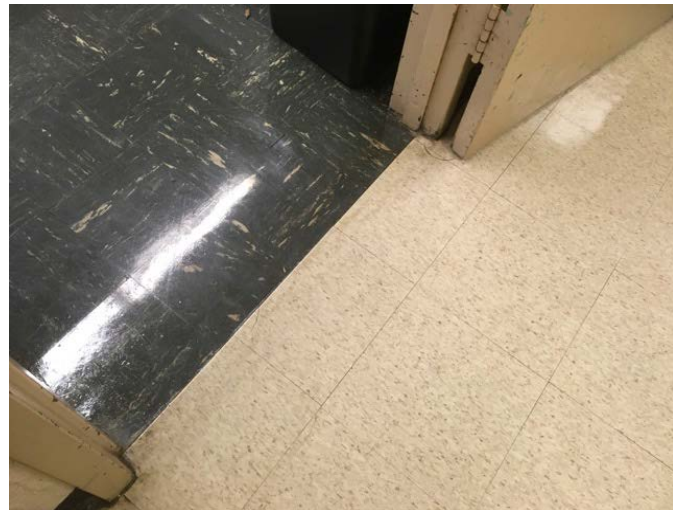
16 - VINYL TILE, W/ ASBESTOS ABATEMENT

The two-story school building was constructed in 1959. All windows were replaced around 1999, along with some floor and ceiling finishes around that time. The windows do show typical age wear and will reach the expected service life within the next few years. The roof membrane was replaced around 2018 and does not have major issues. The exterior brick finishes are holding up over time, however, there are some cracks that have developed over some windows in several classrooms. As a result, there are ongoing water leaks at the roof/wall and window levels. There are still some original suspected ACM-vinyl tile flooring remaining in the classrooms.

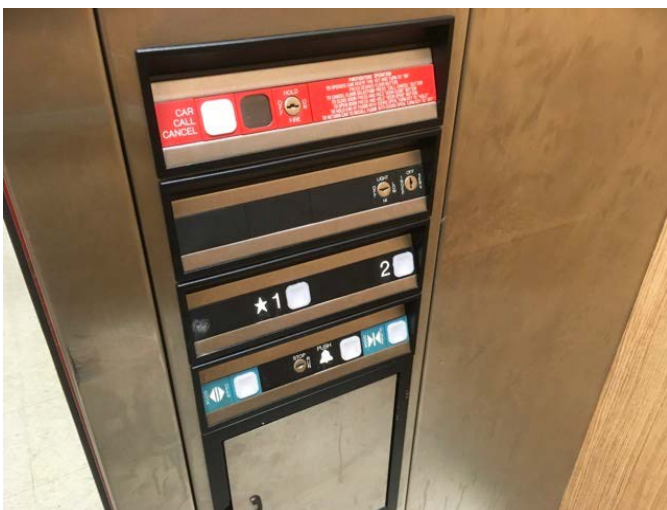
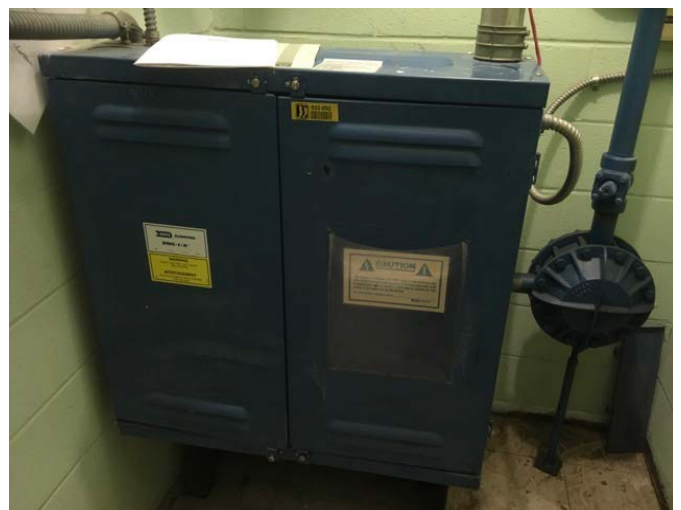
### Passenger Elevator in Poor condition.

Uniformat Code: D1010  
Recommendation: **Renovate in 2024**

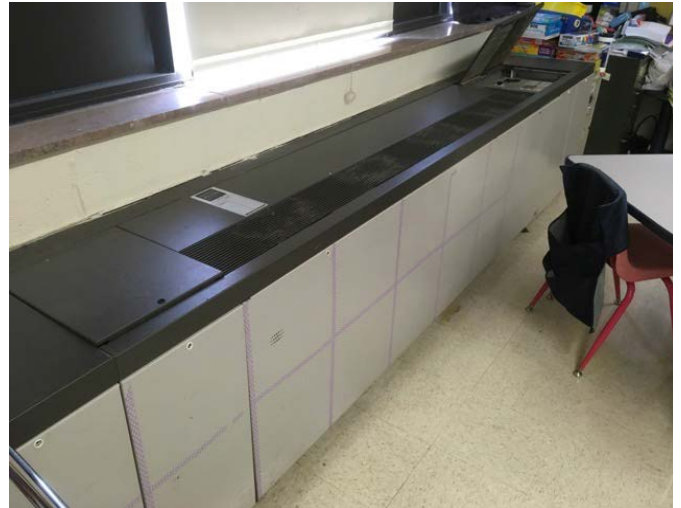
26 - UNIT VENTILATOR

Classrooms in the main school are cooled and ventilated by cabinet style unit ventilators. The unit ventilators were installed around 1999 and have reached the expected service life. This equipment is frequently breaking down and often leads to uncomfortable classrooms. The boiler plant was replaced around 2004 and should only require typical maintenance for the next 10 years. Classrooms in the annex building are heated and cooled by packaged rooftop units. The units are still relatively new and should only require standard maintenance for the long term. The main school underwent electrical upgrades around 1991; however, the school has occasional nuisance breaker trips due to overloaded circuits. Some original electrical distribution has been retained and this equipment is now obsolete and undersized.
