# FACILITY CONDITION ASSESSMENT

**Shelby County Board of Education**  
160 South Hollywood Street, Room 126  
Memphis, Tennessee 38112-4892  
Mary Taylor

Kingsbury High School  
1270 North Graham Street  
Memphis, Tennessee 38122

*April 19, 2024*

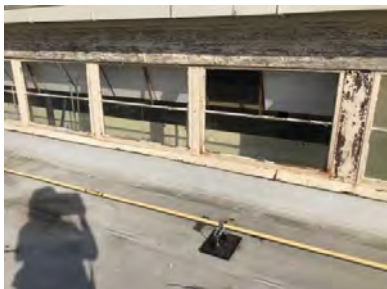
The exterior paint is peeling and should be refinished to prevent further deterioration. - AssetCALC ID: 7023983

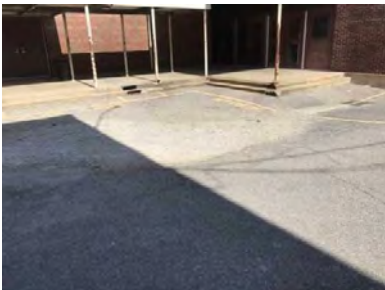
Damaged curb has exposed re-bar creating trip hazard. - AssetCALC ID: 7023531

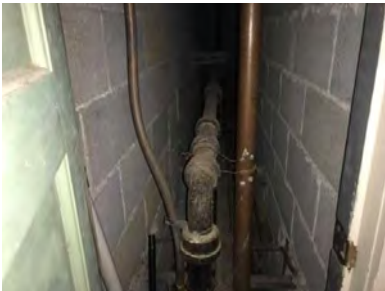
The age of the plumbing could not be determined. A follow up study is recommended to verify condition and age. Area allowed for limited locations of restrooms. - AssetCALC ID: 7026041

Uniformat Code: D2010  
Recommendation: **Replace in 2025**

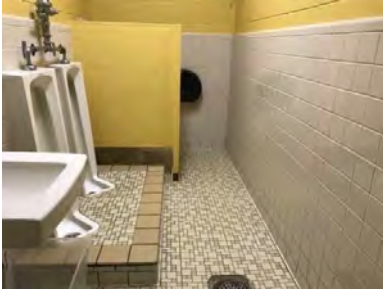
The age of the plumbing could not be determined. A follow up study is recommended to verify condition and age. Area allowed for limited locations of restrooms. - AssetCALC ID: 7031077

Uniformat Code: D2010  
Recommendation: **Replace in 2025**

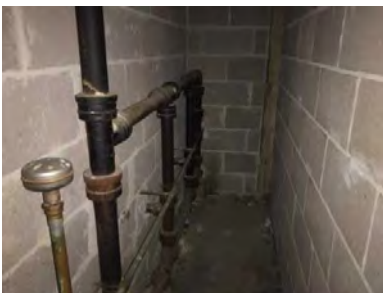
The age of the plumbing could not be determined. A follow up study is recommended to verify condition and age. Area allowed for limited locations of restrooms. - AssetCALC ID: 7031076

Recommendation: **Replace in 2025**

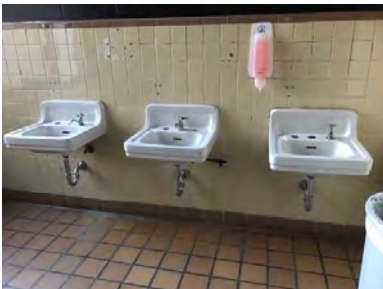
The age of the plumbing could not be determined. A follow up study is recommended to verify condition and age. Area allowed for limited locations of restrooms. - AssetCALC ID: 7031078

Recommendation: **Replace in 2025**

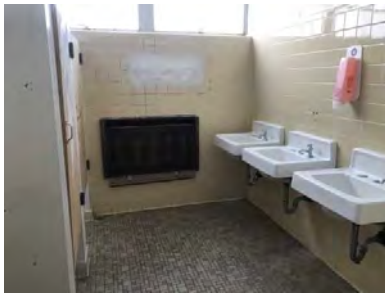
The plumbing has a history of backups and the age could not be determined. - AssetCALC ID: 7027354

Uniformat Code: P2030  
Recommendation: **Evaluate/Report in 2023**

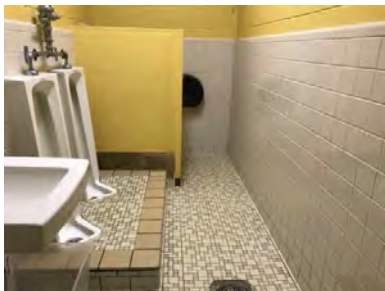
Age of existing and concealed plumbing could not be determined. - AssetCALC ID: 7026042

Uniformat Code: P2030  
Recommendation: **Evaluate/Report in 2023**

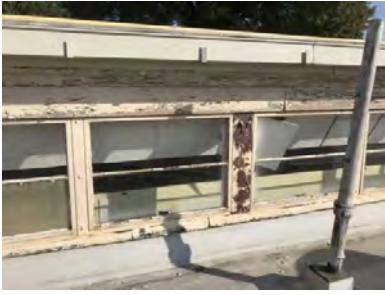
The exterior paint is peeling and should be refinished to prevent further deterioration. - AssetCALC ID: 7023983

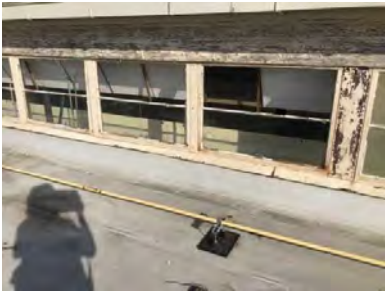
The high windows appear to be the original single-pane energy inefficient and should be replaced. - AssetCALC ID: 7023998

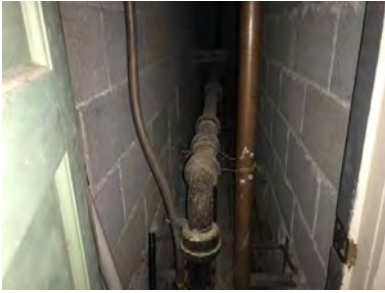
### Plumbing System in Poor condition.

Supply and Sanitary, Low Density (excludes fixtures)  
Gymnasium Kingsbury High School  
Throughout

The age of the plumbing could not be determined. A follow up study is recommended to verify condition and age. Area allowed for limited locations of restrooms. - AssetCALC ID: 7031077

Uniformat Code: D2010  
Recommendation: **Replace in 2025**

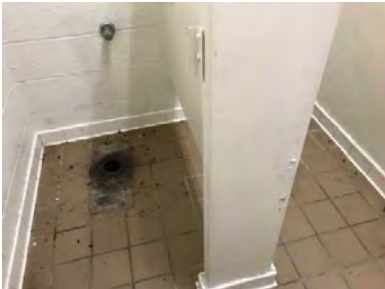
### Toilet in Poor condition.

Commercial Water Closet  
Gymnasium Kingsbury High School  
Restrooms-not used

The east toilet rooms are not in use. - AssetCALC ID: 7024031

Uniformat Code: D2010  
Recommendation: **Replace in 2025**

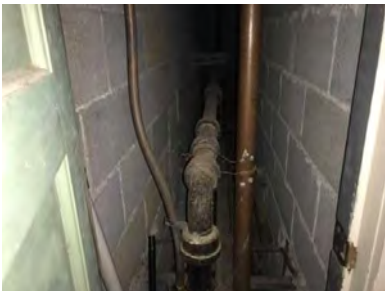
### Recommended Follow-up Study: Plumbing, Video Survey

Plumbing, Video Survey  
Gymnasium Kingsbury High School  
Throughout

The concealed plumbing age could not be determined and is likely original. A professional consultant must be retained to analyze the existing condition, provide recommendations and, if necessary, estimate the scope and cost of any required repairs - AssetCALC ID: 7031082

Uniformat Code: P2030  
Recommendation: **Evaluate/Report in 2023**

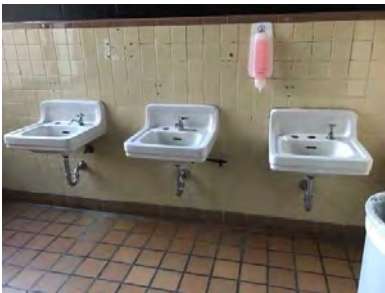
### Plumbing System in Poor condition.

Supply and Sanitary, Medium Density (excludes fixtures)  
Main Building Kingsbury High School  
Restrooms-girls (closed)

The west student restrooms on the first floor are closed because of plumbing issues. - AssetCALC ID: 7023623

Uniformat Code: D2010  
Recommendation: **Replace in 2025**

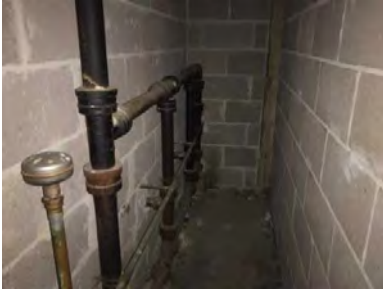
### Recommended Follow-up Study: Plumbing, Video Survey

Plumbing, Video Survey  
Main Building Kingsbury High School  
Throughout

The plumbing has a history of backups and the age could not be determined. - AssetCALC ID: 7027354

Uniformat Code: P2030  
Recommendation: **Evaluate/Report in 2023**

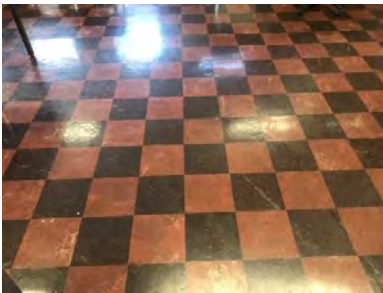
### Flooring in Poor condition.

Vinyl Tile (VCT), with Asbestos Abatement  
Main Building Kingsbury High School  
Classrooms

Classrooms with original VCT should have VCT abated and replaced. - AssetCALC ID: 7023664

Uniformat Code: C2030  
Recommendation: **Replace in 2023**

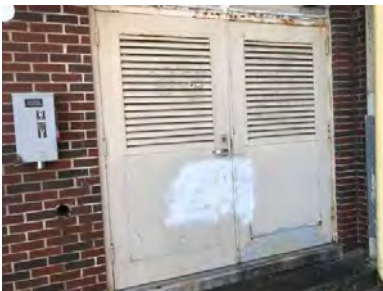
### Exterior Door in Poor condition.

Steel, any type  
Main Building Kingsbury High School Building  
exterior

Exterior doors require refinishing. - AssetCALC ID: 7023662

Uniformat Code: B2050  
Recommendation: **Refinish in 2025**

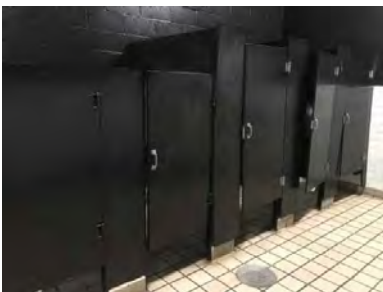
### Toilet Partitions in Poor condition.

Wood  
Main Building Kingsbury High School  
Restrooms-girls (closed)

The painted plywood toilet partitions are significantly aged. - AssetCALC ID: 7023621

Uniformat Code: C1090  
Recommendation: **Replace in 2025**

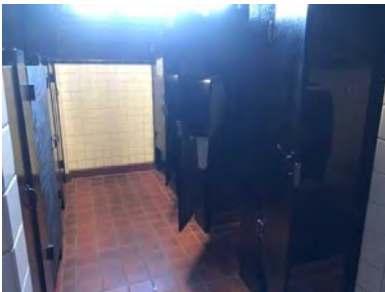
**Toilet Partitions in Poor condition.**Priority Score: **81.7**

Wood  
Main Building Kingsbury High School  
Restrooms-2nd floor

The painted plywood toilet partitions are significantly aged. - AssetCALC ID: 7023541

Uniformat Code: C1090  
Recommendation: **Replace in 2025**

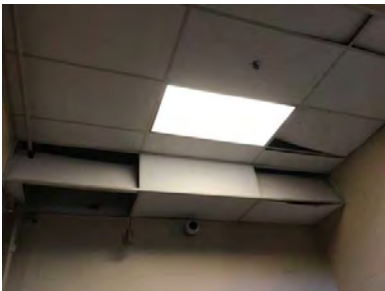
**Suspended Ceilings in Poor condition.**Priority Score: **81.7**

Acoustical Tile (ACT)  
Main Building Kingsbury High School  
Throughout building

Broken, damaged or stained acoustical ceiling tile should be replaced. - AssetCALC ID: 7023550

Uniformat Code: C1070  
Recommendation: **Replace in 2025**

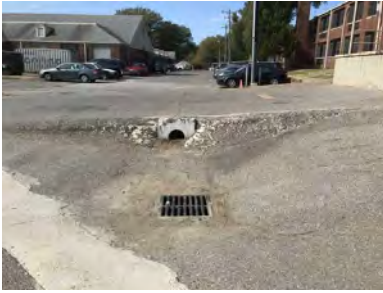
### Roadways in Poor condition.

Guard Rails, Steel  
Site Kingsbury High School Site, cafeteria

There is a significant drop off adjacent to the kitchen loading area. A guardrail should be installed. -  
AssetCALC ID: 7024048

Uniformat Code: G2010  
Recommendation: **Replace in 2023**

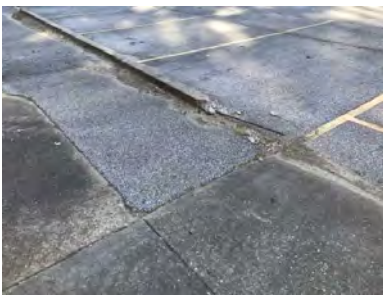
### Parking Lots in Poor condition.

Curb and Gutter, Concrete  
Site Kingsbury High School Auditorium parking lot

Damaged curb has exposed re-bar creating trip hazard. - AssetCALC ID: 7023531

Uniformat Code: G2020  
Recommendation: **Repair in 2023**

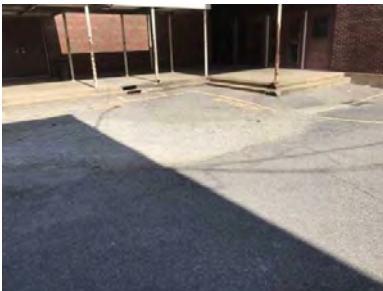
### Sidewalk in Poor condition.

Asphalt  
Site Kingsbury High School Site, gymnasium southwest entry

The asphalt walkways leading to the southwest entry is significantly degraded, presenting trip hazards. -  
AssetCALC ID: 7024073

Uniformat Code: G2030  
Recommendation: **Replace in 2025**

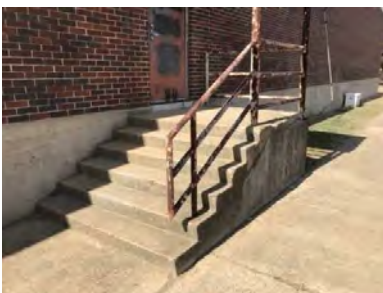
### Stair/Ramp Rails in Poor condition.

Metal  
Site Kingsbury High School Entry balconies

The stair railings are rusting and should be refinished to prevent further deterioration. - AssetCALC ID: 7024084

Uniformat Code: B1080  
Recommendation: **Refinish in 2025**
