# FACILITY CONDITION ASSESSMENT

Levi Elementary  
1270 North Graham Street  
Memphis, Tennessee 38122

**BV PROJECT #:**  
163745.23R000-132.354

**DATE OF REPORT:**  
October 2, 2024

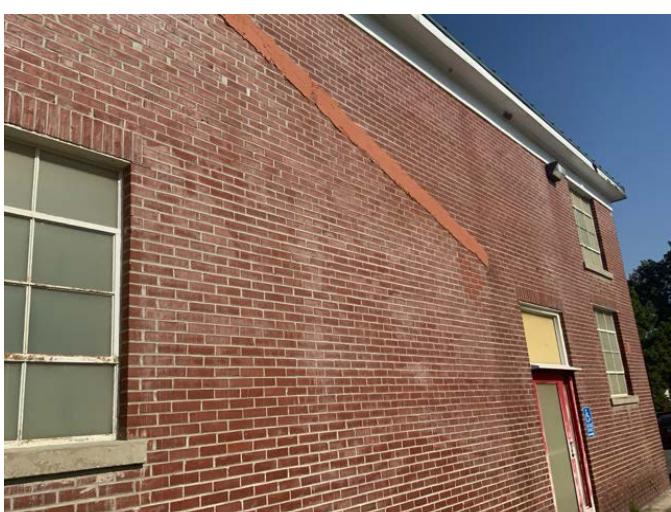
11 - EXTERIOR WALLS - GYMNASIUM

The gymnasium building is the older building. The brick walls need cleaning and sealing. The fascia and soffit areas have failed in areas with dry rot which has open holes. The windows are single pane steel framed. The doors and frames are starting to rust out. The interior paint is peeling on the exterior walls. The ceiling in the restroom is cracking and starting to fall down. The classroom building has exterior doors that letting water into the hallway. The gutters in this area has holes in the bottom. The walls are painted CMU, the flooring is mainly VCT, some quarry tile, ceramic tile and parquet, the ceilings are ACT and painted. The finishes are as expected for a building of this age.

Recommendation: **Clean in 2026**

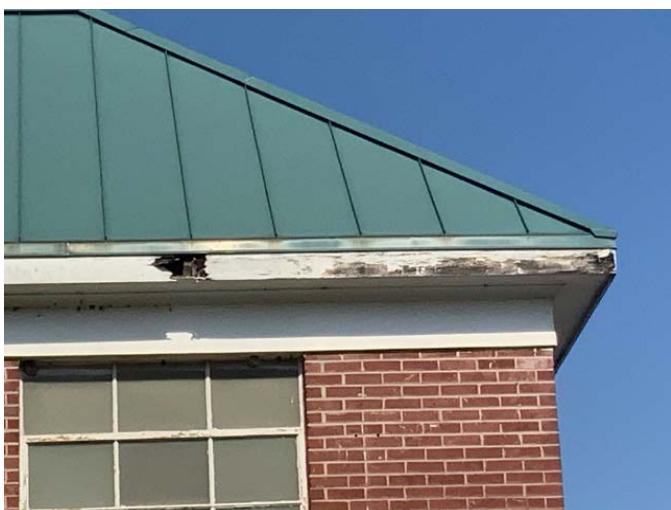
15 - SOFFIT/FASCIA - GYMNASIUM

Holes and missing - AssetCALC ID: 8304247

Uniformat Code: B3080  
Recommendation: **Replace in 2025**

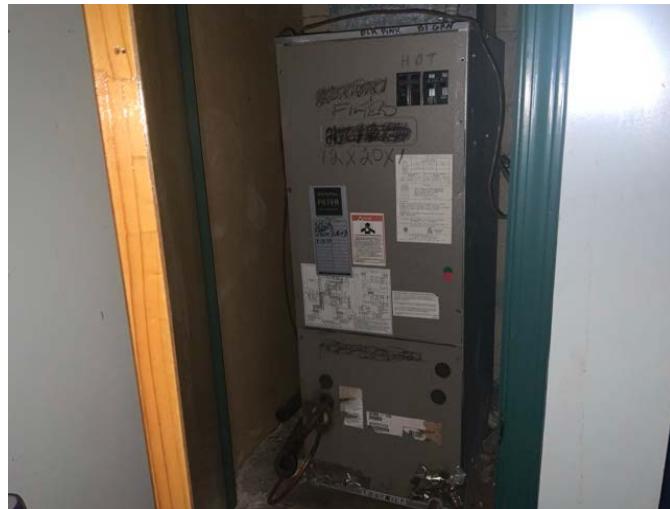
28 - FURNACE - GYMNASIUM

The furnaces in the gymnasium are older and the air conditioner disconnects are turned off. The gymnasium and salon are heated with unit heaters. The whole HVAC system in the gymnasium should be reviewed. The classroom building is heated and cooled with a combination of Boiler, Chiller, and Rooftop package units. The rooftop package units and air handlers were replaced and are in the middle of there expected life. The lighting has not been upgraded to LED. The building is equipped with an emergency generator and automatic transfer switch. The electrical components are nearing end of normal life so future replacement could be considered in the future. The plumbing in the gymnasium is original and replacement maybe required. The hallway trough sinks have issues and replacements may be required. Based on age normal maintenance is required. The AED is missing from the gymnasium. The buildings are protected with portable fire extinguishers and a fire alarm system. The kitchen has an automatic hood system for the range.

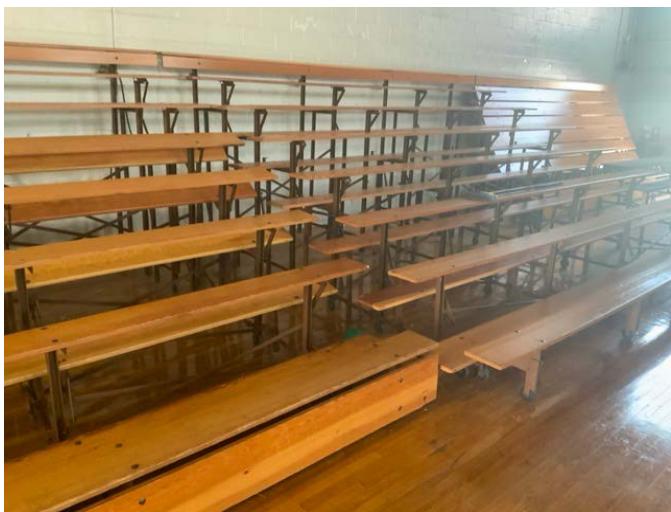
29 - BLEACHERS - GYMNASIUM

### Bleachers in Failed condition.

Recommendation: **Replace in 2025**

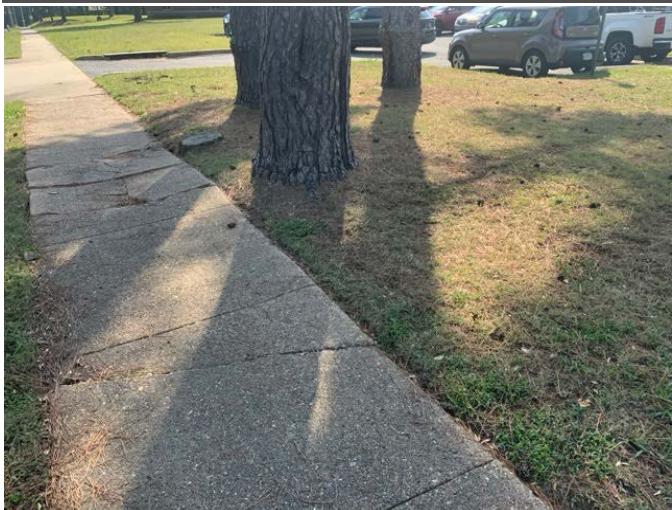
31 - SIDEWALK

The sidewalk near the small parking lot is cracked, heaved, and could be trip hazard. The playgrounds are either poured rubber or compacted dirty/grass, nothing to cushion a fall. The parking lot will need to be seal coated and striped. IN a few years Mill and Overlay will be required. The lights have been upgraded to LED. The tree in the HVAC fenced area and next to the building should be removed.

System	Description	Condition
<b>Pavement/Flatwork</b>	Asphalt lots with limited areas of concrete and adjacent concrete sidewalks, curbs, ramps	Fair
<b>Site Development</b>	Building-mounted and Property entrance signage; chain link fencing; wood-board fence dumpster enclosures Playgrounds, fencing, and site lights Limited park benches, picnic tables	Fair
<b>Landscaping and Topography</b>	Limited landscaping features including lawns, trees, bushes, and planters Irrigation not present No retaining walls Severe site slopes along west boundary	Fair
<b>Utilities</b>	Municipal water and sewer Local utility-provided electric and natural gas	Good
<b>Site Lighting</b>	Pole-mounted: LED Building-mounted: LED	Good
<b>Ancillary Structures</b>	None	--
<b>Accessibility</b>	Presently it does not appear an accessibility study is needed for this property. See Appendix D.	
<b>Key Issues and Findings</b>	Sidewalk near small parking lot is cracked and heaved with possible trip hazard.

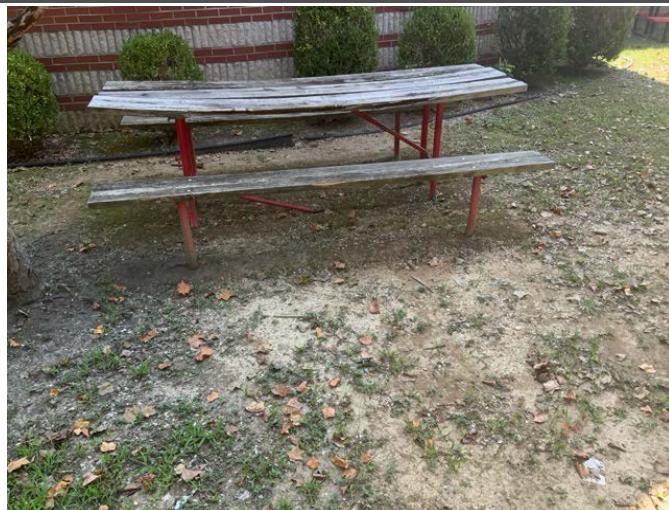
32 - PICNIC TABLE

<b>Pedestrian Plazas &amp; Walkways</b>						
G2020	Site	Fair	Parking Lots, Wheel Stops, Concrete or Plastic, Replace/Install	3	10	8305212
<b>Sitework</b>						
G2060	Site	Poor	Picnic Table, Wood/Composite/Fiberglass	2	2	8305196

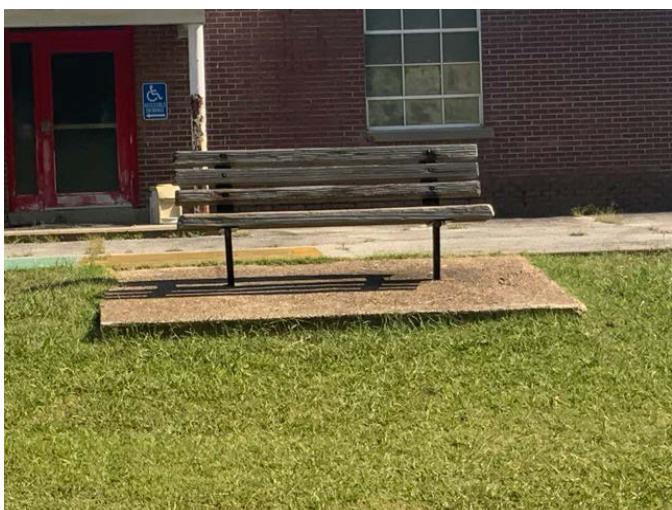
33 - PARK BENCH

UF L3 Code	Location	Condition	Asset/Component/Repair	Quantity	RUL	ID
G2060	Site	Fair	Fences & Gates, Fence, Chain Link 8'	100 LF	10	8305220
G2060	Site	Fair	Park Bench, Wood/Composite/Fiberglass	4	5	8305205
G2060	Site	Good	Picnic Table, Metal Powder-Coated	2	15	8305194

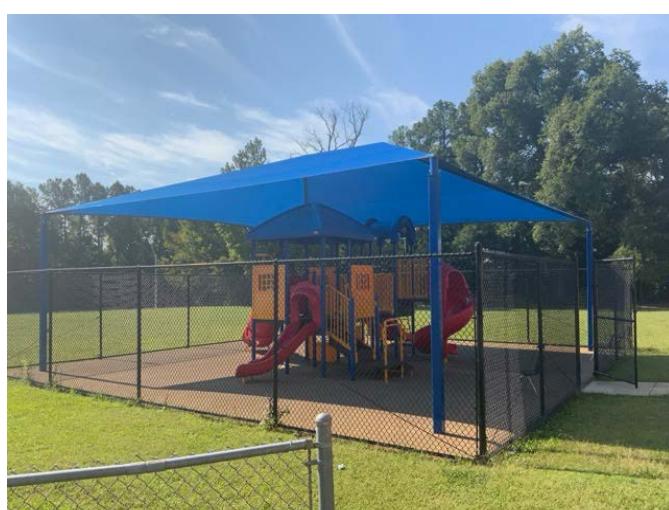
36 - PLAYGROUND

UF L3 Code	Location	Condition	Asset/Component/Repair	Quantity	RUL	ID
<b>Special Construction &amp; Demo</b>						
F1020	Site	Good	Covered Play Structure, Light Gauge w/ Fabric Top	1,300 SF	16	8303863
<b>Pedestrian Plazas &amp; Walkways</b>						
G2020	Site	Fair	Parking Lots, Pavement, Asphalt, Mill & Overlay	54,400 SF	3	8303879
G2020	Site	Fair	Parking Lots, Wheel Stops, Concrete or Plastic, Replace/Install	50	5	8303869
G2020	Site	Fair	Parking Lots, Pavement, Concrete	500 SF	10	8303861
G2030	Site	Fair	Sidewalk, Concrete, Large Areas	11,000 SF	17	8303867
<b>Athletic, Recreational &amp; Playfield Areas</b>						
G2050	Site	Good	Playfield Surfaces, Rubber, Poured-in-Place	3,100 SF	16	8303878
G2050	Site	Fair	Play Structure, Swing Set, 4 Seats	1	5	8303860
G2050	Site	Good	Play Structure, Multipurpose, Medium	1	16	8303877
G2050	Site	Fair	Play Structure, Multipurpose, Medium	1	10	8303876
G2050	Site	Fair	Play Structure, Multipurpose, Small	1	4	8303862
