FACILITY CONDITION ASSESSMENT

Melrose High School
2870 Deadrick Avenue
Memphis, Tennessee 38114

April 19, 2024

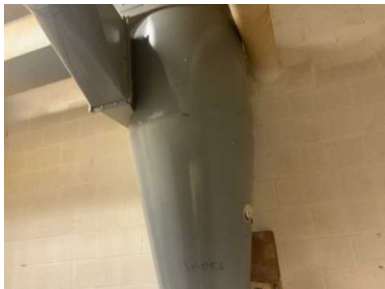
Out of service - AssetCALC ID: 7209952

Exhaust Fan

Industrial Dust Collection, 15 HP Motor
Melrose High School Classrooms

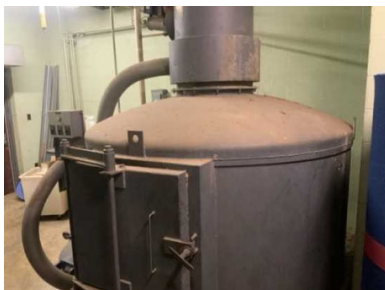
Out of service - AssetCALC ID: 7209844

Healthcare Equipment

Medical Waste Incinerator
Melrose High School Mechanical room

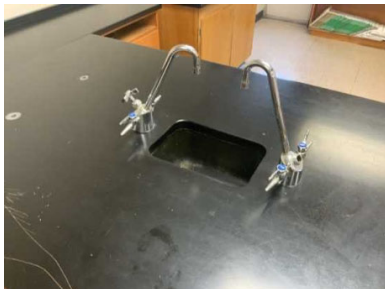
Out of service - AssetCALC ID: 7209948

Laboratory Equipment

Lab Sink, Epoxy Resin
Melrose High School Classrooms

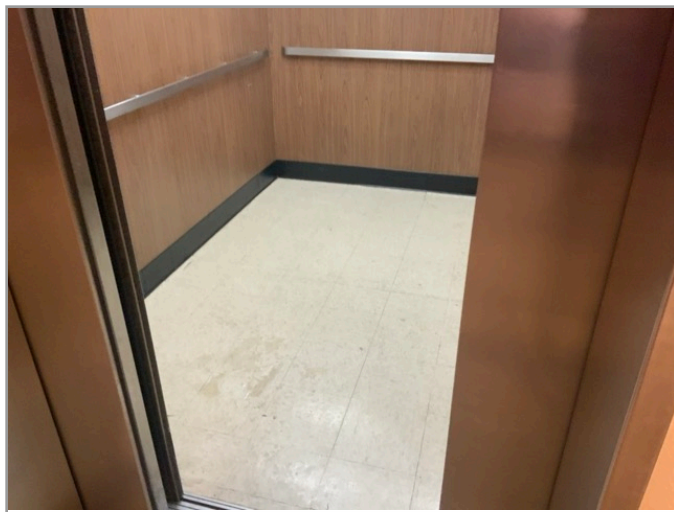
LOBBY LOOKING AT CABS (WITH DOORS OPEN)

7	Are tactile and Braille characters mounted to the left of each elevator car control button ?		×		
8	Are audible and visual floor position indicators provided in the elevator car?	×			Broken
9	Is the emergency call system on or adjacent to the control panel and does it not require voice communication ?		×		Nothing
