FACILITY CONDITION ASSESSMENT

Shelby County Board of Education
160 South Hollywood Street
Memphis, Tennessee 38112-4892
Michelle Stuart

Knight Road Elementary
3237 Knight Road
Memphis, Tennessee 38118

June 19, 2024

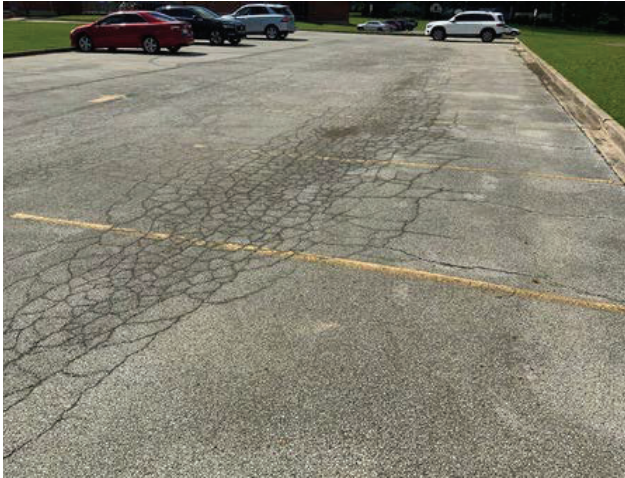
19 - PARKING LOTS

Parking Lots in Poor condition.

Was playground now a parking lot Cracking and not draining - AssetCALC ID: 7597301

Uniformat Code: G2020
Recommendation: **Mill and Overlay in 2025**

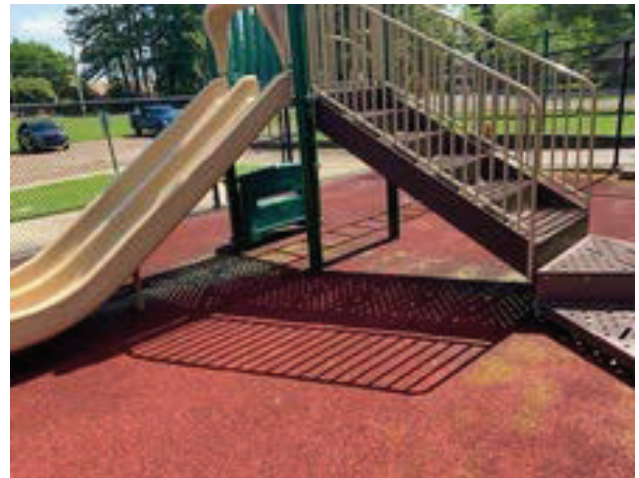
22 - PLAY STRUCTURE

The site has older playground and sports related installations that are no longer in use by the school. Some of these are in failed condition. The backstop has damaged poles, fencing that is collapsed and the benches are gone. The basketball poles do not have rims. The playground is being used as a parking lot. The asphalt paving is cracked and breaking up. Different areas do not drain and have ponding. The grass next to the sidewalk near the building has areas that are depressed and need to be raised. There are treated timbers used for curbing that are showing signs of dry rot. The swings are not all down and in usable condition. The climbing structures are locked off and not available for use.

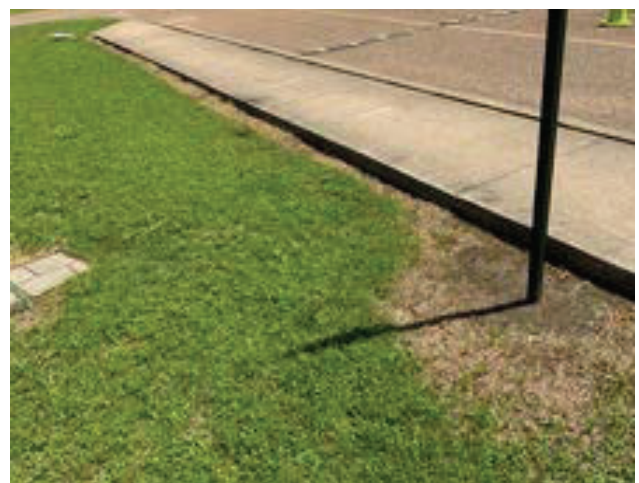
24 - LANDSCAPING

Landscaping in Poor condition.

Uniformat Code: G2080
Recommendation: **Repair in 2026**

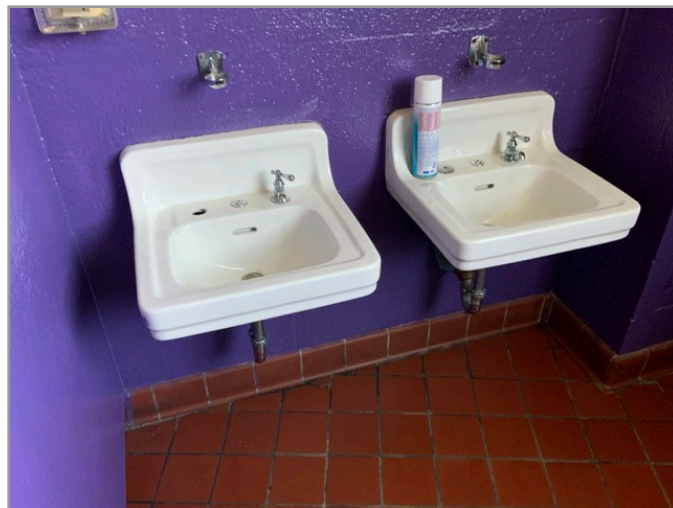
SINK, FAUCET HANDLES AND ACCESSORIES

Question		Yes	No	NA	Comments
1	Do publicly accessible toilet rooms appear to have a minimum compliant floor area ?		✗		
2	Does the lavatory appear to be mounted at a compliant height and with compliant knee area ?	✗			
3	Does the lavatory faucet have compliant handles ?	✗			No hot water, not mixing faucet
4	Is the plumbing piping under lavatories configured to protect against contact ?		✗		
5	Are grab bars provided at compliant locations around the toilet ?		✗		Bars are copper pipes, too small
6	Do toilet stall doors appear to provide the minimum compliant clear width ?		✗
