# FACILITY CONDITION ASSESSMENT

**Shelby County Board of Education**  
160 South Hollywood Street  
Memphis, Tennessee 38112-4892  
Michelle Stuart

Middle College High School  
750 East Parkway, South  
Memphis, Tennessee 38104

October 14, 2024

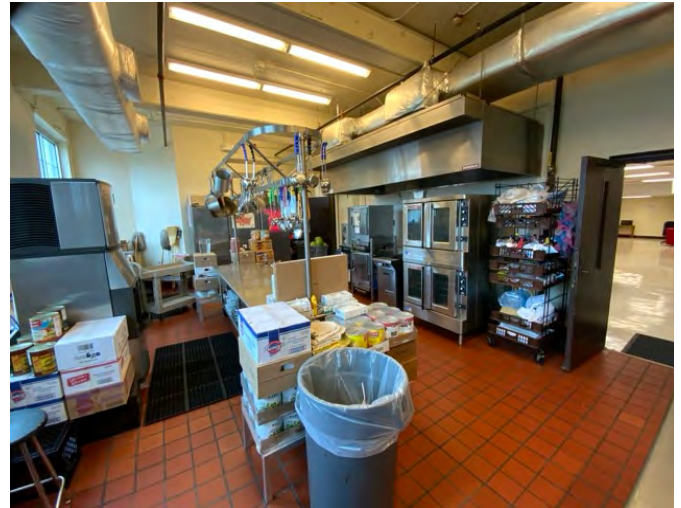
14 - COMMERCIAL KITCHEN

The kitchen contains a variety of food service equipment with no deficiencies observed. Future lifecycle replacements are anticipated and appear in the cost tables.

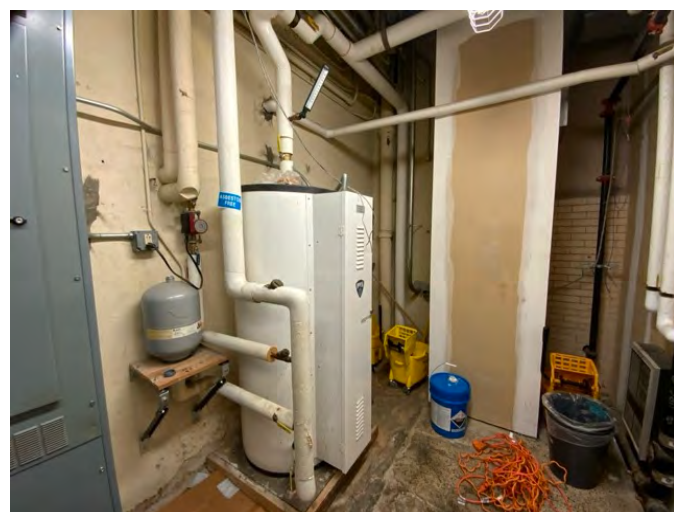
18 - DOMESTIC HOT WATER SUPPLY

The domestic water service within the building is well maintained, with no evidence of leaks observed. Domestic hot water is supplied by a residential gas water heater installed in 2012, which is within three years of its expected useful life and is showing signs of wear; and a commercial electric water heater installed in 2011. The plumbing fixtures in the restrooms show very little wear.
