# FACILITY CONDITION ASSESSMENT

**Shelby County Board of Education**  
160 South Hollywood Street  
Memphis, Tennessee 38112-4892  
Michelle Stuart

Oakhaven High School  
3125 Ladbrook Road  
Memphis, Tennessee 38118

*October 1, 2024*

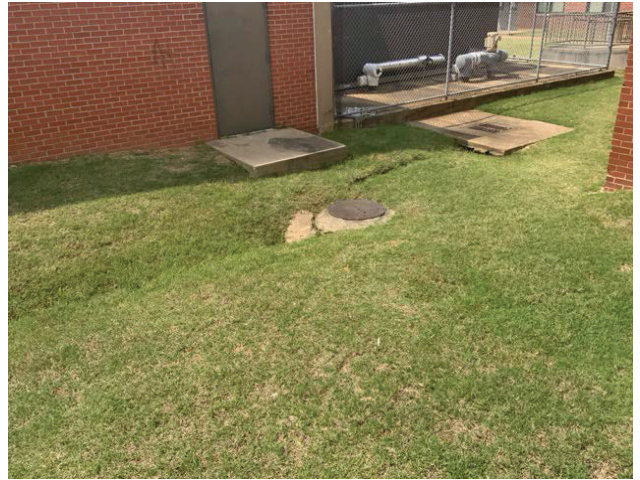
38 - STORM DRAINAGE COMPONENTS

G3030	Site	Poor	Storm Drainage Components, Catch Basin, 6' Deep, Replace/Install	2	2	8200908
-------	------	------	--	---	---	---------

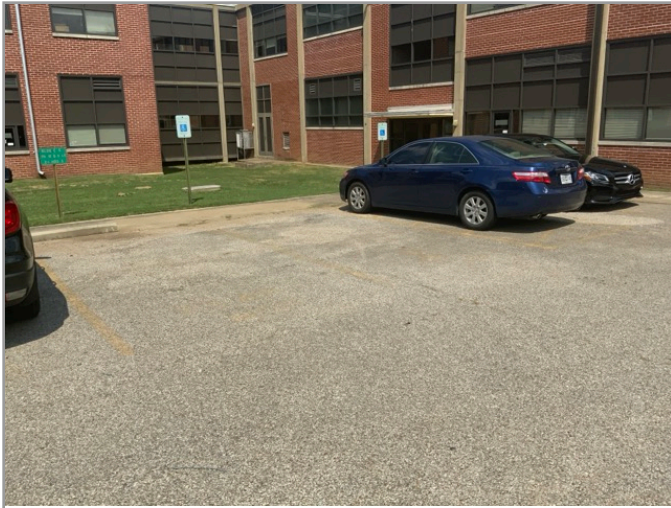
OVERVIEW OF ACCESSIBLE PARKING AREA

Question		Yes	No	NA	Comments
1	Does the required number of standard ADA designated spaces appear to be provided ?		✗		Does not include stalls in Elementary lot
2	Does the required number of van-accessible designated spaces appear to be provided ?	✗			
3	Are accessible spaces on the shortest accessible route to an accessible building entrance ?	✗			
4	Does parking signage include the International Symbol of Accessibility ?	✗			
5	Does each accessible space have an adjacent access aisle ?	✗			
6	Do parking spaces and access aisles appear to be relatively level and without obstruction ?	✗
