# FACILITY CONDITION ASSESSMENT

**Shelby County Board of Education**  
160 South Hollywood Street  
Memphis, Tennessee 38112-4892  
Michelle Stuart

Oakhaven Stadium  
3125 Ladbrook Road  
Memphis, Tennessee 38118

October 1, 2024

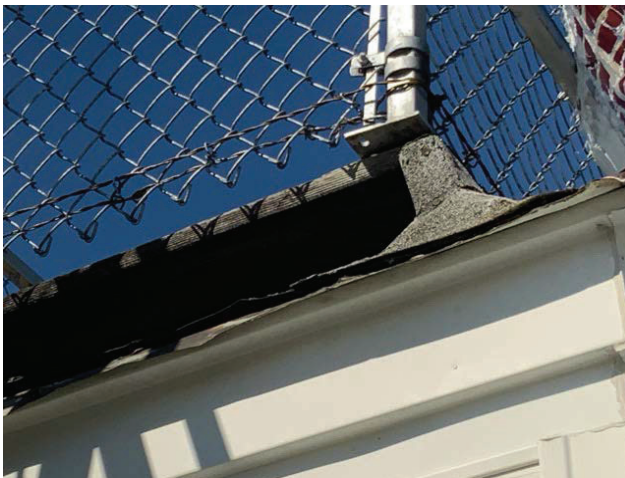
**Roofing in Poor condition.**

9 - MODIFIED BITUMEN ROOFING

Uniformat Code: B3010  
Recommendation: **Replace in 2025**
