FACILITY CONDITION ASSESSMENT

163745.23R000-030.354

March 6, 2024

Peabody Elementary School
2086 Young Avenue
Memphis, Tennessee 38104

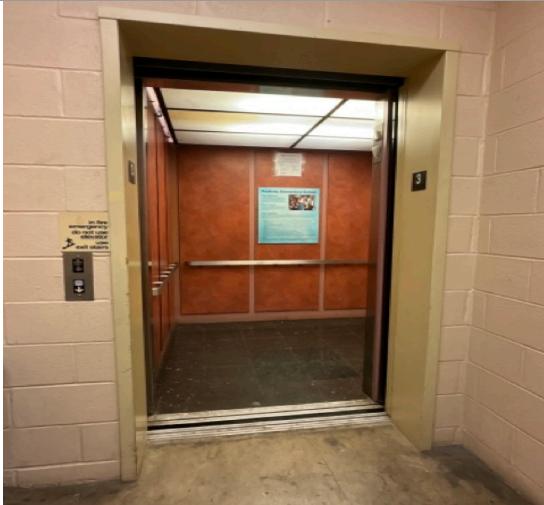
LOBBY LOOKING AT CAB

Question		Yes	No	NA	Comments
1	Are hallway call buttons configured with the "UP" button above the "DOWN" button?	✗			
2	Is accessible floor identification signage present on the hoistway sidewalls on each level?	✗			
3	Do the elevators have audible and visual arrival indicators at the lobby and hallway entrances?	✗			No audible indicator
4	Do the elevator hoistway and car interior appear to have a minimum compliant clear floor area?	✗			
5	Do the elevator car doors have automatic re-opening devices to prevent closure on obstructions?	✗			
6	Do elevator car control buttons appear to be mounted at a compliant height?	✗

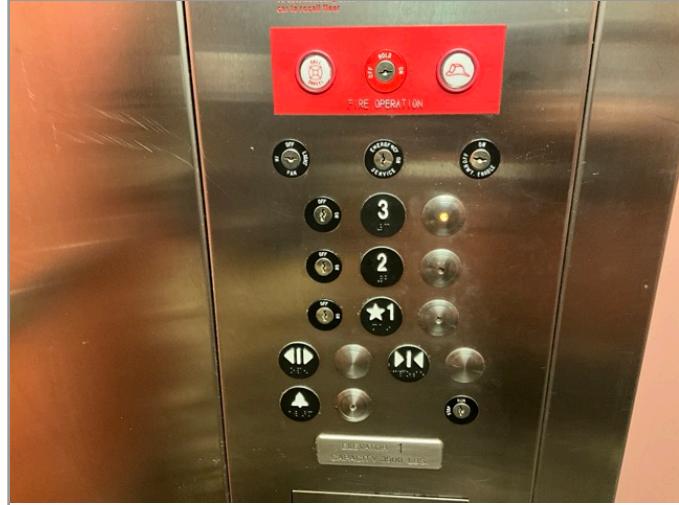
IN-CAB CONTROLS

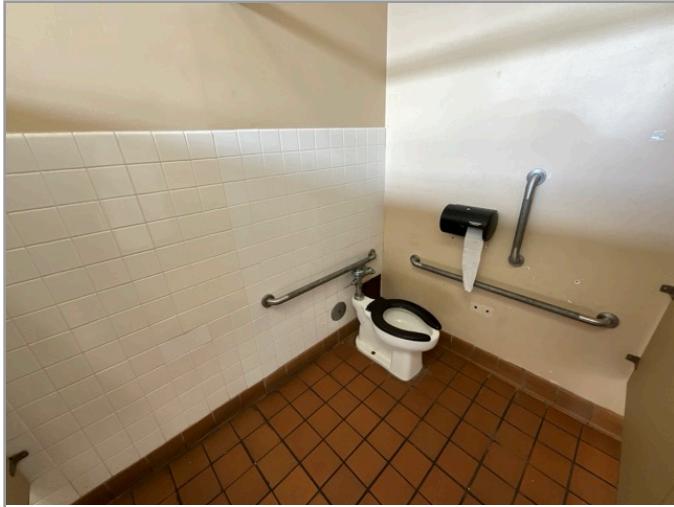
TOILET STALL OVERVIEW

Question		Yes	No	NA	Comments
1	Do publicly accessible toilet rooms appear to have a minimum compliant floor area ?	✗			
2	Does the lavatory appear to be mounted at a compliant height and with compliant knee area ?	✗			
3	Does the lavatory faucet have compliant handles ?		✗		
4	Is the plumbing piping under lavatories configured to protect against contact ?		✗		
5	Are grab bars provided at compliant locations around the toilet ?	✗			
6	Do toilet stall doors appear to provide the minimum compliant clear width ?	✗

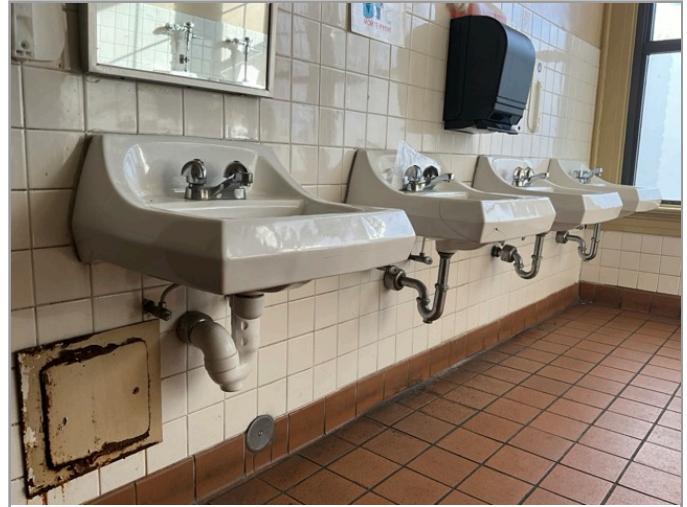
SINK, FAUCET HANDLES AND ACCESSORIES

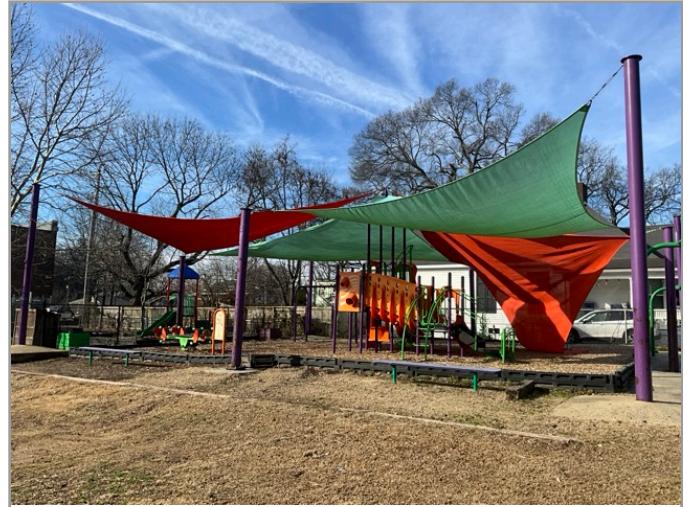
OVERVIEW OF PLAYGROUND

Question		Yes	No	NA	Comments
1	Is there an accessible route to the play area / s?		✗		No wheel chair access
2	Has the play area been reviewed for accessibility ?	✗			
3	Are publicly accessible swimming pools equipped with an entrance lift ?			✗
