# FACILITY CONDITION ASSESSMENT

**Shelby County Board of Education**  
160 South Hollywood Street  
Memphis, TN 38112-4892  
Michelle Stuart

Raleigh Egypt High School  
3970 Voltaire Avenue  
Memphis, TN 38128

*May 2, 2024*

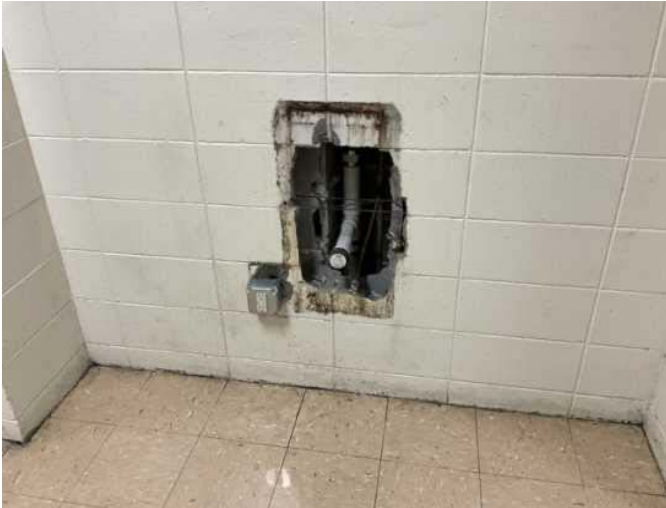
31 - ROUGH OPENING IN WALL

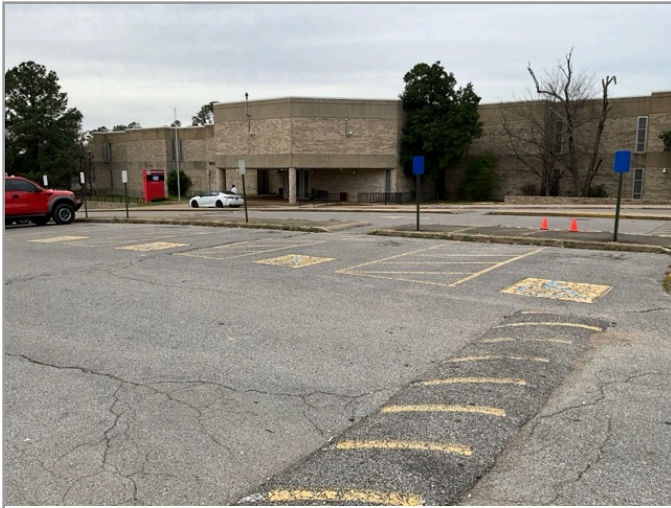
OVERVIEW OF ACCESSIBLE PARKING AREA
