# FACILITY CONDITION ASSESSMENT

**Shelby County Board of Education**  
160 South Hollywood Street  
Memphis, Tennessee 38112-4892  
Michelle Stuart

Riverview Elementary and Middle School  
241 Majuba Avenue  
Memphis, Tennessee 38109

*September 30, 2024*

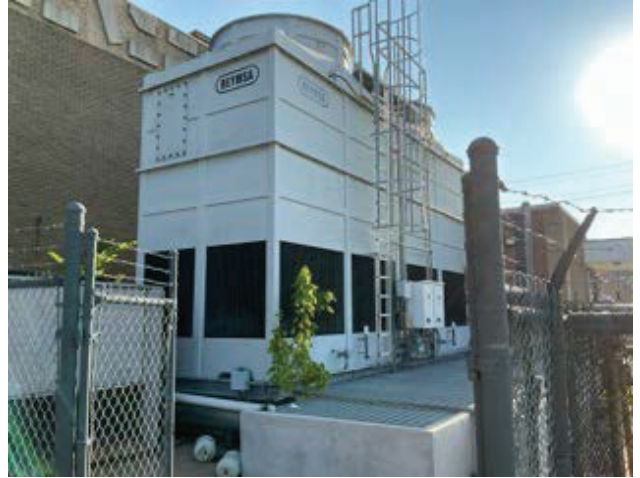
20 - COOLING TOWER

#### Cooling Tower in Failed condition.

Uniformat Code: D3030  
Recommendation: **Replace in 2024**

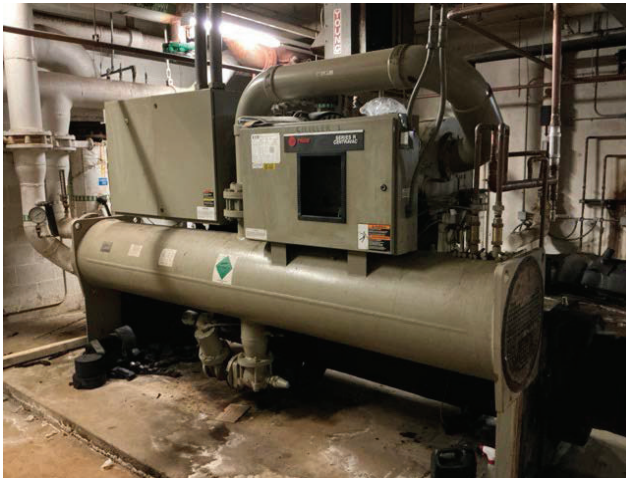
21 - CHILLER

**Chiller in Poor condition.**

Uniformat Code: D3030  
Recommendation: **Replace in 2024**

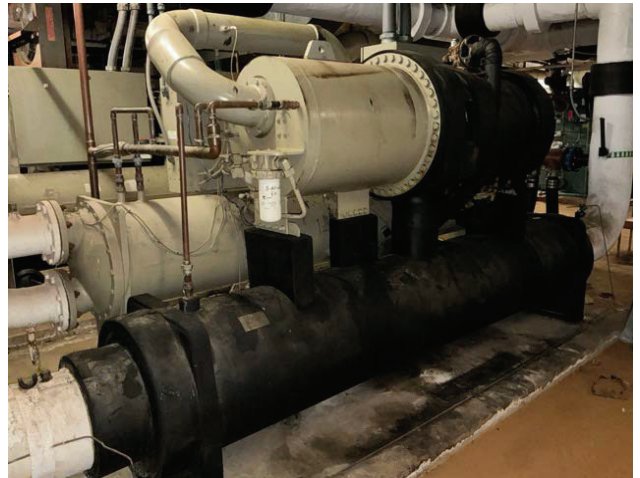
22 - CHILLER

**Chiller in Poor condition.**

Uniformat Code: D3030  
Recommendation: **Replace in 2026**

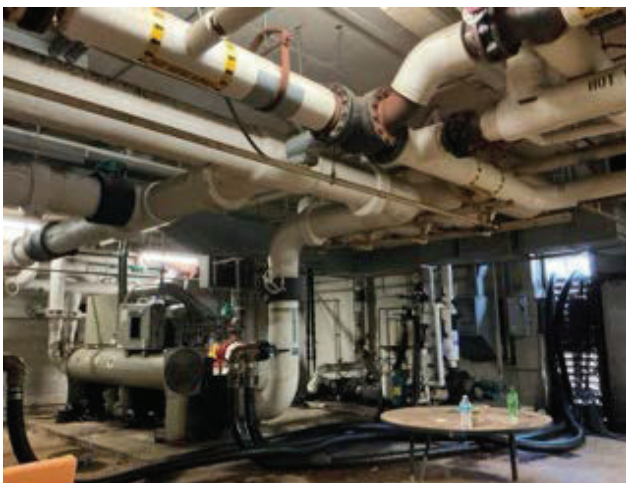
23 - HVAC SYSTEM

**HVAC System in Poor condition.**

Uniformat Code: D3050  
Recommendation: **Replace in 2026**

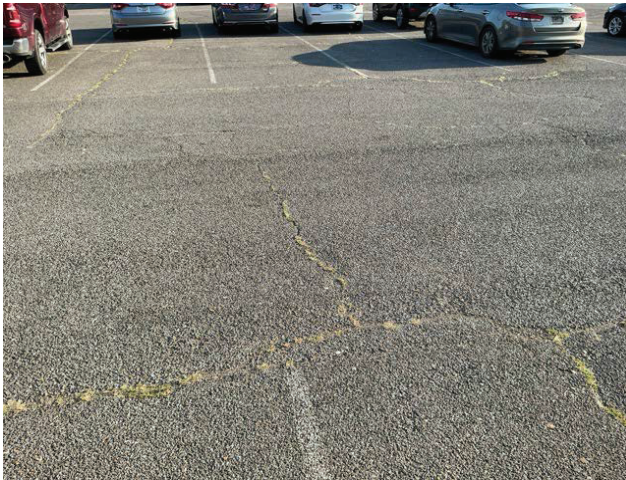
27 - PARKING LOT

**Parking Lots in Poor condition.**

Uniformat Code: G2020  
Recommendation: **Seal and Stripe in 2025**

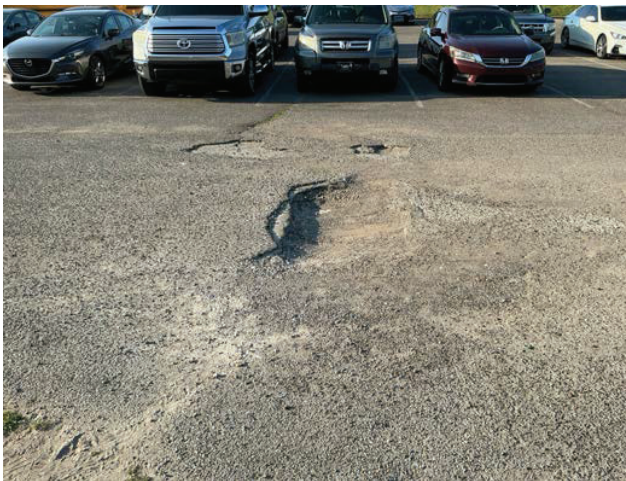
29 - PARKING LOT

**Parking Lots in Poor condition.**

Cracking throughout, failed patchwork - AssetCALC ID: 8121820

Uniformat Code: G2020  
Recommendation: **Mill and Overlay in 2025**
