FACILITY CONDITION ASSESSMENT

Sharpe Elementary
3431 Sharpe Avenue
Memphis, Tennessee 38111

DATE OF REPORT:
April 22, 2024

ON SITE DATE:
January 30, 2024

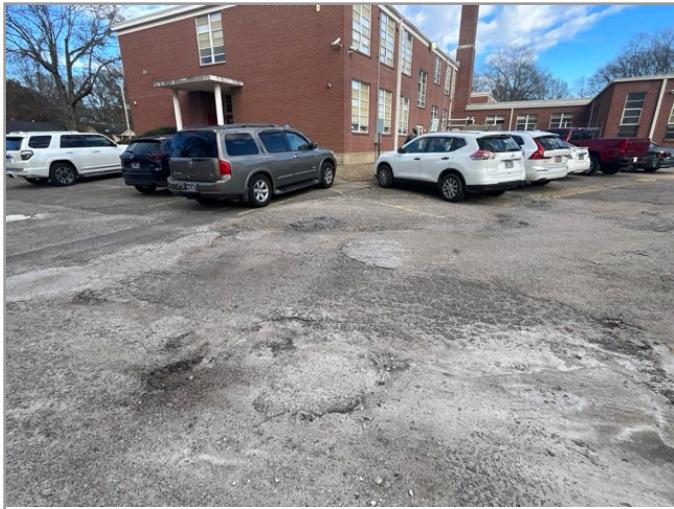
OVERVIEW OF ACCESSIBLE PARKING AREA

Question		Yes	No	NA	Comments
1	Does the required number of standard ADA designated spaces appear to be provided ?	✗			2 identified on site
2	Does the required number of van-accessible designated spaces appear to be provided ?	✗			1 identified on site
3	Are accessible spaces on the shortest accessible route to an accessible building entrance ?	✗			
4	Does parking signage include the International Symbol of Accessibility ?	✗			Signage is significantly worn
5	Does each accessible space have an adjacent access aisle ?		✗		
6	Do parking spaces and access aisles appear to be relatively level and without obstruction ?		✗

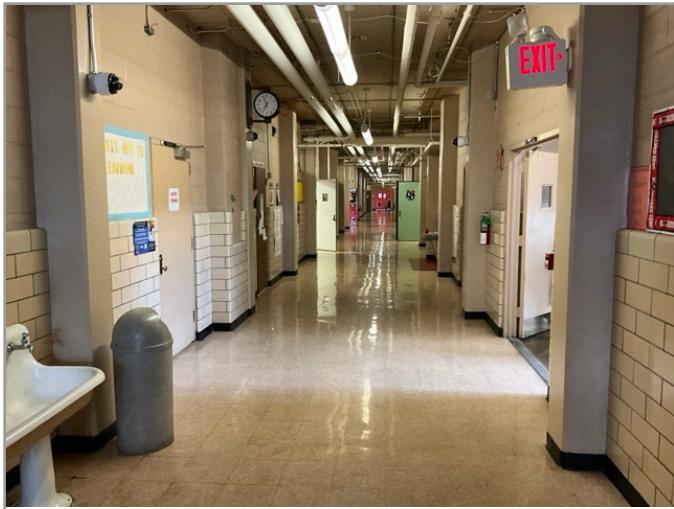
ACCESSIBLE INTERIOR PATH

Question		Yes	No	NA	Comments
1	Does an accessible route appear to connect all public areas inside the building ?		✗		No elevator to second Floor
2	Do accessible routes appear free of obstructions and/or protruding objects ?	✗			
3	Do ramps on accessible routes appear to have compliant slopes ?			✗	
4	Do ramp runs on an accessible route appear to have a compliant rise and width ?			✗	
5	Do ramps on accessible routes appear to have compliant end and intermediate landings ?			✗	
6	Do ramps on accessible routes appear to have compliant handrails ?			✗

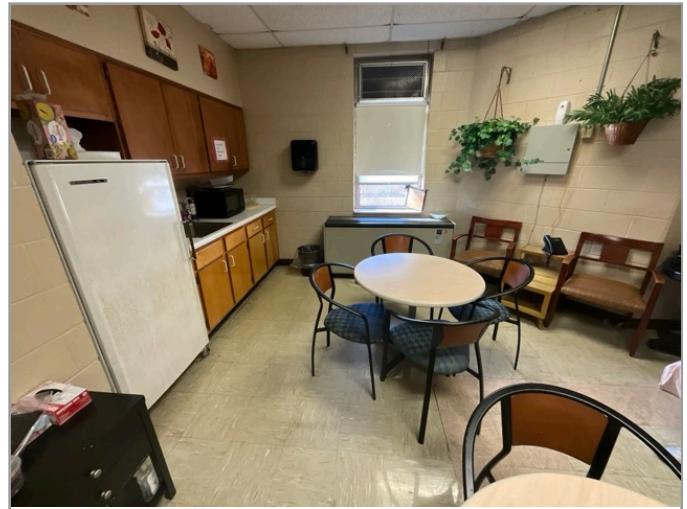
BREAKROOM OVERVIEW

Question		Yes	No	NA	Comments
1	Do kitchens/kitchenettes appear to have a minimum compliant path of travel or area of maneuverability ?	✗			Rearrange furniture layout to allow 40" clear path of travel
2	Are the appliances centered for a parallel or forward approach with adequate clear floor space ?	✗			
3	Is there an accessible countertop/preparation space of proper width and height ?		✗		
4	Is there an accessible sink space of proper width and height ?		✗		
5	Does the sink faucet have compliant handles ?	✗			
6	Is the plumbing piping under the sink configured to protect against contact ?		✗

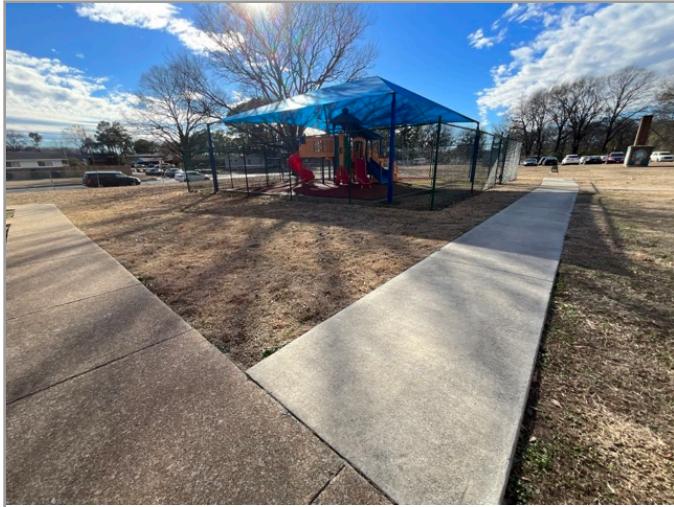
ACCESSIBLE ROUTE TO PLAYGROUND

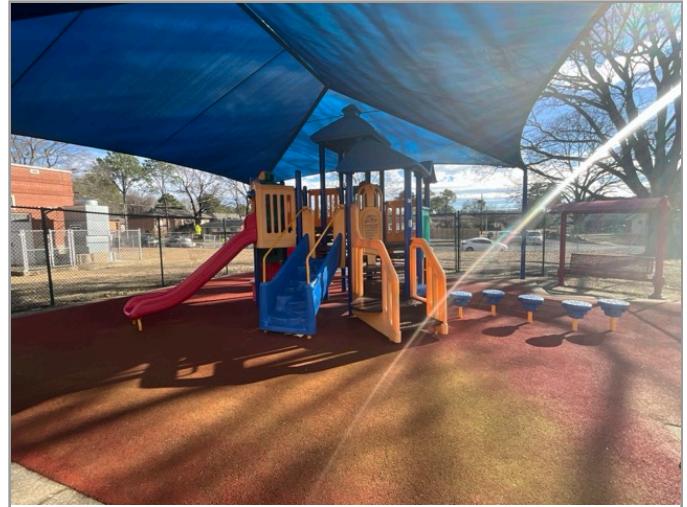
OVERVIEW OF PLAYGROUND
