FACILITY CONDITION ASSESSMENT

Sherwood Elementary School
1156 Robin Hood Lane
Memphis, Tennessee 38111

163745.23R000-055.354

January 12, 2024

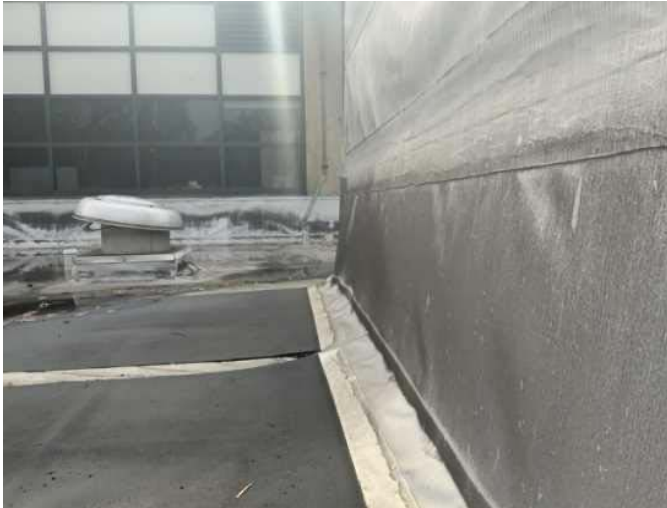
7 - ROOFING

The school is three stories with concrete panels and replaced aluminum windows. The roof is a TPO membrane that is near the end of life. No active roof leaks were reported. The ceiling tiles in the classrooms and hallways were replaced with a fiberglass style in 2023. Most of the classrooms and some areas of the hallway VCT tile were replaced in 2023. The walls are in need of repainting, some areas have paint peeling. The restrooms have water stained or damaged hard ceiling tiles and, in some cases, raise flooring. The toilet partitions are mainly a short wooden style or plastic for the ADA stalls. The plastic ones in some restrooms are pushed inside the latch so are non-functional and often cracked. There are no powered ADA door openers.

Roofing in Poor condition.

Uniformat Code: B3010
Recommendation: **Replace in 2025**

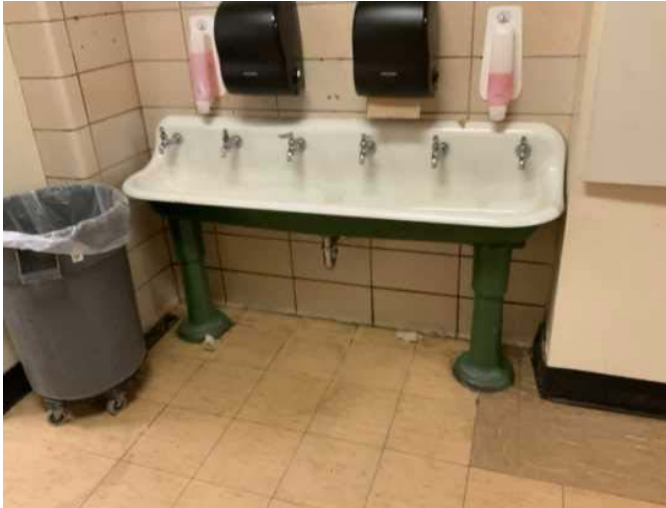
13 - SINK/LAVATORY

Sink/Lavatory in Poor condition.

Cast iron, faucets leaking - AssetCALC ID: 7172781

Uniformat Code: D2010
Recommendation: **Replace in 2025**

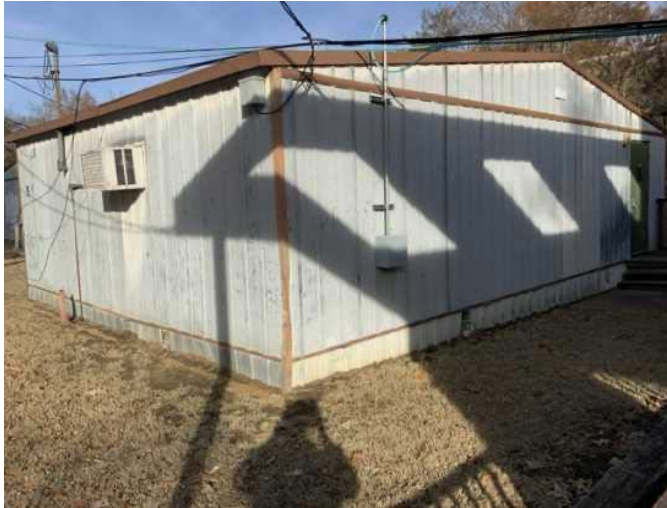
19 - PORTABLE CLASSROOM BUILDING

Ancillary Building in Poor condition.

Uniformat Code: F1020
Recommendation: **Replace in 2023**

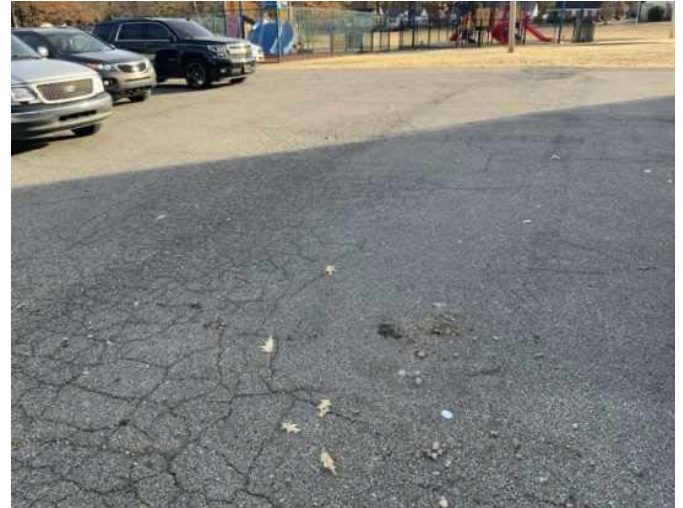
20 - PARKING LOTS

The parking lots are deteriorating both asphalt and concrete. The steps are old, and replacement may be required. The playground's play surfaces are missing wood chips or need the rubber patched. The fire hydrants are bent or broken off. The sport areas are old and not maintained. There are areas along the sidewalks that need to be backfilled to prevent additional washout.

Parking Lots in Poor condition.

Some cracking, broken out area in circle - AssetCALC ID: 7172689

Uniformat Code: G2020
Recommendation: **Mill and Overlay in 2025**

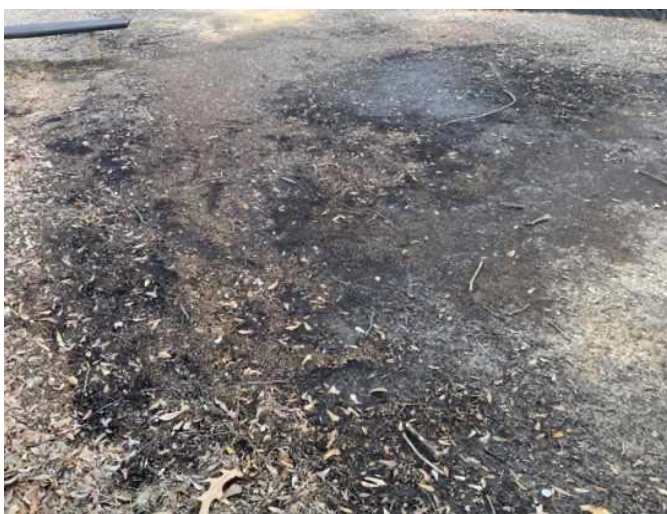
23 - PLAYFIELD SURFACES WOOD CHIPS

Playfield Surfaces in Failed condition.

Uniformat Code: G2050
Recommendation: **Replace in 2023**

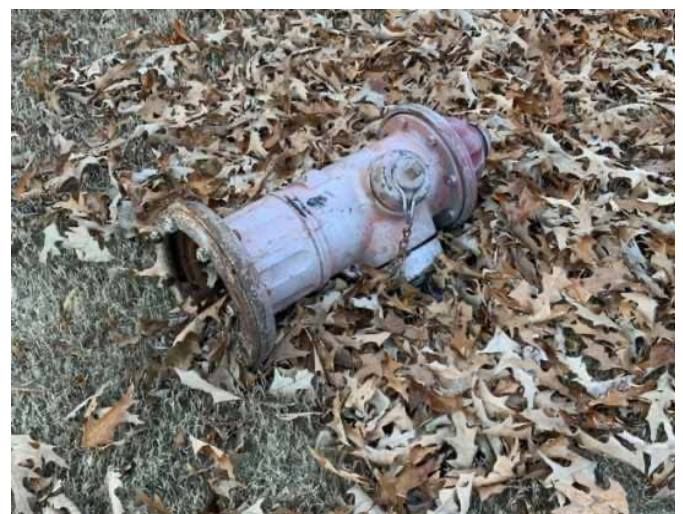
24 - HYDRANT

Hydrant in Failed condition.

Broken off - AssetCALC ID: 7172700

Uniformat Code: G3010
Recommendation: **Replace/Install in 2023**

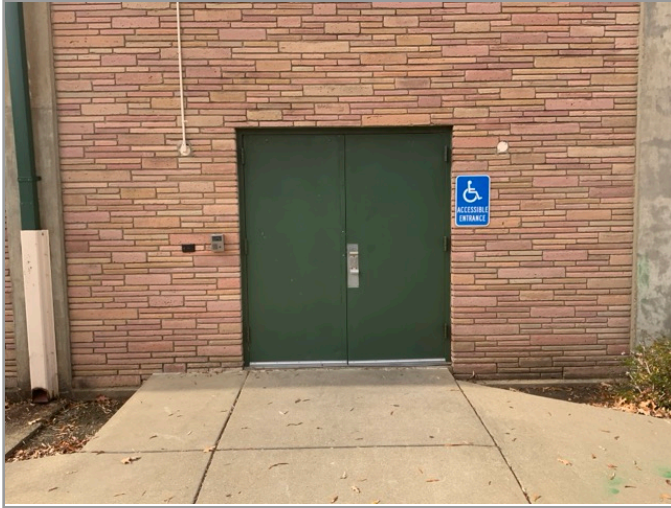
MAIN ENTRANCE

Question		Yes	No	NA	Comments
1	Do a sufficient number of accessible entrances appear to be provided ?		✗		Most are not Accessible
2	If the main entrance is not accessible, is an alternate accessible entrance provided?			✗	
3	Is signage provided indicating the location of alternate accessible entrances ?	✗			
4	Do doors at accessible entrances appear to have compliant maneuvering clearance area on each side ?	✗			
5	Do doors at accessible entrances appear to have compliant hardware ?	✗			No openers
6	Do doors at accessible entrances appear to have a compliant clear opening width ?	✗

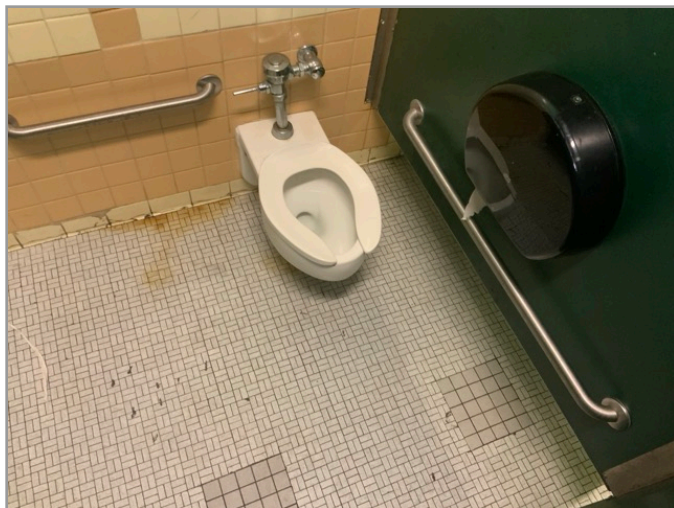
TOILET STALL OVERVIEW

Question		Yes	No	NA	Comments
1	Do publicly accessible toilet rooms appear to have a minimum compliant floor area ?	✗			
2	Does the lavatory appear to be mounted at a compliant height and with compliant knee area ?	✗			
3	Does the lavatory faucet have compliant handles ?	✗			
4	Is the plumbing piping under lavatories configured to protect against contact ?	✗			
5	Are grab bars provided at compliant locations around the toilet ?		✗		No bar behind toilet
6	Do toilet stall doors appear to provide the minimum compliant clear width ?	✗

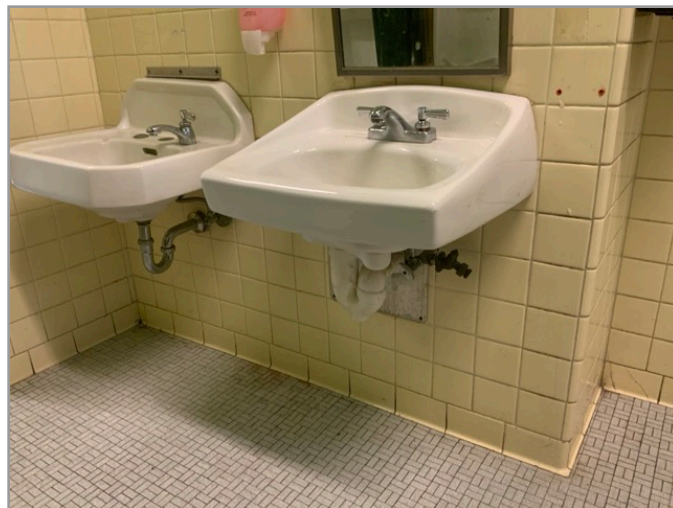
SINK, FAUCET HANDLES AND ACCESSORIES

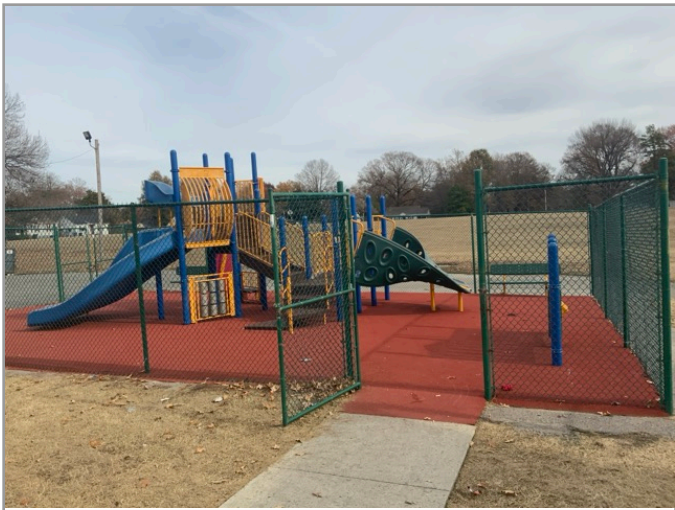
OVERVIEW OF PLAYGROUND

Question		Yes	No	NA	Comments
1	Is there an accessible route to the play area / s?	✗			
2	Has the play area been reviewed for accessibility ?			✗	Unknown
3	Are publicly accessible swimming pools equipped with an entrance lift ?			✗

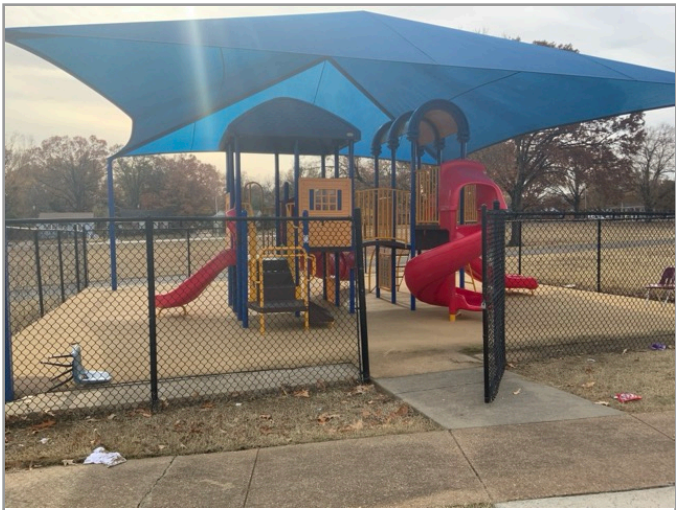
OVERVIEW OF PLAYGROUND
