# FACILITY CONDITION ASSESSMENT

**Shelby County Board of Education**  
160 South Hollywood Street  
Memphis, Tennessee 38112-4892  
Michelle Stuart

Sherwood Middle School  
3480 Rhodes Avenue  
Memphis, Tennessee 38111

*January 18, 2024*

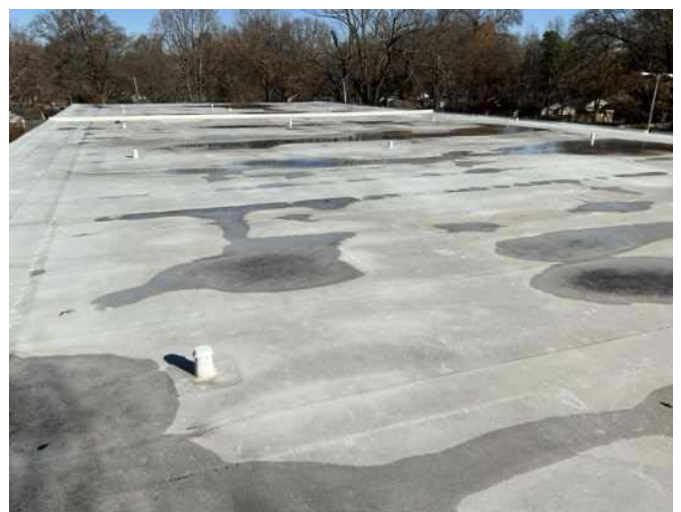
6 - ROOFING

The TPO was observed to have significant ponding, cracking and leaks throughout the building. - AssetCALC ID: 7178059

Uniformat Code: B3010  
Recommendation: **Replace in 2024**

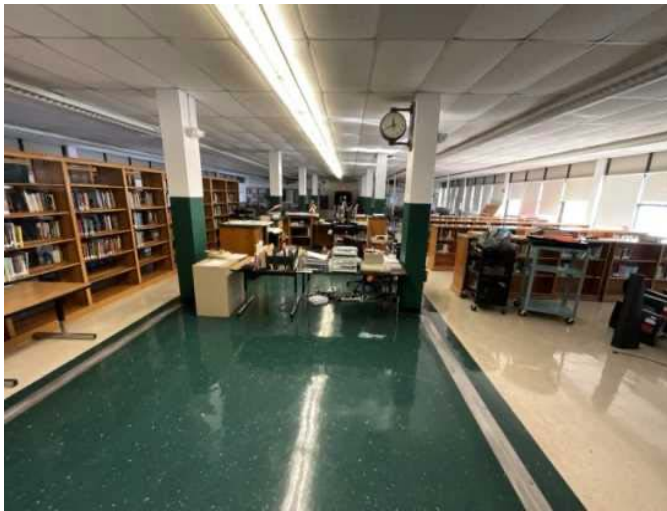
9 - LIBRARY

The building has issues; the library left wall was observed to have structural cracking. In addition, the TPO roof was observed to be in poor condition, due to significant ponding, seam failure, punctures, and tears. The Concrete Masonry Unit (CMU) siding appeared to be in fair condition. The aluminum-framed windows appeared to significantly aged, and the painted steel exterior doors showed significant wear and tear. The building interior consists of durable institutional finishes including VCT, ceramic tile, and acoustical ceiling tiles. Periodic painting, finish maintenance and replacement, and other measures to increase the longevity of the interior elements is evident. In general, typical lifecycle-based interior and exterior finish replacements are budgeted and anticipated.

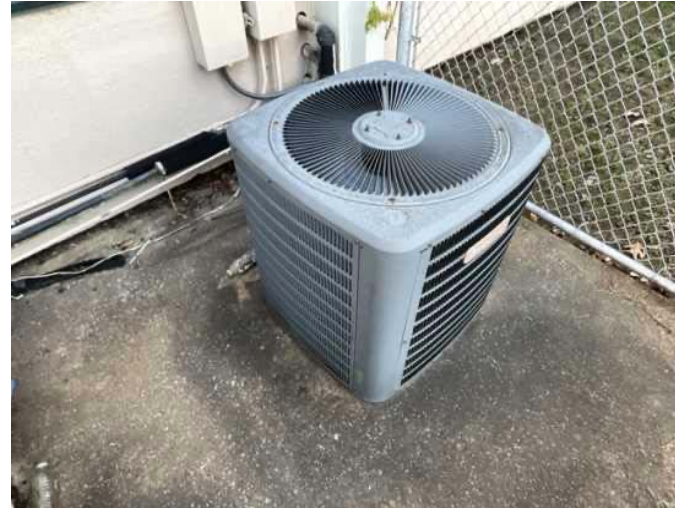
20 - SPLIT SYSTEM

Significant rusting and outdated components were observed. - AssetCALC ID: 7178084

Uniformat Code: D3030  
Recommendation: **Replace in 2024**

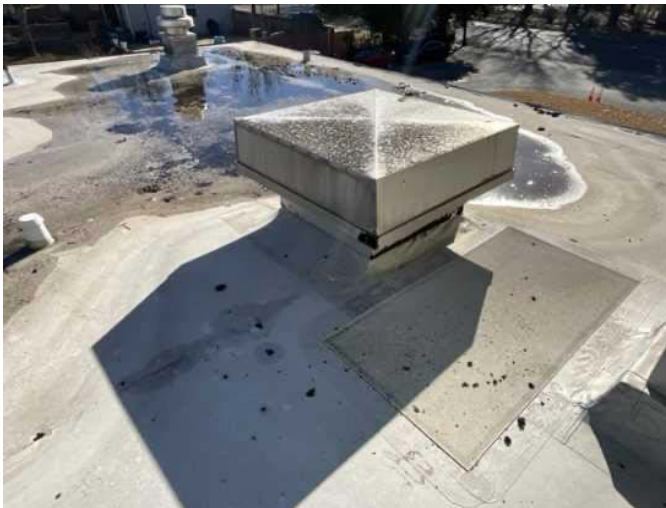
21 - AXIAL FLOW FAN

Barely in operational conditions. - AssetCALC ID: 7178173

Uniformat Code: D3060  
Recommendation: **Replace in 2025**

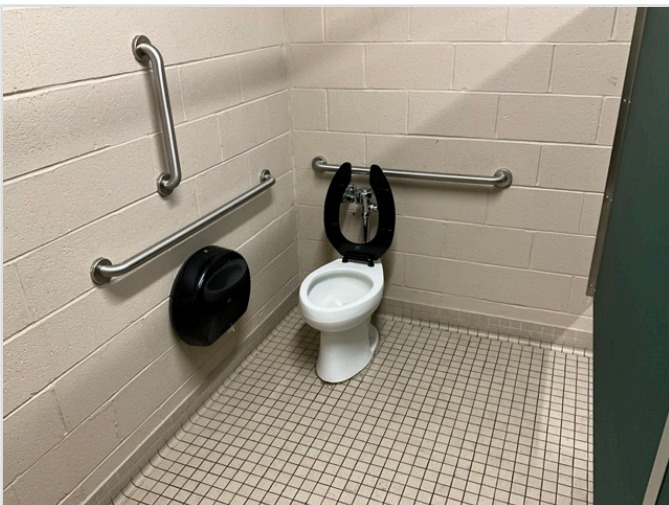
TOILET STALL OVERVIEW

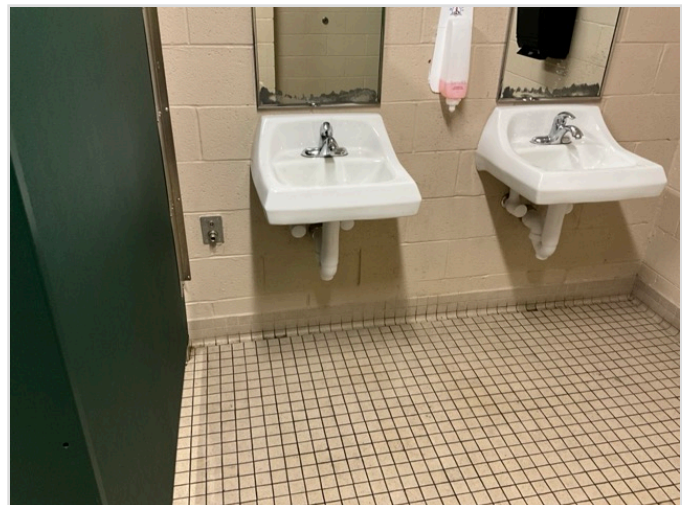
SINK, FAUCET HANDLES AND ACCESSORIES

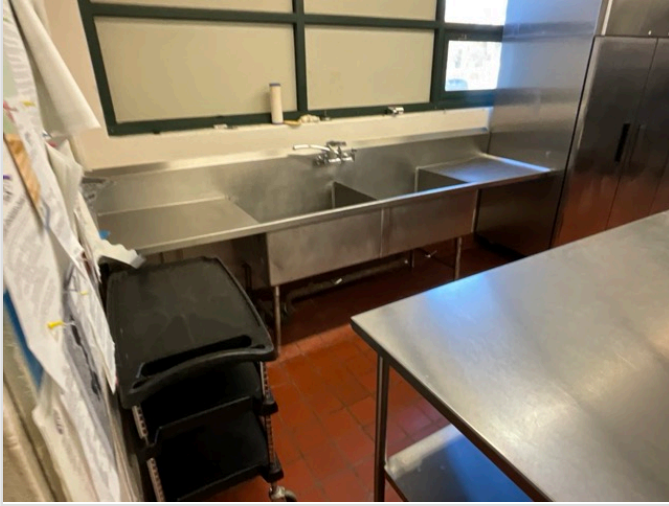
SINK CLEARANCE

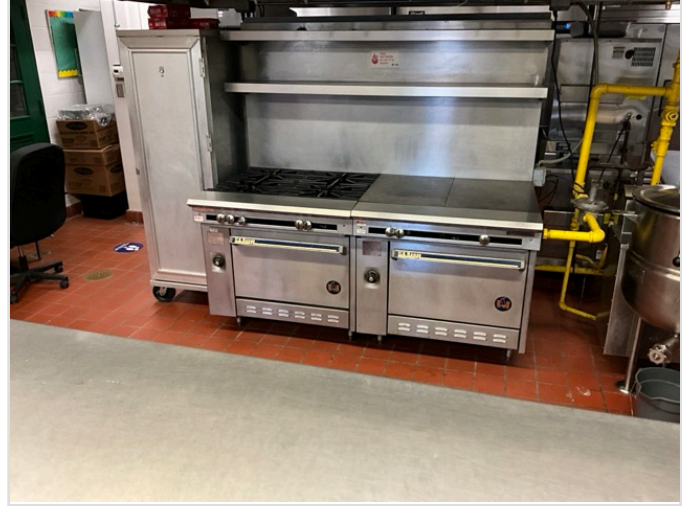
OVEN WITH CONTROLS
