FACILITY CONDITION ASSESSMENT

Trezevant CTC
3224 Range Line Road
Memphis, Tennessee 38127

163745.23R000-186.354

May 2, 2024

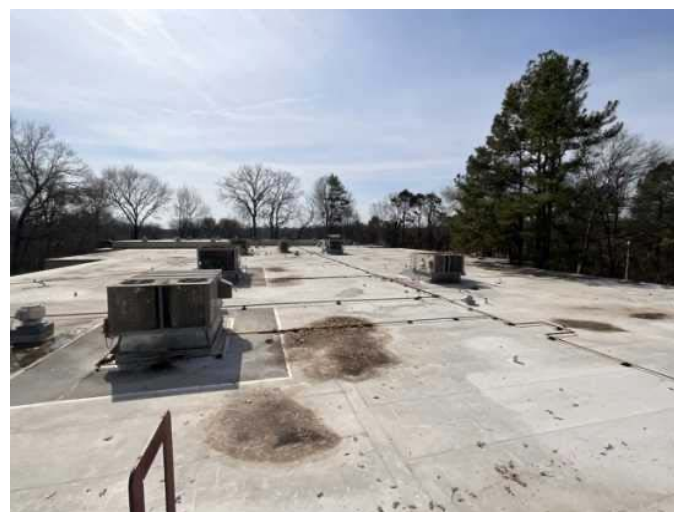
6 - ROOF OVERVIEW

The flat modified bitumen roof portion of the building is near the end of its useful life. Leaks have been reported on the east side of the central wing of the building. Classrooms in this portion of the building cannot be used due to the leaking roof.

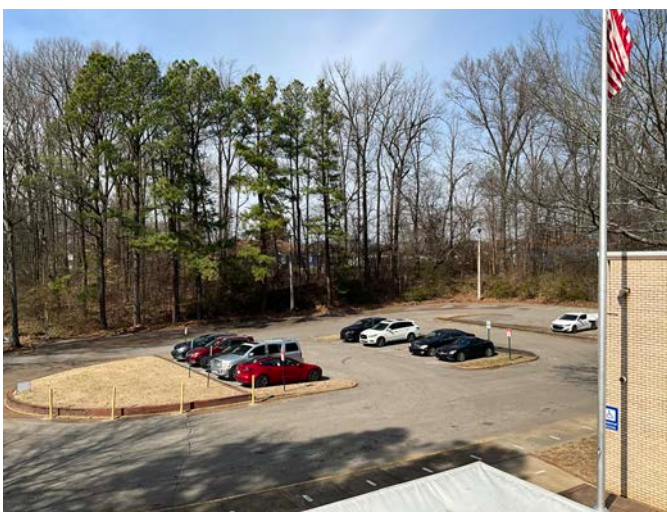
23 - MAIN PARKING AREA

Parking Lots in Failed condition.

Potholes and asphalt cracks throughout. - AssetCALC ID: 7412830

Uniformat Code: G2020
Recommendation: **Cut and Patch in 2024**

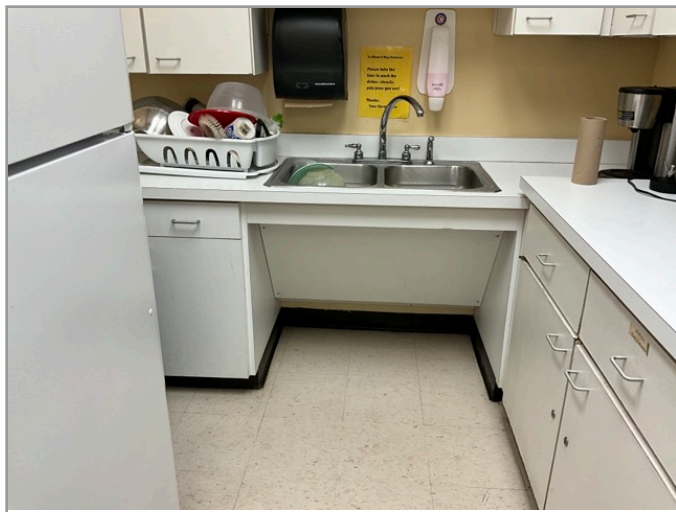
SINK CLEARANCE

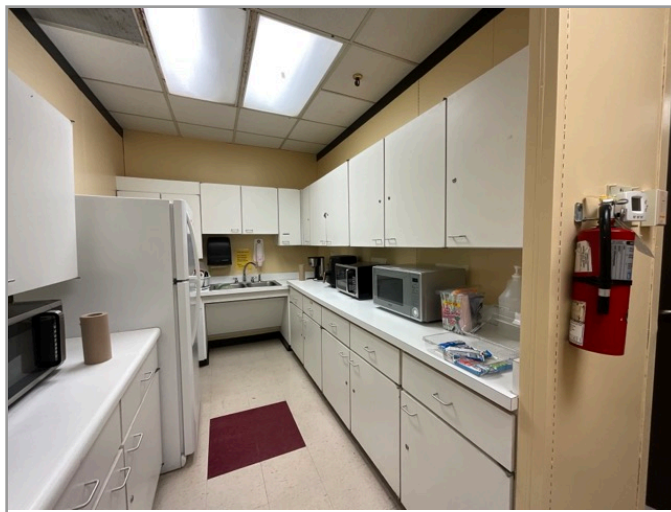
KITCHEN OVERVIEW
