FACILITY CONDITION ASSESSMENT

Wells Station Elementary
1610 Wells Station Road
Memphis, Tennessee 38108

BV PROJECT #:
163745.23R000-189.354

DATE OF REPORT:
October 1, 2024

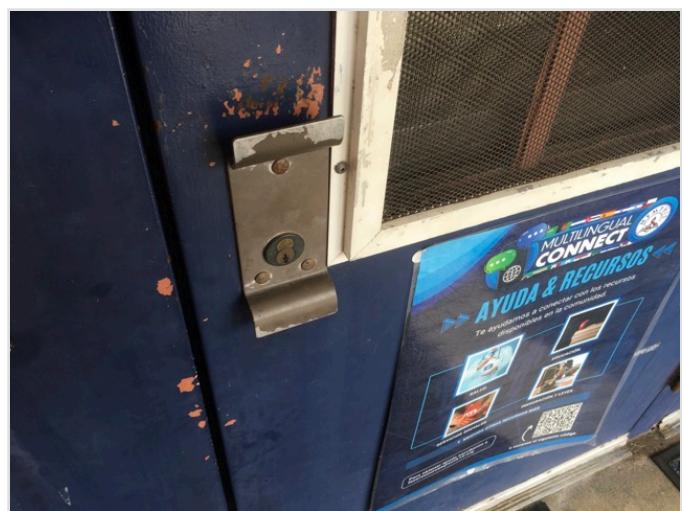
DOOR HARDWARE

Category	Major Issues (ADA study recommended)	Moderate Issues (ADA study recommended)	Minor Issues	None*
Parking				X
Exterior Accessible Route				X
Building Entrances			Door handles	
Interior Accessible Route				X
Elevators				X
Public Restrooms			Under sinks	
Kitchens/Kitchenettes	NA			
Playgrounds & Swimming Pools				
Other	NA
