# FACILITY CONDITION ASSESSMENT

**Shelby County Board of Education**  
160 South Hollywood Street  
Memphis, Tennessee 38112-4892  
Michelle Stuart

Brewster Elementary  
2605 Sam Cooper Boulevard  
Memphis, Tennessee 38112

*September 30, 2024*

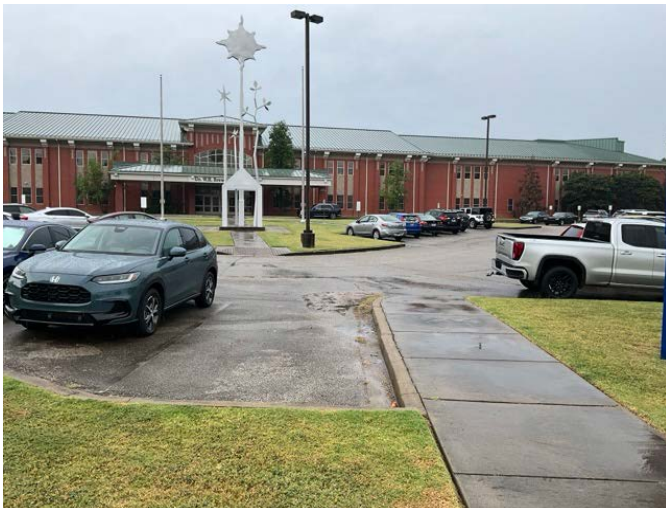
33 - SECONDARY PARKING AREA

Site maintenance appears to be in fair condition. However, the sidewalks are pocked and uneven. The asphalt parking lot is in poor condition, with large cracks, and signs of ponding and alligator cracking.
