FACILITY CONDITION ASSESSMENT

Shelby County Board of Education 160 South Hollywood Street Memphis, Tennessee 38112-4892 Michelle Stuart

Carver High School 1591 Pennsylvania Street Memphis, Tennessee 38109

163745.23R000-075.354

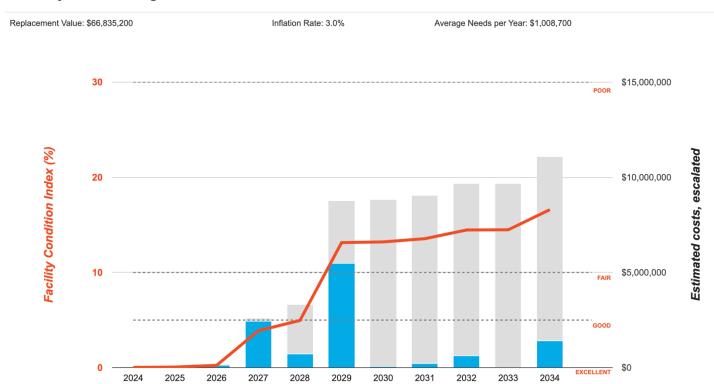
FCI Analysis: Carver High School

FCI, unabated

Reserve costs, escalated

Deferred costs, escalated

One of the major goals of the FCA is to calculate each building's Facility Condition Index (FCI), which provides a theoretical objective indication of a building's overall condition. By definition, the FCI is defined as the ratio of the cost of current needs divided by current replacement value (CRV) of the facility. The chart below presents the industry standard ranges and cutoff points.

The deficiencies and lifecycle needs identified in this assessment provide the basis for a portfolio-wide capital improvement funding strategy. In addition to the current FCI, extended FCI's have been developed to provide owners the intelligence needed to plan and budget for the "keep-up costs" for their facilities. As such the 3-year, 5-year, and 10-year FCI's are calculated by dividing the anticipated needs of those respective time periods by current replacement value. As a final point, the FCI's ultimately provide more value when used to relatively compare facilities across a portfolio instead of being overanalyzed and scrutinized as stand-alone values. The table below summarizes the individual findings for this FCA:

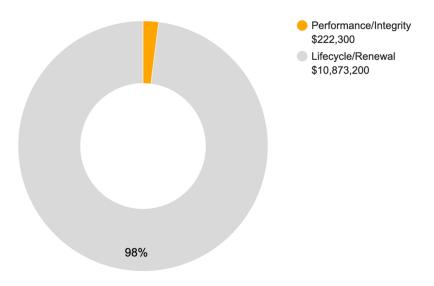
Plan Type Distribution (by Cost)

10-YEAR TOTAL: \$11,095,500

Each line item in the cost database is assigned a Plan Type, which is the primary reason or rationale for the recommended replacement, repair, or other corrective action. This is the "why" part of the equation. A cost or line item may commonly have more than one applicable Plan Type; however, only one Plan Type will be assigned based on the "best" fit, typically the one with the greatest significance.

Plan Type Descriptions						
Safety	An observed or reported unsafe condition that if left unaddressed could result in injury; a system or component that presents potential liability risk.					
Performance/Integrity	Component or system has failed, is almost failing, performs unreliably, does not perform as intended, and/or poses risk to overall system stability.					
Accessibility	Does not meet ADA, UFAS, and/or other handicap accessibility requirements.					
Environmental	Improvements to air or water quality, including removal of hazardous materials from the building or site.					
Retrofit/Adaptation	 Components, systems, or spaces recommended for upgrades in in order to meet current standards, facility usage, or client/occupant needs. 					
Lifecycle/Renewal	Any component or system that is not currently deficient or problematic but for which future replacement or repair is anticipated and budgeted.

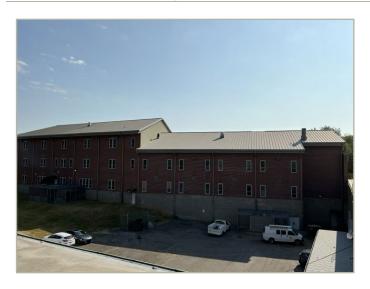
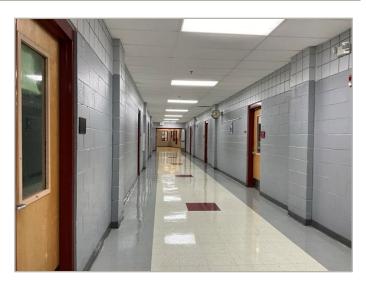
2. Main Building

Main Building: Syster	ms Summary	
Constructed/Renovated	1958/1999	
Building/Group Size	142,113 SF	
Number of Stories	3 above grade with one below-grade basement level	
System	Description	Condition
Structure	Masonry bearing walls with metal roof deck supported by open-web steel joists and concrete slab and basement foundation systems	Fair
Façade	Primary Wall Finish: Brick Windows: Aluminum	Fair
Roof	Primary: Gable construction with metal finish Secondary: Flat and domed construction with single-ply TPO/PVC membrane Tertiary: Flat with modified bitumen finish	Fair
Interiors	Walls: Painted gypsum board and CMU Floors: VCT, sports wood plank, and Terrazzo Ceilings: Painted gypsum board, ACT, and Unfinished/exposed	Fair
Elevators	Passenger: 2 hydraulic cars serving all 4 floors within the central section of the main building	Good
Plumbing	Distribution: Copper and Galvanized iron supply and cast-iron waste and venting Hot Water: Gas domestic boilers and water heaters Fixtures: Toilets, urinals, and sinks in all restrooms	Fair

Main Building: Systems Summary					
HVAC	Central System: Boilers, chillers, and air handlers feeding hydronic radiators and cabinet terminal units. Non-Central System: RTU, Ductless split-systems				
Fire Suppression	Wet-pipe sprinkler system and fire extinguishers, and kitchen hood system	n Fair			
Electrical	Source & Distribution: Main switchboard with copper wiring. Interior Lighting: Linear fluorescent Emergency Power: None	Fair			
Fire Alarm	Alarm panel with smoke detectors, heat detectors, alarms, strobes, pull stations, back-up emergency lights, and exit signs	Fair			
Equipment/Special	Commercial kitchen equipment	Fair			
Accessibility	Presently it does not appear an accessibility study is needed for this building. S Appendix D.				
Key Issues and Findings	Electrical and HVAC systems are damaged and or missing from the auditoriu dishwasher in inoperable.	m. Kitchen

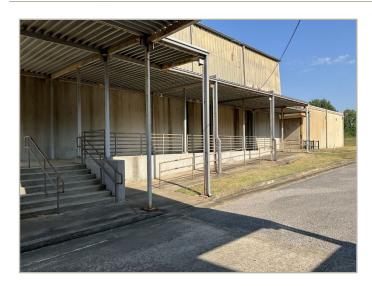
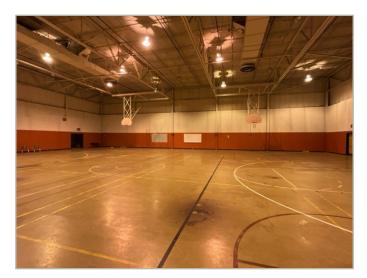
3. Old Gymnasium

Old Gymnasium: Systems Summary					
Constructed/Renovated	1958, Unknown				
Building Size	22,906 SF				
Number of Stories	1 above grade				
System	Description	Condition			
Structure	Masonry bearing walls with metal roof deck supported by open-web steel joists and concrete slab foundation system	Fair			
Façade	Primary Wall Finish: Concrete integral to superstructure Secondary Wall Finish: Metal siding Windows: Aluminum	Fair			
Roof	Flat construction with single-ply TPO/PVC membrane	Fair			
Interiors	Walls: Painted CMU and Gypsum board Floors: Sports flooring, sealed concrete Ceilings: ACT, Unfinished/exposed	Fair			
Elevators	None				
Plumbing	Distribution: Copper supply and cast-iron waste and venting Hot Water: Gas water heaters with integral tanks Fixtures: Toilets, urinals, and sinks in all restrooms	Fair			
HVAC	Non-Central System: Packaged units Supplemental components: Suspended unit heaters	Good

Old Gymnasium: Systems Summary					
Fire Suppression	Wet-pipe sprinkler system and fire extinguishers	Fair			
Electrical	Source & Distribution: Main panel with copper wiring Interior Lighting: Linear fluorescent, metal halide Emergency Power: None	Fair			
Fire Alarm	Alarm panel with smoke detectors, heat detectors, alarms, strobes, pull stations, back-up emergency lights, and exit signs	Fair			
Equipment/Special	None				
Accessibility	Presently it does not appear an accessibility study is needed for this build Appendix D.	ing. See			
Key Issues and Findings	Gym lighting is outdated.

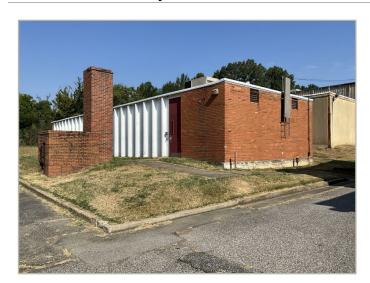
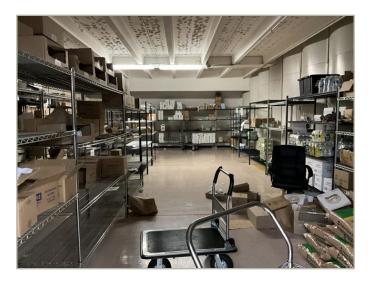
4. Food Pantry

Food Pantry: Systems Summary				
Constructed/Renovated	1958			
Building Size	2,069 SF			
Number of Stories	1 above grade			
System	Description	Condition		
Structure	Steel frame with concrete-topped metal decks and CMU over concrete pad	Fair		
Façade	Primary Wall Finish: Concrete integral to superstructure Secondary Wall Finish: Brick veneer Windows: Aluminum	Fair		
Roof	Flat construction with single-ply TPO/PVC membrane	Fair		
Interiors	Walls: Painted CMU, concrete Floors: VCT Ceilings: ACT, Unfinished/exposed	Fair		
Elevators	None			
Plumbing	Distribution: Copper supply and cast-iron waste and venting Hot Water: Electric water heaters with integral tanks Fixtures: Toilets, and sinks in all restrooms	Fair		
HVAC	Non-Central System: Packaged units	Good		
Fire Suppression	Fire extinguishers only	Good

Food Pantry: Systems Summary		
Electrical	Source & Distribution: Main panel with copper wiring fed from main building Interior Lighting: Linear fluorescent	Fair
Fire Alarm	Alarm panel from main building with smoke detectors, heat detectors, alarms, strobes, pull stations, back-up emergency lights, and exit signs	Fair
Equipment/Special	None	
Accessibility	Presently it does not appear an accessibility study is needed for this build Appendix D.	ing. See
Key Issues and Findings	Exterior brickwork pointing has failed

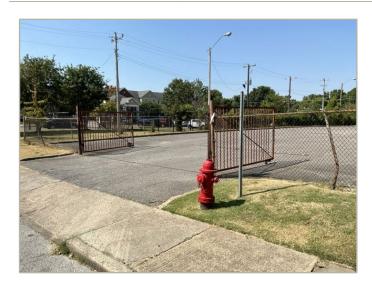
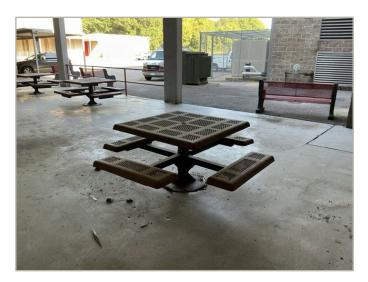
5. Site Summary

Site Information		
System	Description	Condition
Pavement/Flatwork	Asphalt lots with limited areas of concrete aprons and pavement and adjacent concrete sidewalks, curbs, ramps, and stairs	Fair
Site Development	Property entrance and building mounted signage; chain link fencing Limited, park benches, picnic tables, trash receptacles	Fair
Landscaping and Topography	Limited landscaping features including lawns, trees, bushes, and planters Irrigation present Low to moderate site slopes throughout	Fair
Utilities	Municipal water and sewer Local utility-provided electric and natural gas	Good
Site Lighting	Pole-mounted: LED, HPS Building-mounted: LED	Fair
Ancillary Structures	None	
Accessibility	Presently it does not appear an accessibility study is needed for the exterior site areas. See Appendix D.	
Key Issues and Findings	Parking lots: worn asphalt and striping

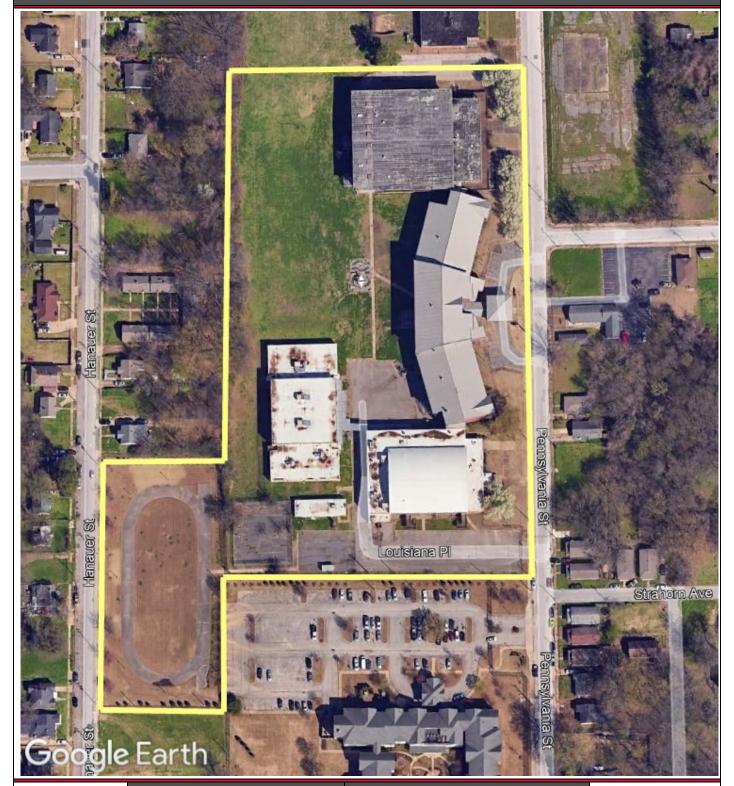
Site Plan

Project Number	Project Name
163745.23R000-075.354	Carver High School
Source	On-Site Date
Google	August 27, 2024

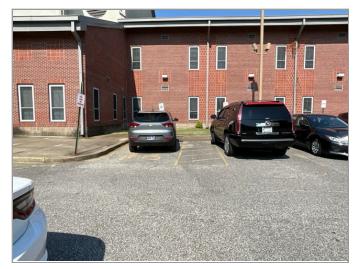
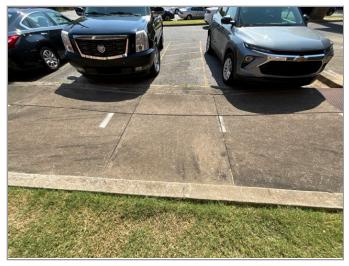
Parking

CLOSE-UP OF STALL

Question	Yes	No	NA	Comments
1	Does the required number of standard ADA designated spaces appear to be provided?	×			
2	Does the required number of van-accessible designated spaces appear to be provided?	×			
3	Are accessible spaces on the shortest accessible route to an accessible building entrance ?	×			
4	Does parking signage include the International Symbol of Accessibility?	×			
5	Does each accessible space have an adjacent access aisle ?	×			
6	Do parking spaces and access aisles appear to be relatively level and without obstruction?	×

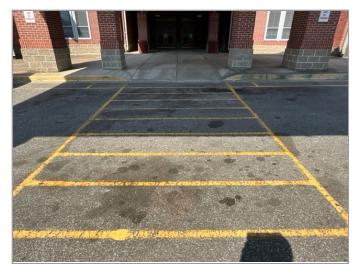
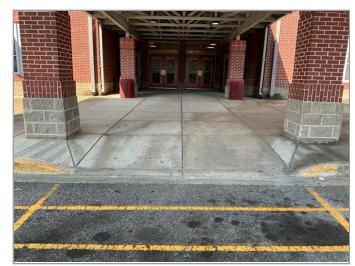
Exterior Accessible Route

ACCESSIBLE PATH

CURB CUT

7	Do ramps on an accessible route appear to have compliant end and intermediate landings?	×		
8	Do ramps and stairs on an accessible route appear to have compliant handrails?	×		
9	For stairways that are open underneath, are permanent barriers present that prevent or discourage access?		×

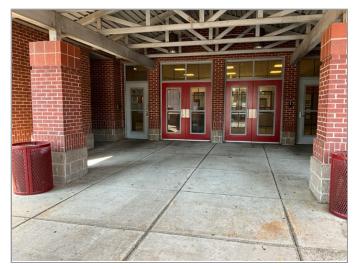
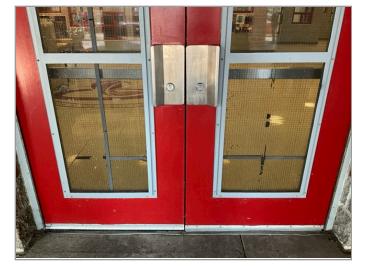
Building Entrances

ACCESSIBLE ENTRANCE

DOOR HARDWARE

7	Do pairs of accessible entrance doors in series appear to have the minimum clear space between them ?	×		
8	Do thresholds at accessible entrances appear to have a compliant height ?	×

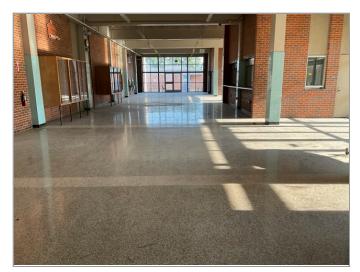
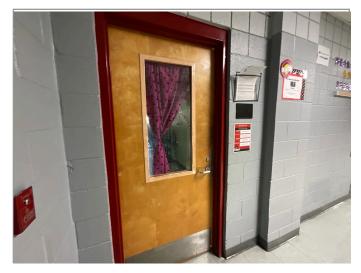
Interior Accessible Route

ACCESSIBLE INTERIOR

DOOR HARDWARE

Question	Yes	No	NA	Comments
1	Does an accessible route appear to connect all public areas inside the building ?	×			
2	Do accessible routes appear free of obstructions and/or protruding objects?	×			
3	Do ramps on accessible routes appear to have compliant slopes ?	×			
4	Do ramp runs on an accessible route appear to have a compliant rise and width ?	×			
5	Do ramps on accessible routes appear to have compliant end and intermediate landings?	×			
6	Do ramps on accessible routes appear to have compliant handrails ?	×

7	Are accessible areas of refuge and the accessible means of egress to those areas identified with accessible signage?	×		
8	Do public transaction areas have an accessible, lowered service counter section ?	×		
9	Do public telephones appear mounted with an accessible height and location ?		×	
10	Do doors at interior accessible routes appear to have compliant maneuvering clearance area on each side ?	×		
11	Do doors at interior accessible routes appear to have compliant hardware ?	×		
12	Do non-fire hinged, sliding, or folding doors on interior accessible routes appear to have compliant opening force ?	×		
13	Do doors on interior accessible routes appear to have a compliant clear opening width?	×

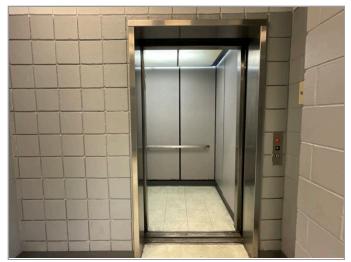
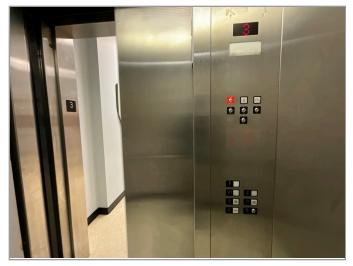
Elevators

LOBBY LOOKING AT CABS (WITH DOORS OPEN)

IN-CAB CONTROLS

Question	Yes	No	NA	Comments
1	Are hallway call buttons configured with the "UP" button above the "DOWN" button?	×			
2	Is accessible floor identification signage present on the hoistway sidewalls on each level ?	×			
3	Do the elevators have audible and visual arrival indicators at the lobby and hallway entrances?	×			
4	Do the elevator hoistway and car interior appear to have a minimum compliant clear floor area ?	×			
5	Do the elevator car doors have automatic reopening devices to prevent closure on obstructions?	×			
6	Do elevator car control buttons appear to be mounted at a compliant height ?	×

7	Are tactile and Braille characters mounted to the left of each elevator car control button?	×		
8	Are audible and visual floor position indicators provided in the elevator car?	×		
9	Is the emergency call system on or adjacent to the control panel and does it not require voice communication ?	×

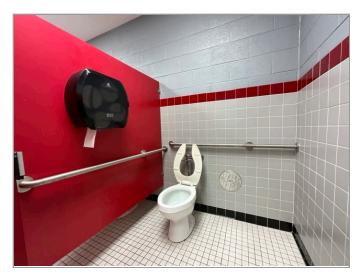
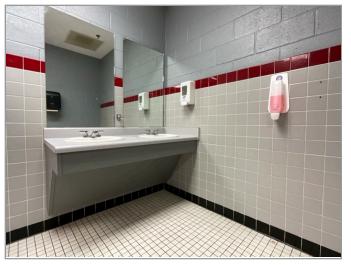
Public Restrooms

SINK, FAUCET HANDLES AND ACCESSORIES

Question	Yes	No	NA	Comments
1	Do publicly accessible toilet rooms appear to have a minimum compliant floor area?	×			
2	Does the lavatory appear to be mounted at a compliant height and with compliant knee area ?	×			
3	Does the lavatory faucet have compliant handles?	×			
4	Is the plumbing piping under lavatories configured to protect against contact?	×			
5	Are grab bars provided at compliant locations around the toilet ?	×			
6	Do toilet stall doors appear to provide the minimum compliant clear width ?	×
