FACILITY CONDITION ASSESSMENT

Shelby County Board of Education
160 South Hollywood Street
Memphis, Tennessee 38112-4892
Michelle Stuart

Westhaven Elementary
4585 Hodge Road
Memphis, Tennessee 38109

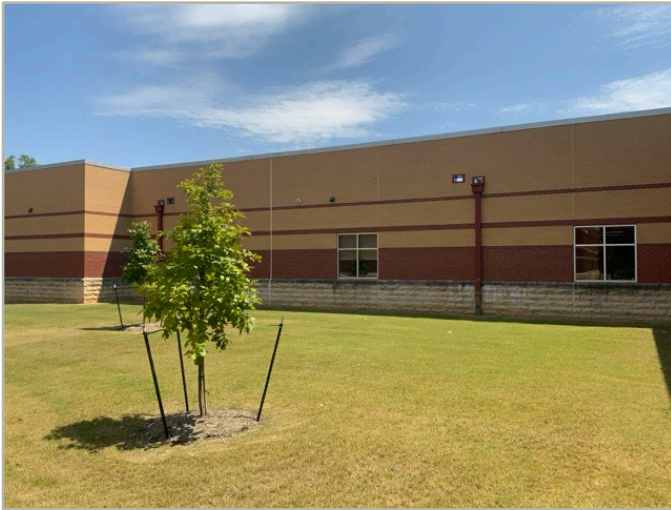
2. Main Classroom Building

Constructed/Renovated	2016	
Building/Group Size	85,300 SF	
Number of Stories	1 above grade	
System	Description	Condition
Structure	Masonry bearing walls with metal roof deck supported by open-web steel joists and concrete strip/wall footing foundation system	Good
Façade	Primary Wall Finish: Brick Secondary Wall Finish: CMU Windows: Aluminum	Good
Roof	Primary: Flat construction with modified bituminous finish Secondary: Shed construction with asphalt shingles Tertiary: Barrel construction with metal finish	Good
Interiors	Walls: Painted gypsum board, ceramic tile, sound panels Floors: Carpet, VCT, ceramic tile, quarry tile, LVT Ceilings: Painted gypsum board and ACT	Good
Elevators	None	--
Plumbing	Distribution: PEX supply and PVC waste and venting Hot Water: Electric water heaters with integral tanks Fixtures: Toilets, urinals, and sinks in all restrooms	Good
HVAC	Non-Central System: Packaged units Supplemental components: Ductless split-systems, Suspended unit heaters, Make-up air units	Good

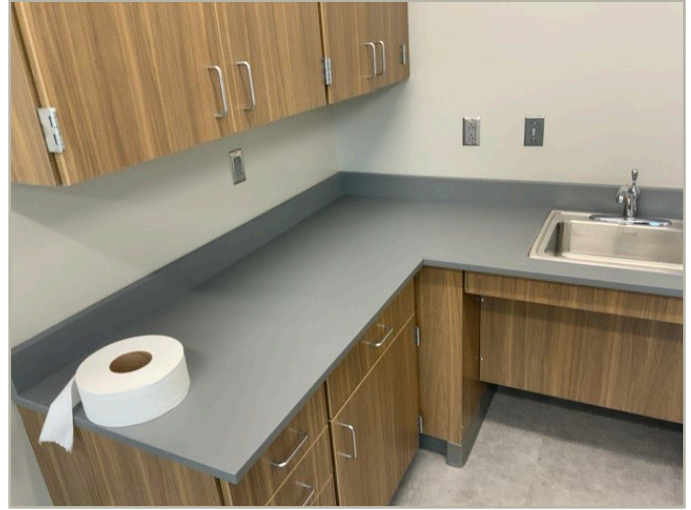
3. Annex Building

Constructed/Renovated	2023	
Building Size	24,200 SF	
Number of Stories	2 above grade	
System	Description	Condition
Structure	Masonry bearing walls with metal roof deck supported by open-web steel joists and concrete strip/wall footing foundation system	Good
Façade	Primary Wall Finish: Brick Secondary Wall Finish: CMU Windows: Aluminum	Good
Roof	Flat construction with single-ply EPDM membrane	Good
Interiors	Walls: Painted CMU, ceramic tile Floors: LVT Ceilings: ACT, Unfinished/exposed	Good
Elevators	Passenger: 1 hydraulic cars serving both floors	Good
Plumbing	Distribution: PEX supply and PVC waste and venting Hot Water: Electric water heaters with integral tanks Fixtures: Toilets, urinals, and sinks in all restrooms	Good
HVAC	Non-Central System: Rooftop Packaged units Supplemental components: Ductless split-system	Good
Fire Suppression	Wet-pipe sprinkler system and fire extinguishers	Good

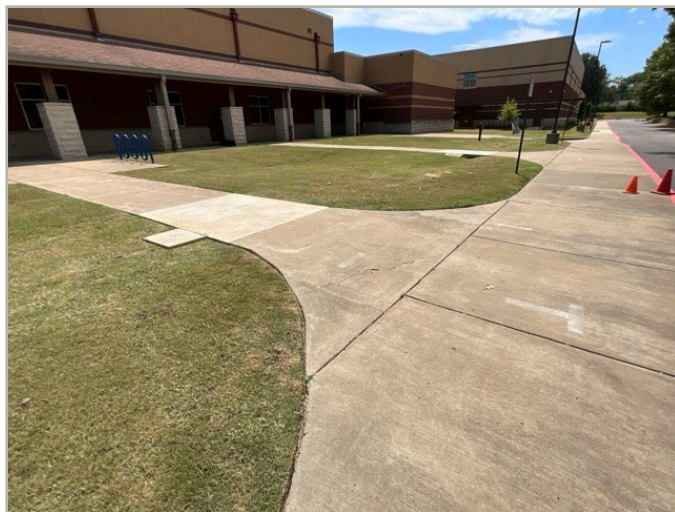
4. Site Summary

System	Description	Condition
Pavement/Flatwork	Asphalt lots with limited areas of concrete aprons and pavement and adjacent concrete sidewalks, curbs, ramps, and stairs	Good
Site Development	Building-mounted and Property entrance signage; chain link fencing; CMU wall dumpster enclosures Playgrounds, fencing Limited park benches, picnic tables, trash receptacles	Good
Landscaping and Topography	Limited landscaping features including lawns, trees, bushes, and planters Irrigation not present CMU, Concrete retaining walls Low to moderate site slopes throughout	Good
Utilities	Municipal water and sewer Local utility-provided electric and natural gas	Good
Site Lighting	Pole-mounted: LED Building-mounted: LED	Good
Ancillary Structures	None	--
Accessibility	Presently it does not appear an accessibility study is needed for the exterior site areas. See Appendix D.	
Key Issues and Findings	None observed at time of assessment.

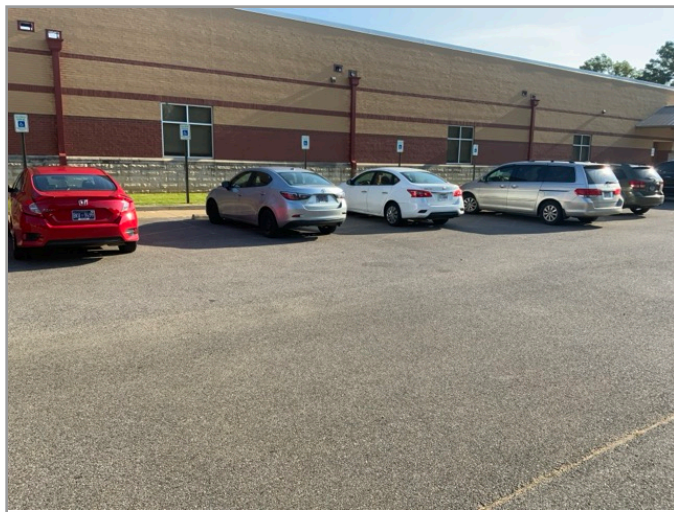
OVERVIEW OF ACCESSIBLE PARKING AREA

Question		Yes	No	NA	Comments
1	Does the required number of standard ADA designated spaces appear to be provided ?	✗			
2	Does the required number of van-accessible designated spaces appear to be provided ?	✗			
3	Are accessible spaces on the shortest accessible route to an accessible building entrance ?	✗			
4	Does parking signage include the International Symbol of Accessibility ?	✗			
5	Does each accessible space have an adjacent access aisle ?	✗			
6	Do parking spaces and access aisles appear to be relatively level and without obstruction ?	✗

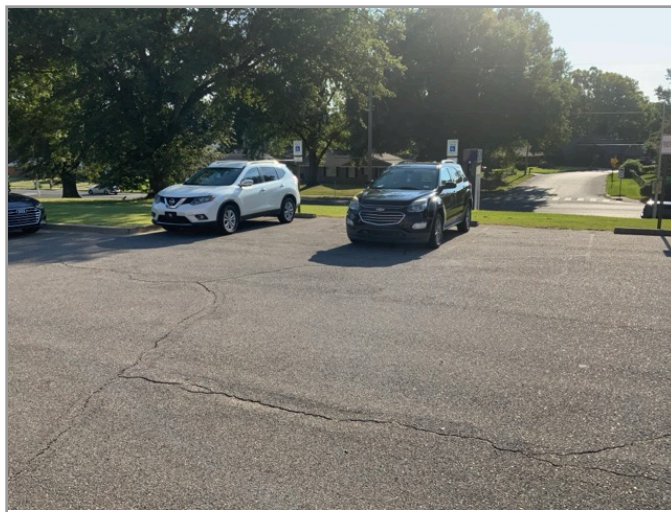
SECOND AREA OF ACCESSIBLE PARKING

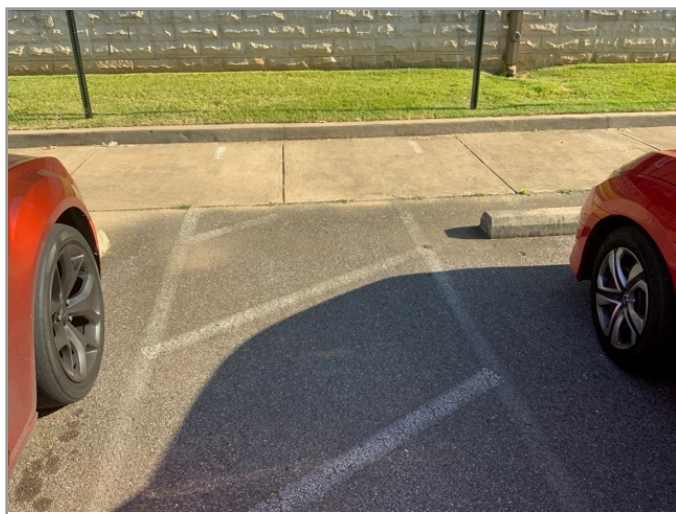
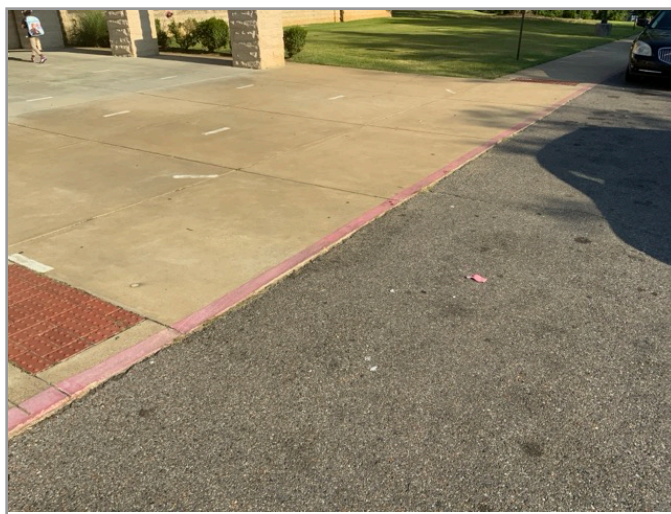
CURB CUT

Question		Yes	No	NA	Comments
1	Is an accessible route present from public transportation stops and municipal sidewalks on or immediately adjacent to the property ?			×	
2	Does a minimum of one accessible route appear to connect all public areas on the exterior, such as parking and other outdoor amenities, to accessible building entrances ?	×			
3	Are curb ramps present at transitions through raised curbs on all accessible routes?	×			
4	Do curb ramps appear to have compliant slopes for all components ?	×			
5	Do ramp runs on an accessible route appear to have compliant slopes ?			×	
6	Do ramp runs on an accessible route appear to have a compliant rise and width ?			×

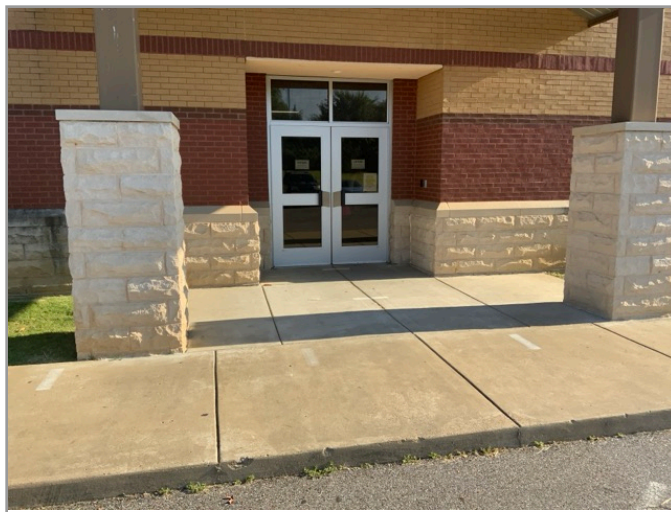
ADDITIONAL ENTRANCE

Question		Yes	No	NA	Comments
1	Do a sufficient number of accessible entrances appear to be provided ?	✗			
2	If the main entrance is not accessible, is an alternate accessible entrance provided?			✗	
3	Is signage provided indicating the location of alternate accessible entrances ?			✗	
4	Do doors at accessible entrances appear to have compliant maneuvering clearance area on each side ?	✗			
5	Do doors at accessible entrances appear to have compliant hardware ?	✗			
6	Do doors at accessible entrances appear to have a compliant clear opening width ?	✗

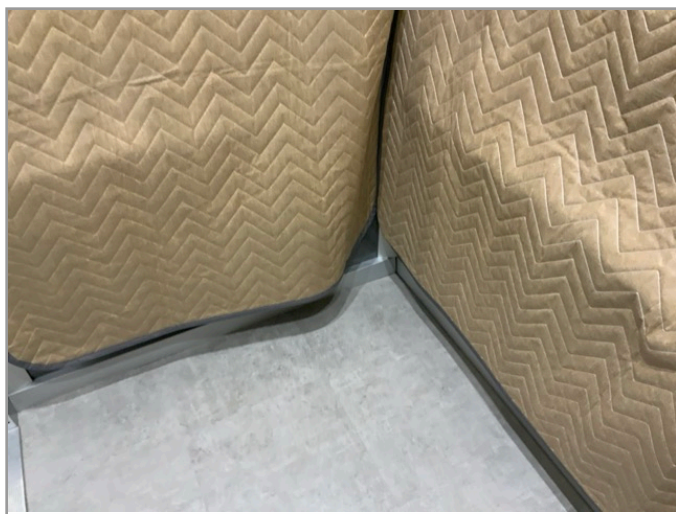
LOBBY LOOKING AT CABS (WITH DOORS OPEN)

Question		Yes	No	NA	Comments
1	Are hallway call buttons configured with the "UP" button above the "DOWN" button?	✗			
2	Is accessible floor identification signage present on the hoistway sidewalls on each level ?	✗			
3	Do the elevators have audible and visual arrival indicators at the lobby and hallway entrances?	✗			
4	Do the elevator hoistway and car interior appear to have a minimum compliant clear floor area ?	✗			
5	Do the elevator car doors have automatic re-opening devices to prevent closure on obstructions?	✗			
6	Do elevator car control buttons appear to be mounted at a compliant height ?	✗

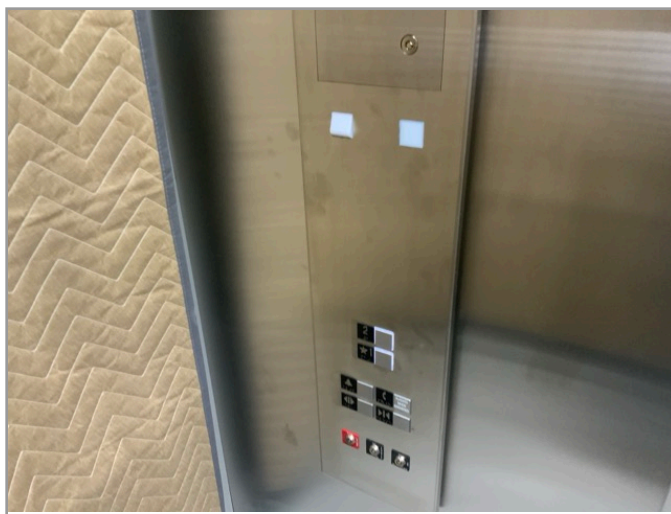
IN-CAB CONTROLS

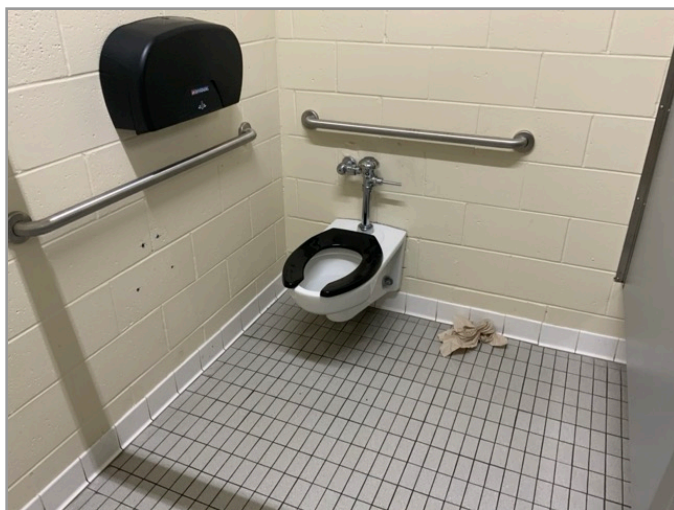
TOILET STALL OVERVIEW

Question		Yes	No	NA	Comments
1	Do publicly accessible toilet rooms appear to have a minimum compliant floor area ?	✗			
2	Does the lavatory appear to be mounted at a compliant height and with compliant knee area ?	✗			
3	Does the lavatory faucet have compliant handles ?	✗			
4	Is the plumbing piping under lavatories configured to protect against contact ?	✗			
5	Are grab bars provided at compliant locations around the toilet ?	✗			
6	Do toilet stall doors appear to provide the minimum compliant clear width ?	✗

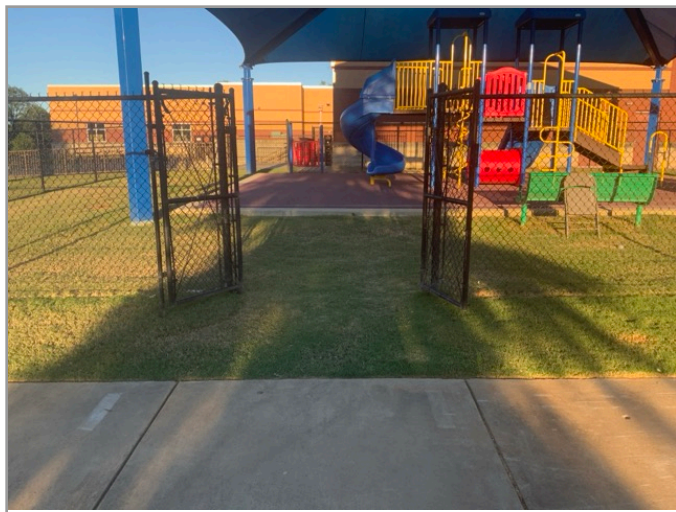
ACCESSIBLE ROUTE TO PLAYGROUND

Question		Yes	No	NA	Comments
1	Is there an accessible route to the play area / s?	✗			
2	Has the play area been reviewed for accessibility ?	✗			
3	Are publicly accessible swimming pools equipped with an entrance lift ?			✗

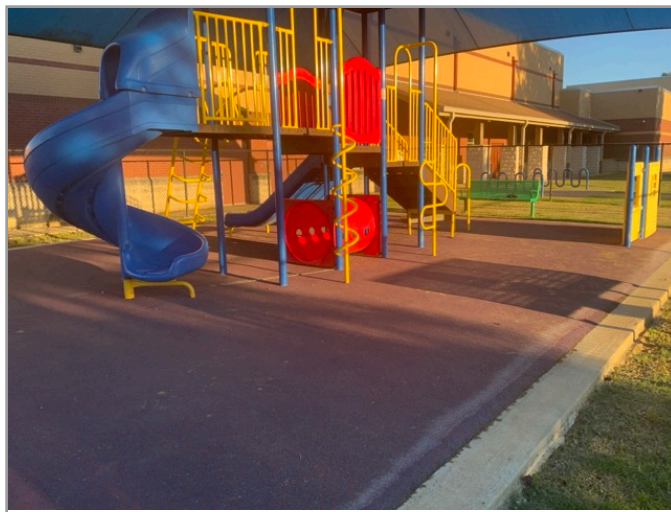
OVERVIEW OF PLAYGROUND
