FACILITY CONDITION ASSESSMENT

Chickasaw Middle School
4060 Westmont Road
Memphis, Tennessee 38109

163745.23R000-036.354

January 11, 2024

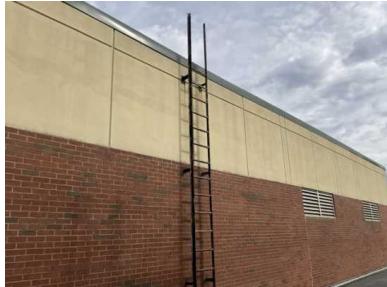
Exterior Walls in Poor condition.

Substantial discoloration is observed on building exterior. - AssetCALC ID: 7127211

Recommendation: **Repair in 2023**

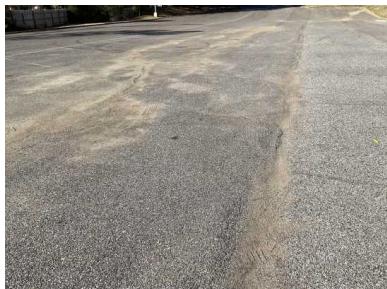
Parking Lots in Poor condition.

Sealing and striping is needed throughout parking lot. - AssetCALC ID: 7127207

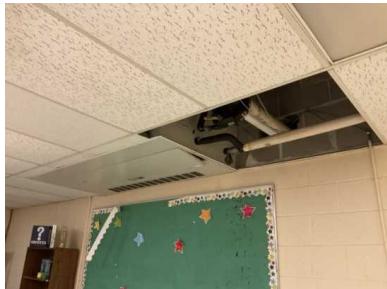
Fan Coil Unit in Failed condition.

Nonworking FCU. Serves library. - AssetCALC ID: 7085033

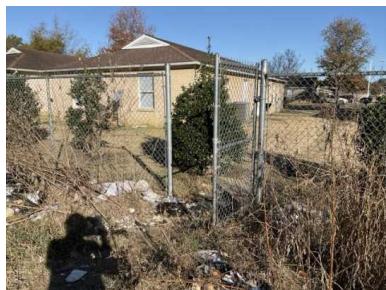
Fences and Gates in Poor condition.

Damaged dugout fencing is observed at the backstop. - AssetCALC ID: 7127204

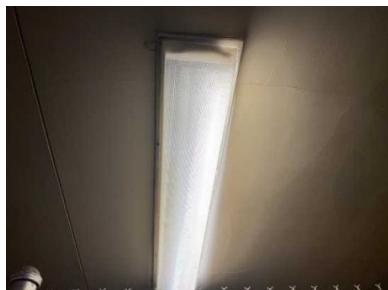
Damaged and water stained ceiling tiles are observed from previous roof leaks. - AssetCALC ID: 7085063

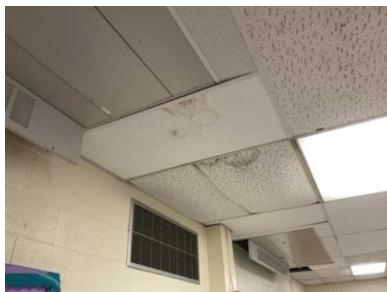
Classroom 214 is in poor condition. There appears to be fungal growth on the ceiling at the fan-coil units along with a mildew odor. A professional consultant must be retained to analyze the existing condition, provide recommendations and, if necessary, estimate the scope and cost of any required repairs. The cost of this study is included in the cost tables. Recommend all classrooms be evaluated as well as part of the study. A budgetary cost allowance to mitigate the fungal growth and replace the ceiling tiles is included in the cost tables.

Fungal growth is observed on ceiling tiles at fan-coil units in classroom 214. - AssetCALC ID: 7085018

Recommended Follow-up Study: Environmental, Remediation of Suspect Fungal Growth

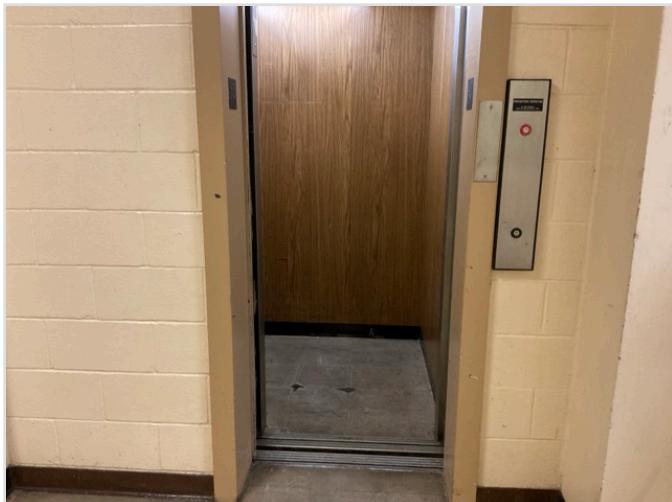
LOBBY LOOKING AT CAB

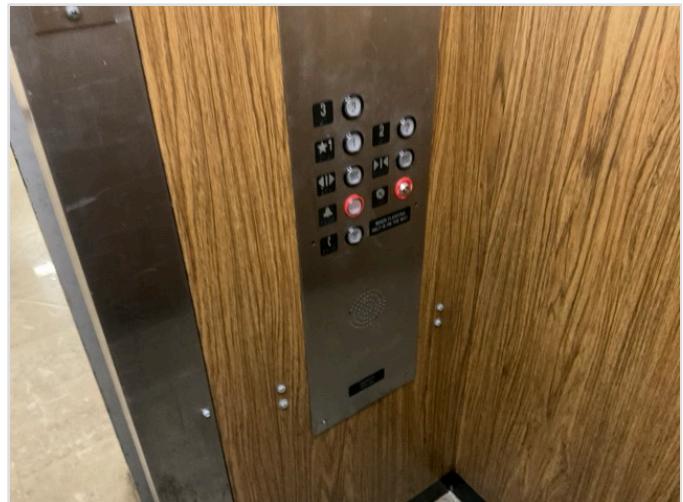
IN-CAB CONTROLS

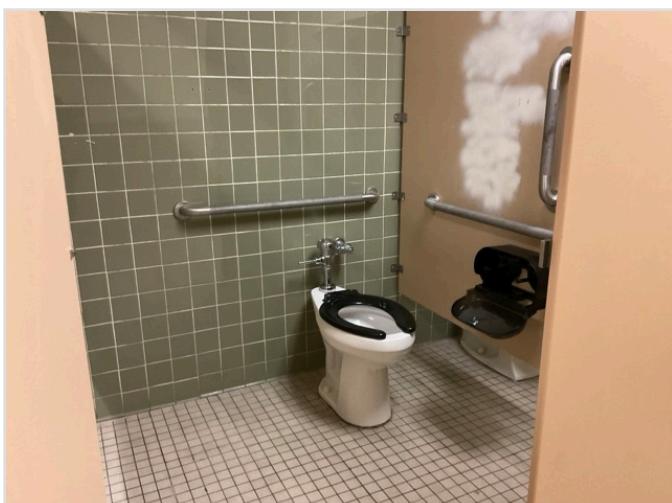
TOILET STALL OVERVIEW

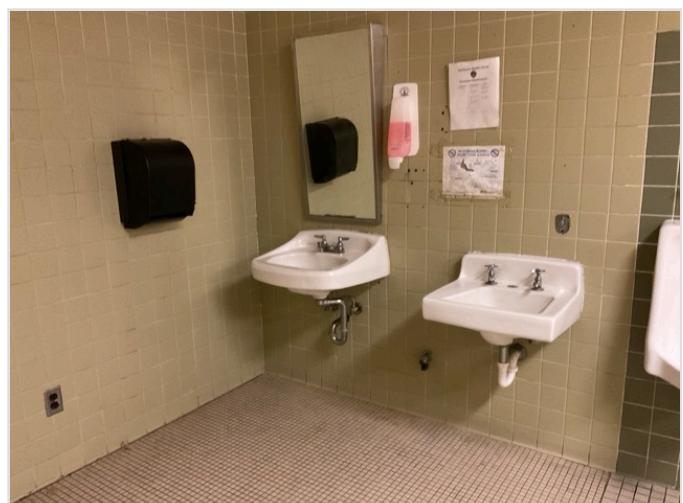
SINK, FAUCET HANDLES AND ACCESSORIES
