FACILITY CONDITION ASSESSMENT

Shelby County Board of Education
160 South Hollywood Street
Memphis, Tennessee 38112-4892
Michelle Stuart

Ford Road Elementary
3336 Ford Road
Memphis, Tennessee 38109

October 1, 2024

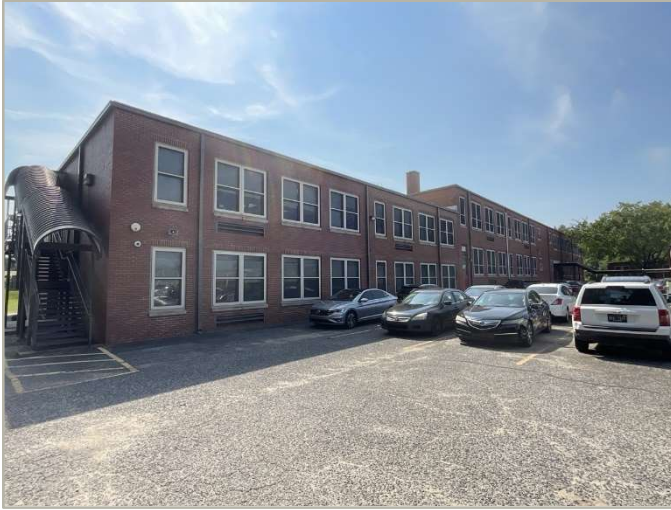
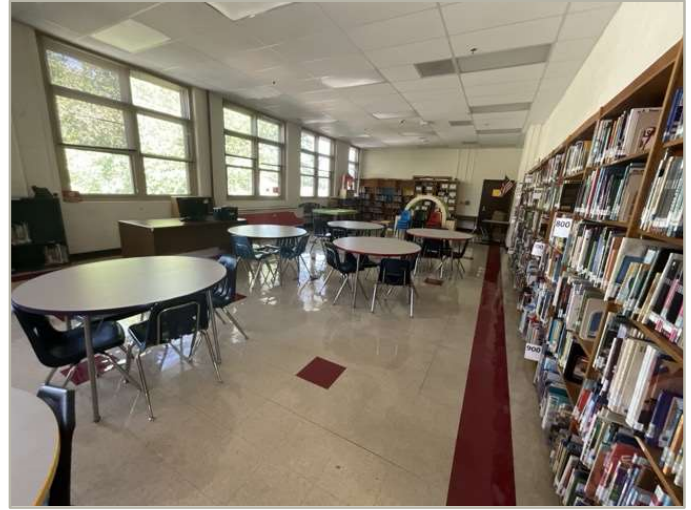
5. 2 Story Building

Electrical	Source & Distribution: Main switchboard with copper wiring Interior Lighting: Linear fluorescent Emergency Power: None	Fair
Fire Alarm	Alarm panel located in the main building with smoke detectors, heat detectors, alarms, strobes, pull stations, back-up emergency lights, and exit signs	Fair
Equipment/Special	None	--
Accessibility	Presently it does not appear an accessibility study is needed for this building. See Appendix D.	
Key Issues and Findings	Chiller and cooling tower not functional

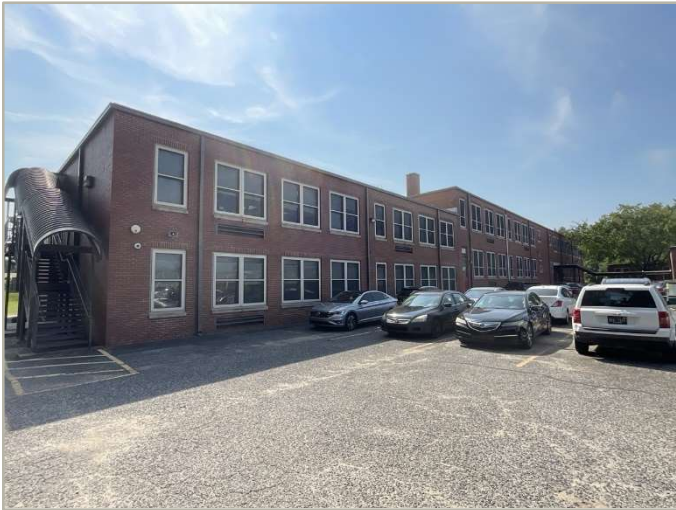
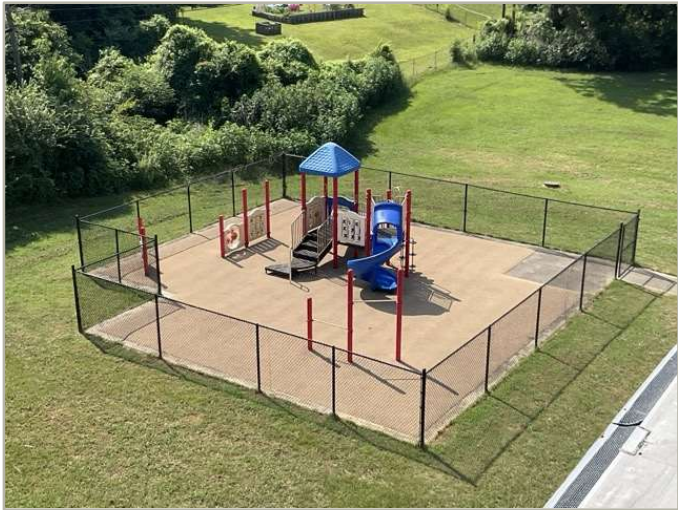
6. Site Summary

Site Information		
System	Description	Condition
Pavement/Flatwork	Asphalt lots with areas of concrete aprons and pavement and adjacent concrete sidewalks, curbs, ramps, and stairs	Failed
Site Development	Roadside and Building-mounted signage; chain link fencing Playgrounds and grass fields Limited number of park benches, picnic tables, trash receptacles	Fair
Landscaping and Topography	Limited landscaping features including lawns, trees, bushes, and planters Irrigation present Low to moderate site slopes throughout	Fair
Utilities	Municipal water and sewer Local utility-provided electric and natural gas	Good
Site Lighting	Building-mounted: LED	Fair
Ancillary Structures	None	--
Accessibility	Presently it does not appear an accessibility study is needed for the exterior site areas. See Appendix D.	
Key Issues and Findings	Asphalt parking lots are severely worn and damaged. The aggregate and base layers appear to be compromised as well.

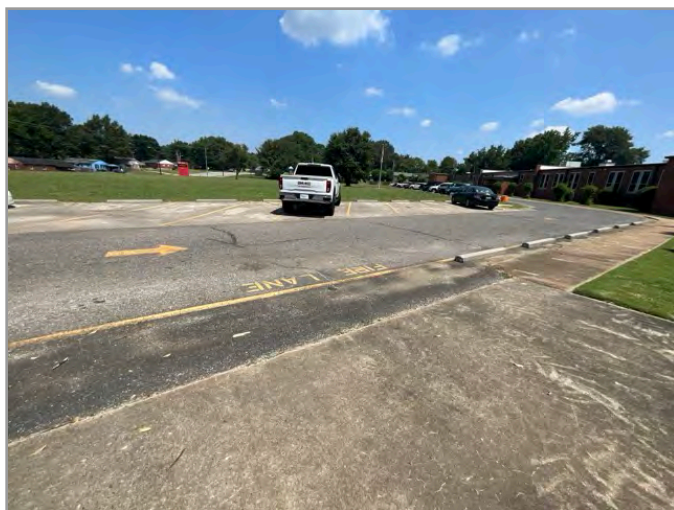
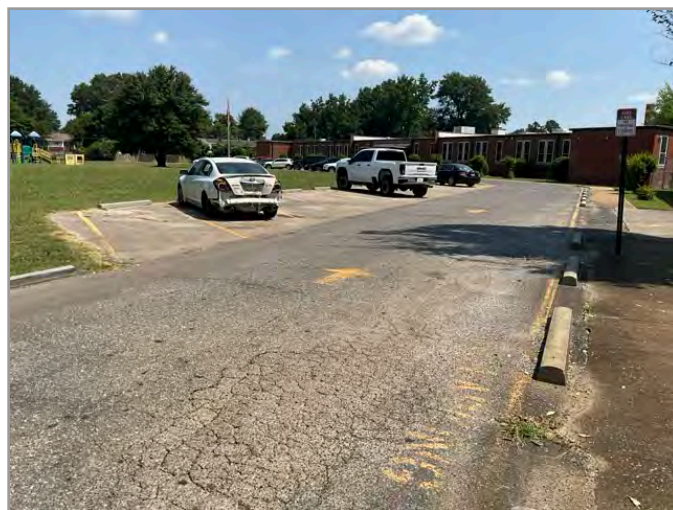
OVERVIEW OF ACCESSIBLE PARKING AREA

Question		Yes	No	NA	Comments
1	Does the required number of standard ADA designated spaces appear to be provided ?		✗		There aren't any designated ADA parking spaces for this building.
2	Does the required number of van-accessible designated spaces appear to be provided ?		✗		
3	Are accessible spaces on the shortest accessible route to an accessible building entrance ?		✗		
4	Does parking signage include the International Symbol of Accessibility ?		✗		
5	Does each accessible space have an adjacent access aisle ?		✗		
6	Do parking spaces and access aisles appear to be relatively level and without obstruction ?		✗

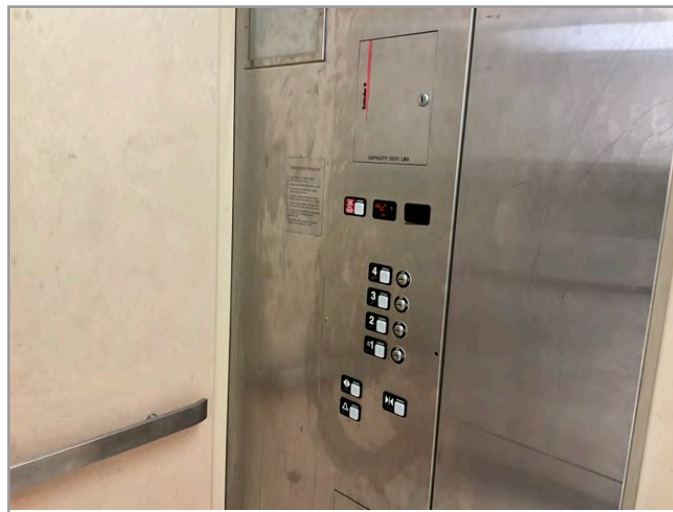
IN-CAB CONTROLS

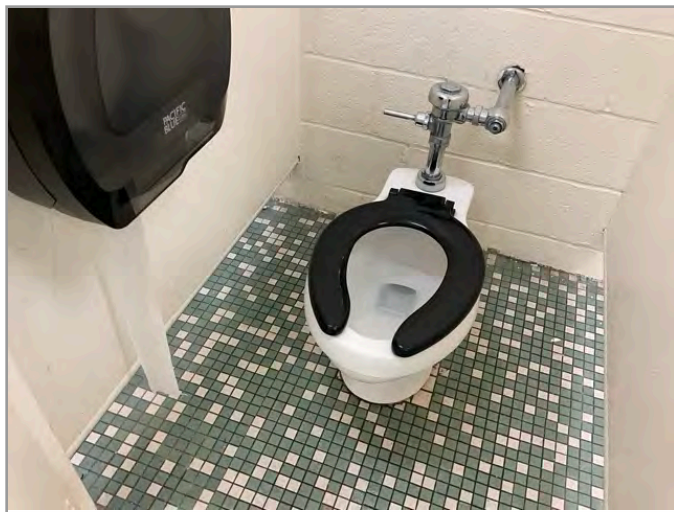
TOILET STALL OVERVIEW

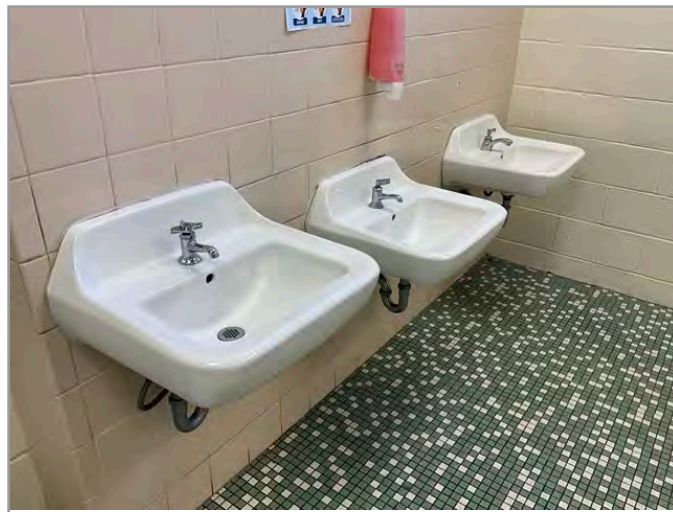
SINK, FAUCET HANDLES AND ACCESSORIES

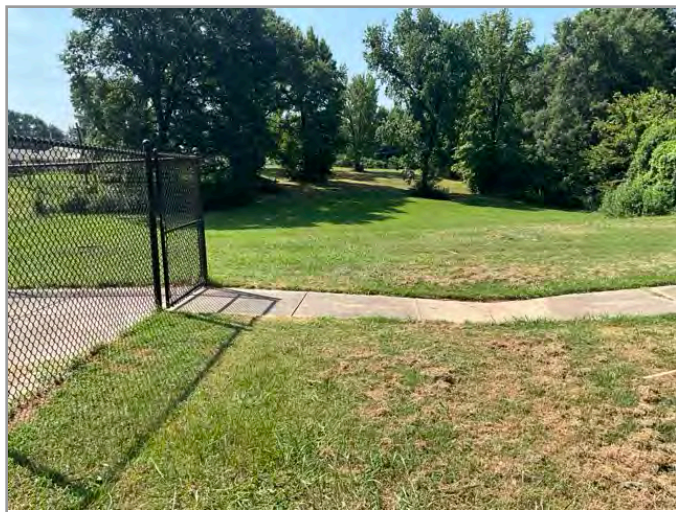
ACCESSIBLE ROUTE TO PLAYGROUND

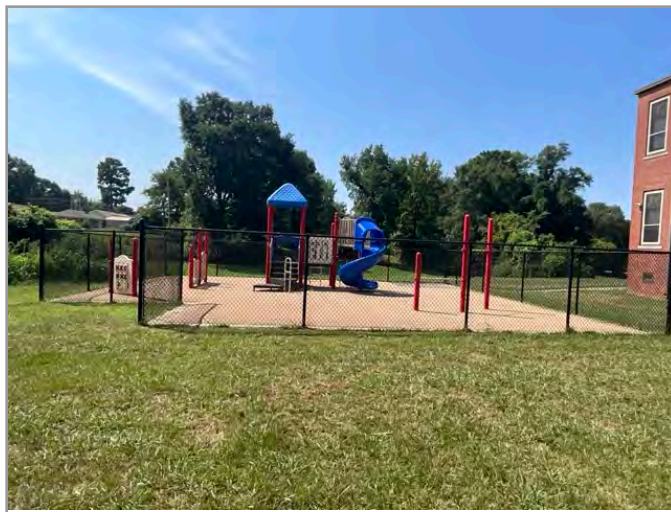
OVERVIEW OF PLAYGROUND
