# FACILITY CONDITION ASSESSMENT

**Shelby County Board of Education**  
160 South Hollywood Street  
Memphis, Tennessee 38112-4892  
Michelle Stuart

Macon Hall Elementary  
9800 Macon Road  
Memphis, Tennessee 38016

*July 31, 2024*

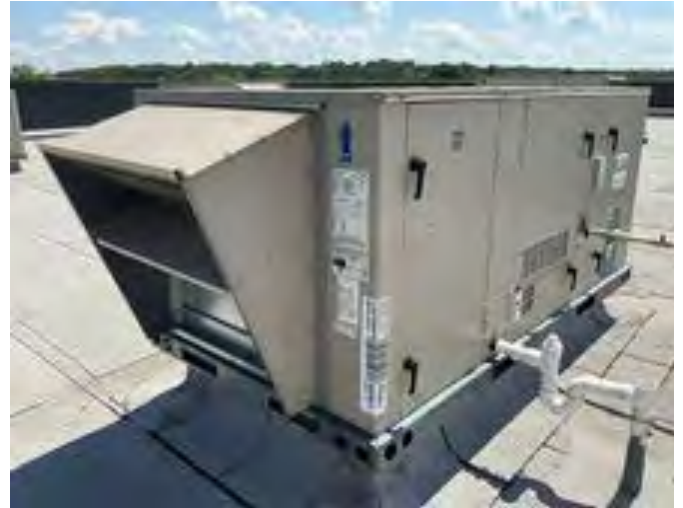
32 - ROOFTOP PACKAGED UNIT

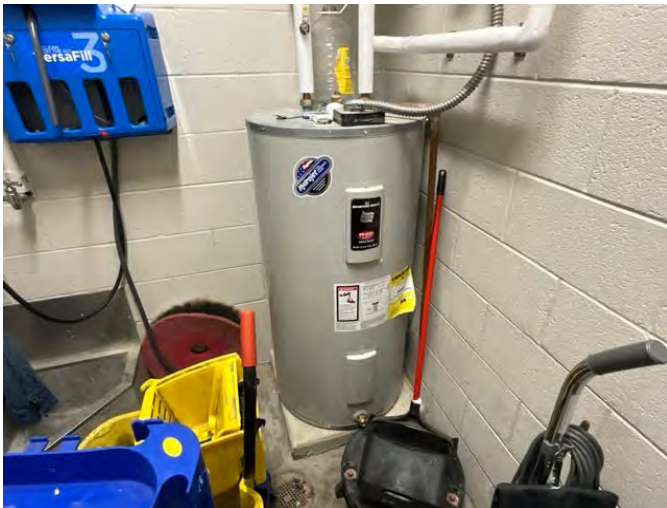
33 - WATER HEATER

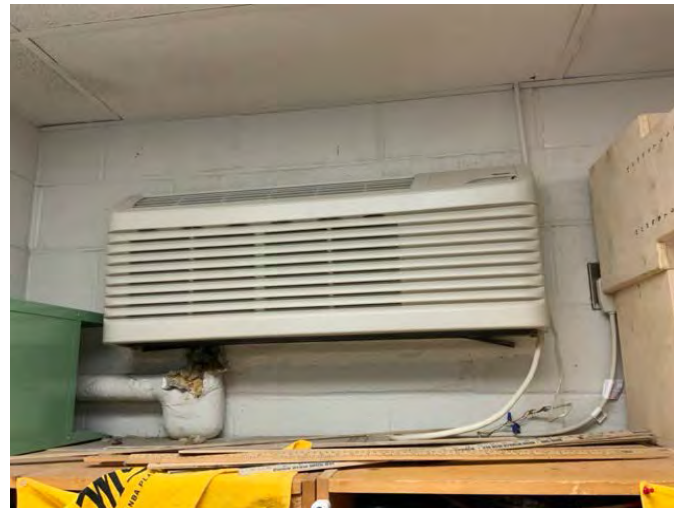
34 - SPLIT SYSTEM DUCTLESS

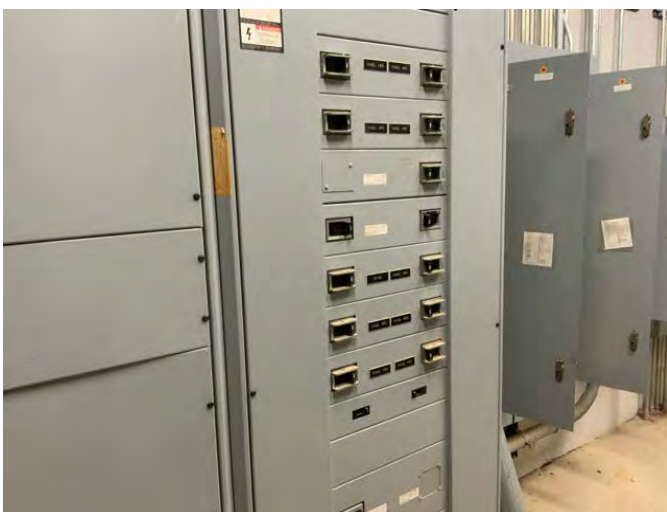
35 - SWITCHBOARD

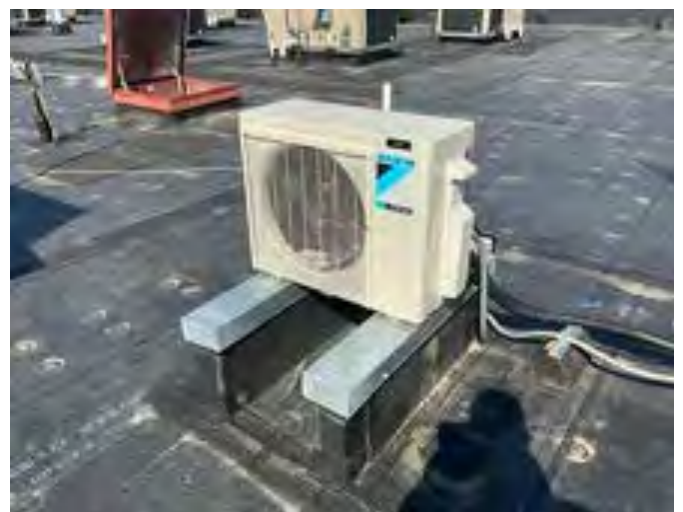
36 - SPLIT SYSTEM DUCTLESS

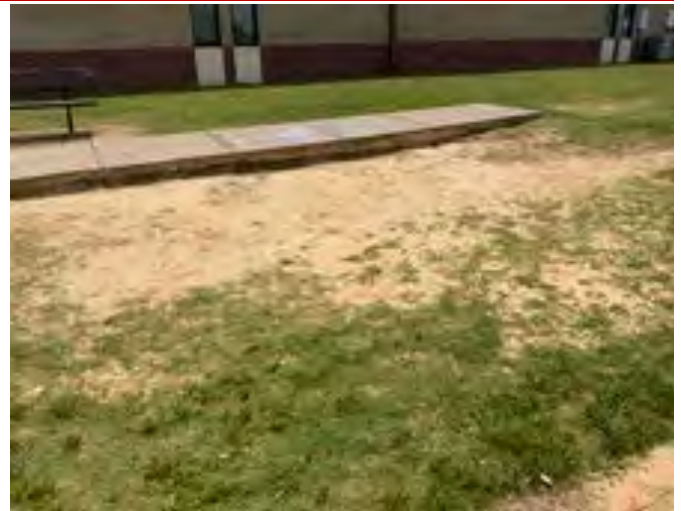
38 - LANDSCAPING

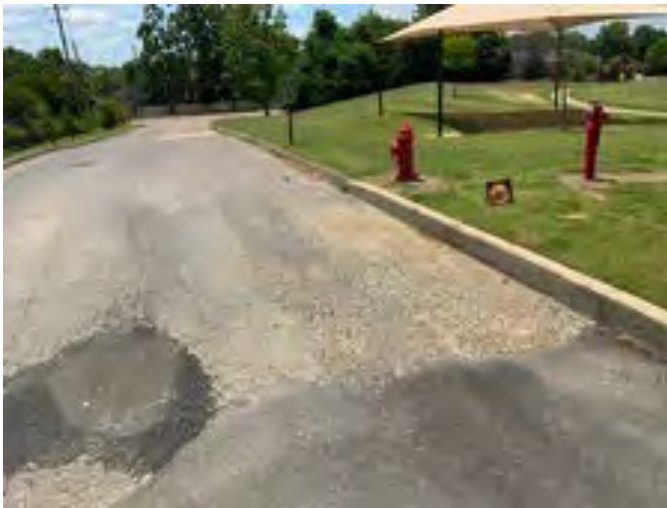
39 - PARKING LOTS

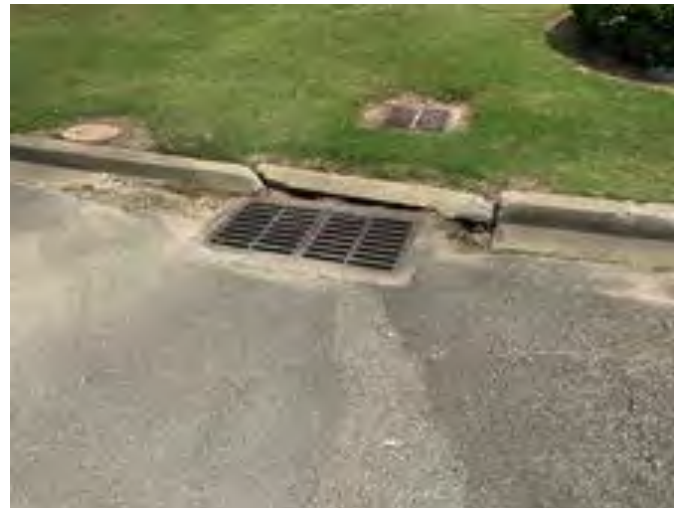
40 - STORM DRAINAGE

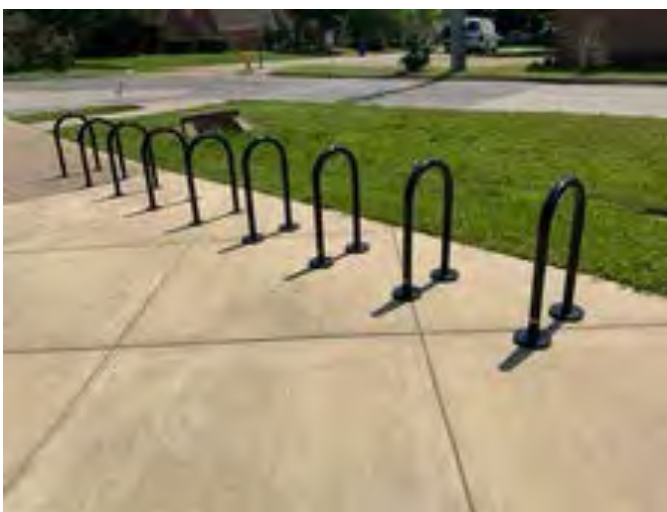
41 - BIKE RACK

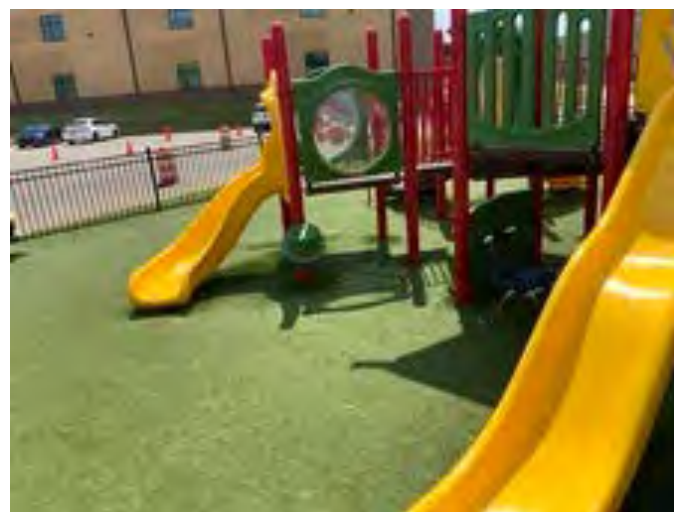
42 - OVERVIEW OF PLAYGROUND
