# FACILITY CONDITION ASSESSMENT

**Shelby County Board of Education**  
160 South Hollywood Street  
Memphis, TN 38112-4892  
Michelle Stuart

Raleigh Egypt High School  
3970 Voltaire Avenue  
Memphis, TN 38128

*May 2, 2024*

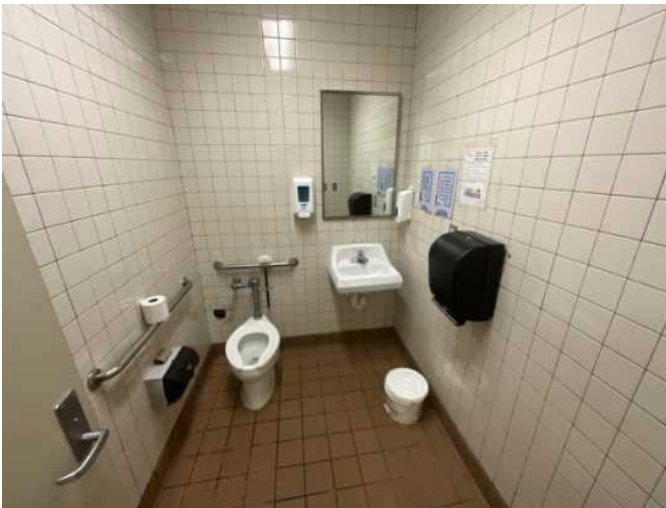
33 - STAFF RESTROOM

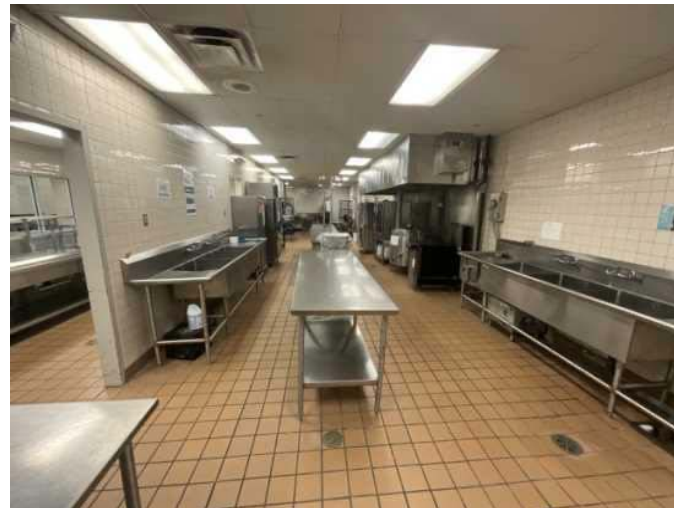
34 - KITCHEN

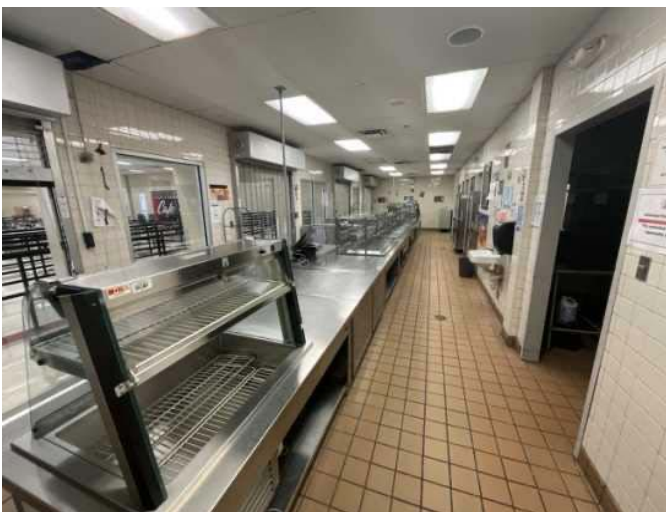
35 - SERVICE AREA

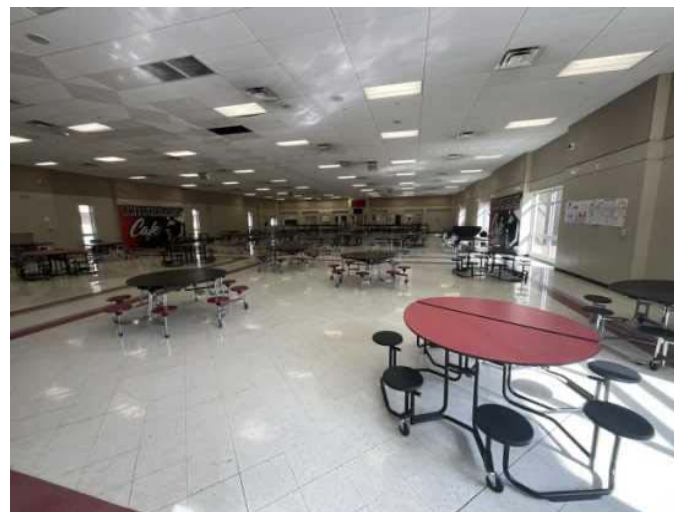
36 - CAFETERIA

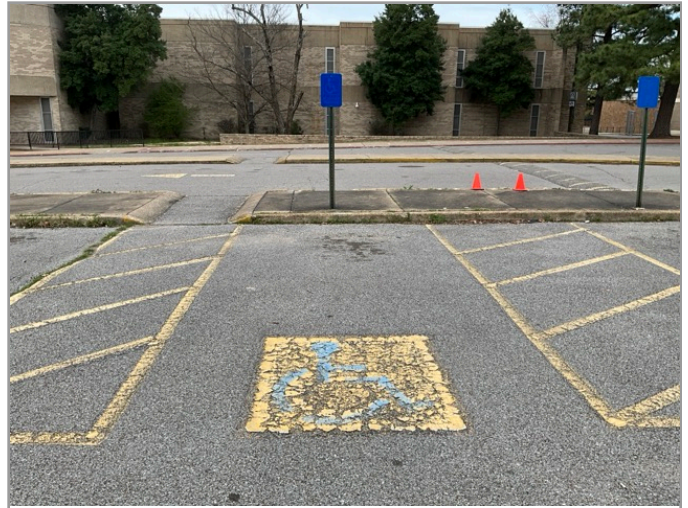
CLOSE-UP OF STALL

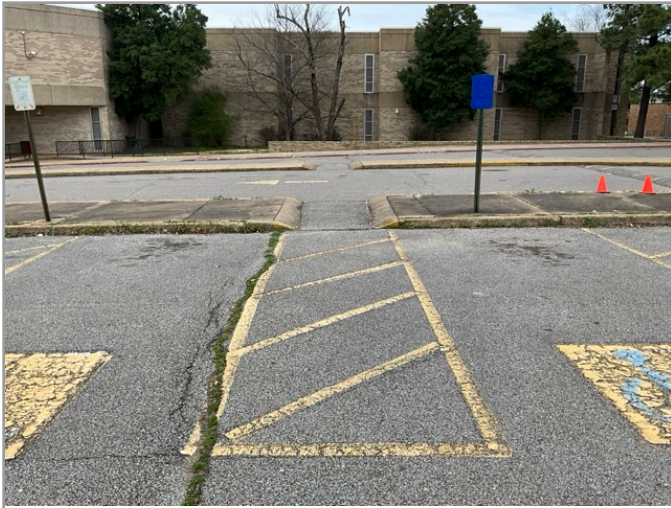
ACCESSIBLE PATH

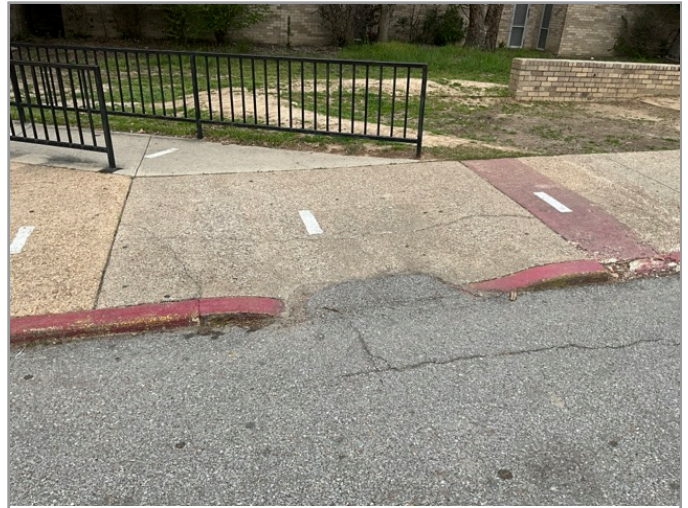
CURB CUT

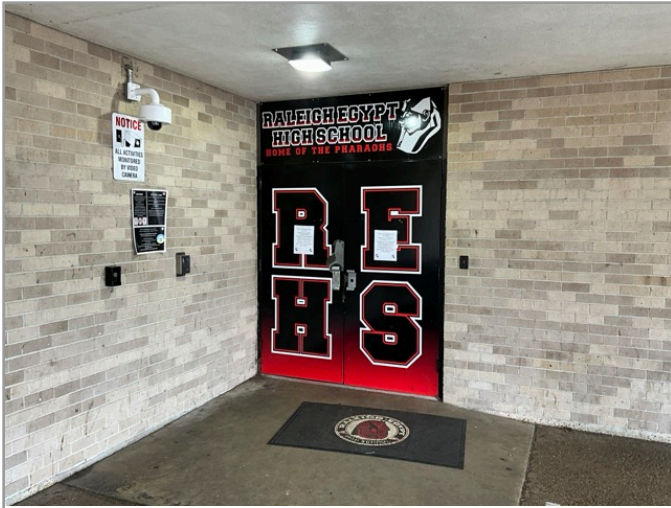
MAIN ENTRANCE

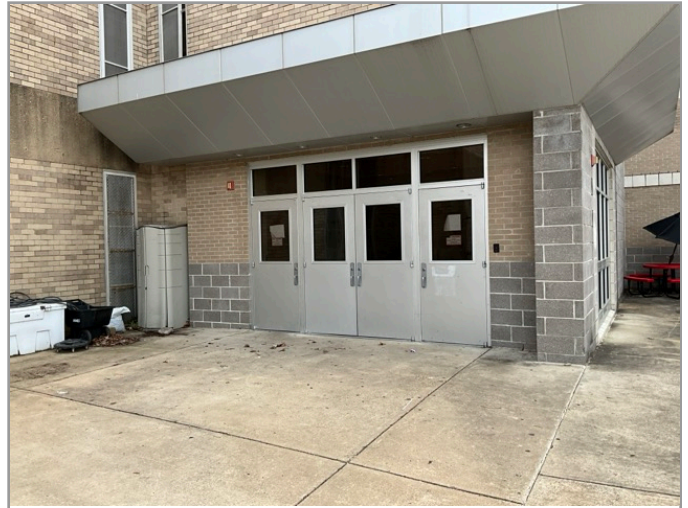
ADDITIONAL ENTRANCE

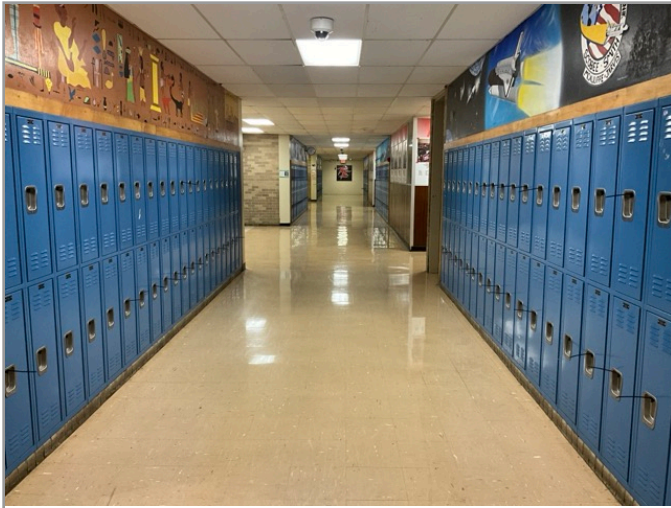
ACCESSIBLE INTERIOR PATH

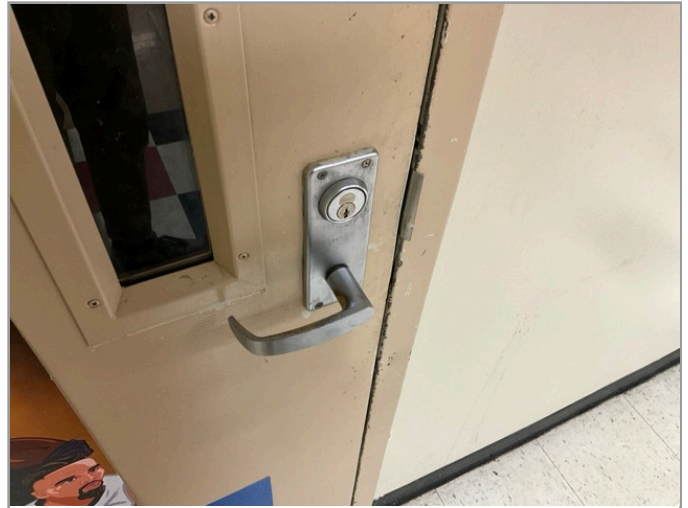
DOOR HARDWARE

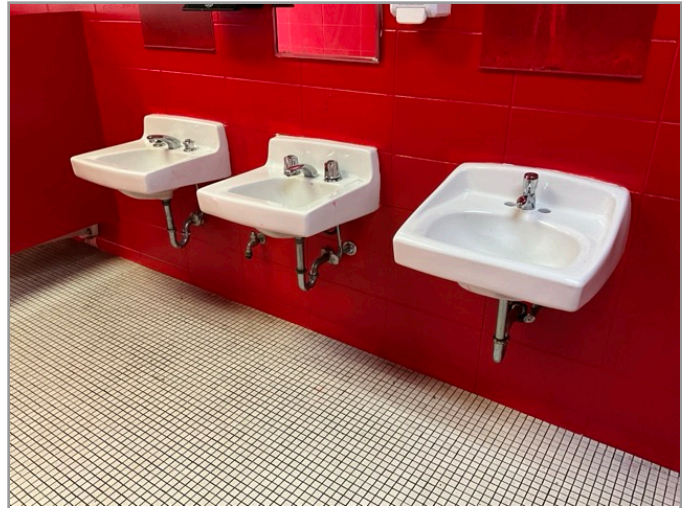
SINK, FAUCET HANDLES AND ACCESSORIES
