# FACILITY CONDITION ASSESSMENT

Springdale Elementary  
880 North Hollywood Street  
Memphis, Tennessee 38108

*163745.23R000-182.354*

*May 10, 2024*

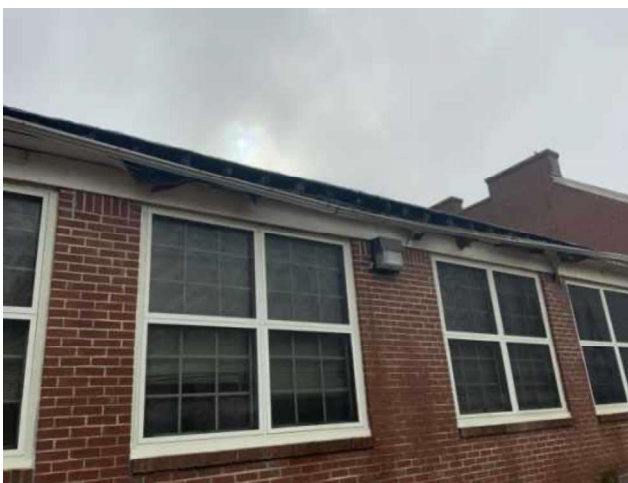
The Roof system is in failed condition. There are areas of dry rotted wood on the soffit and fascia, areas with both missing and water leaking into the walls of the building. A professional engineer must be retained to analyze the existing condition, provide recommendations and, if necessary, estimate the scope and cost of any required repairs. The cost of this study is included in the cost tables. Due to the ambiguity of the required repair scope at the time of this assessment, the cost for any possible subsequent repairs is not included.

11 - DAMAGED SOFFIT AND FASCIA

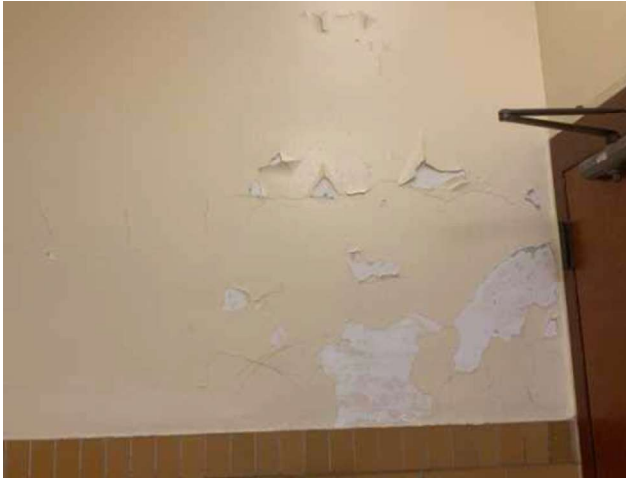
25 - CORRIDOR WALL FINISHES

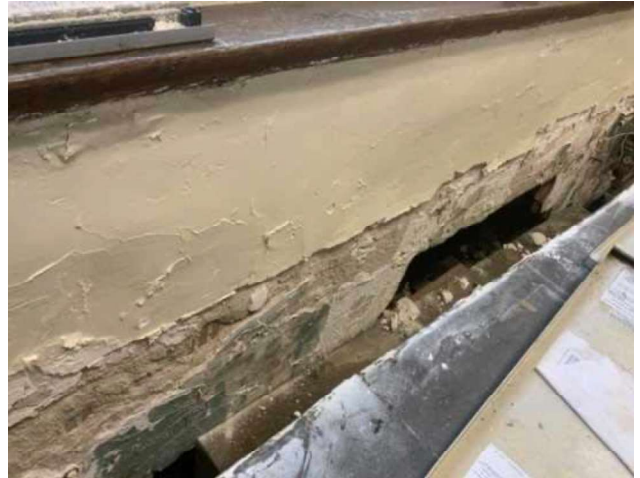
26 - CLASSROOM WALL AT UNI-VENT

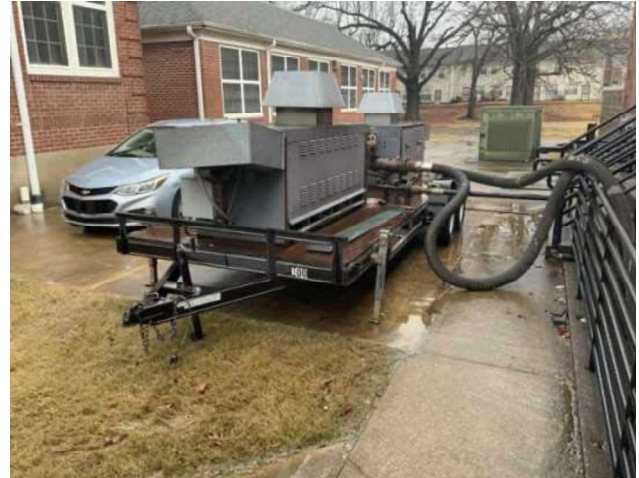
Being replaced - AssetCALC ID: 7541341

32 - TEMPORARY BOILER

Uniformat Code: D3020  
Recommendation: **Replace in 2024**

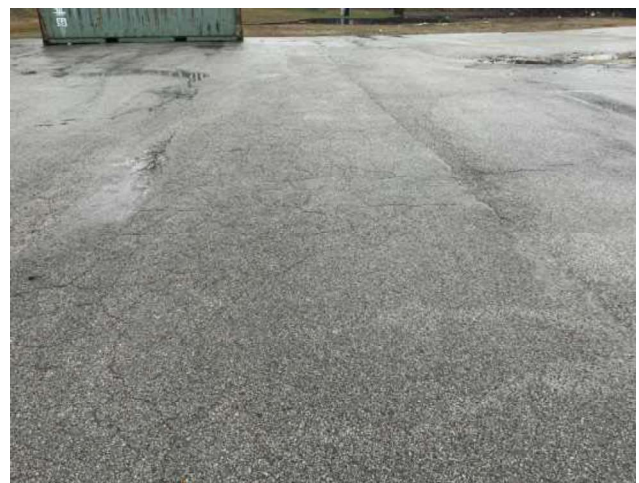
The parking lot should be seal coated and striped. Post sign is outdated and end of life. Landscaping along sidewalks and stairs has washed out and needs to be backfilled and regraded. Areas in sidewalks and stairs are failing and require replacement or extensive repair. Exterior wall lights should be upgraded to LED. Parking lot pole lights are owned by the PUC.

36 - PARKING LOT

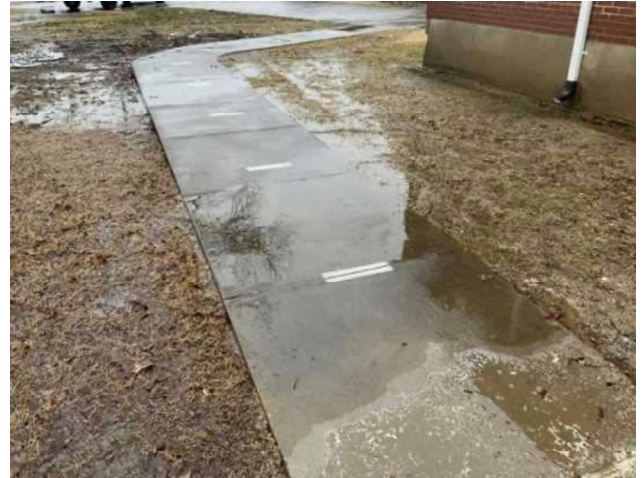
38 - SIDEWALK

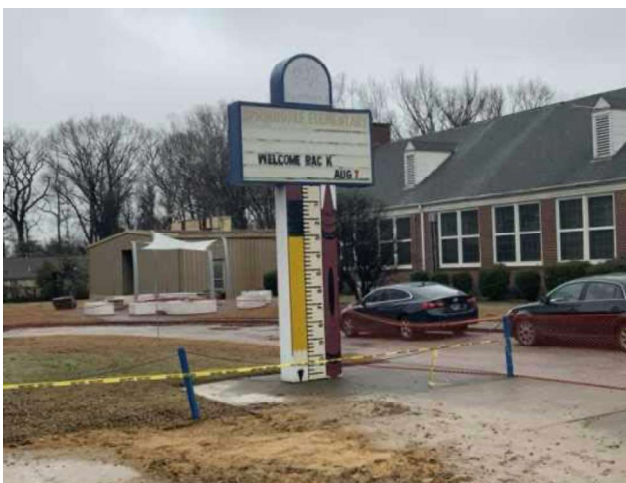
41 - SIGNAGE

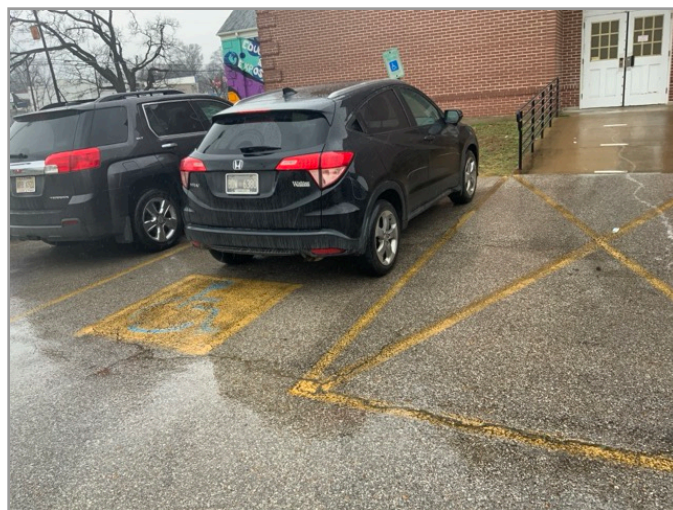
CLOSE-UP OF STALL

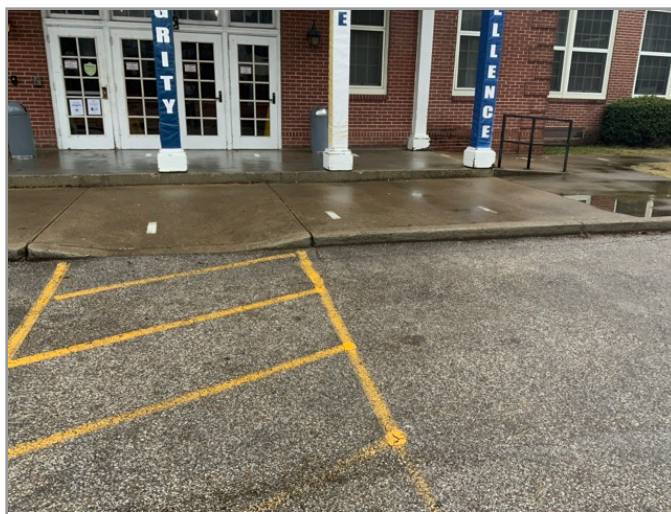
ACCESSIBLE PATH

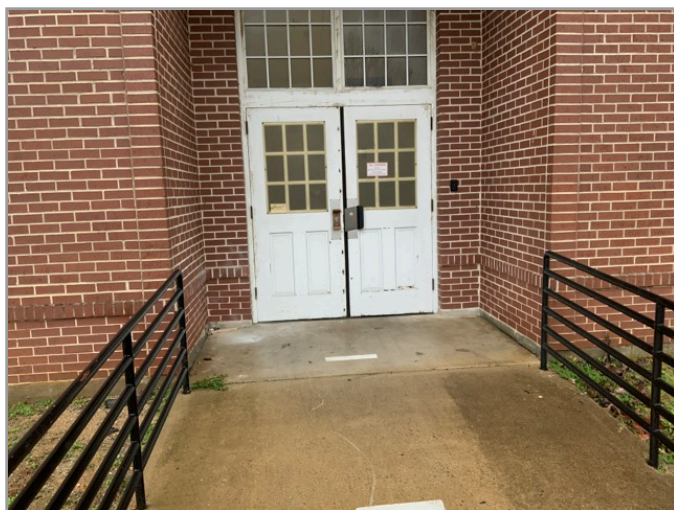
ACCESSIBLE ENTRANCE

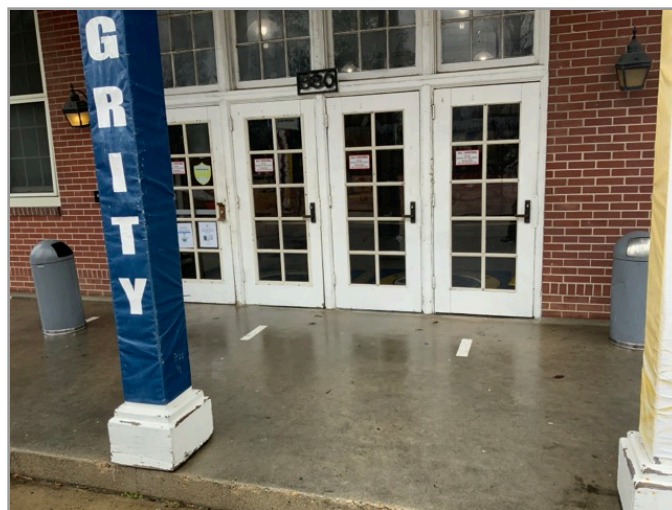
MAIN ENTRANCE

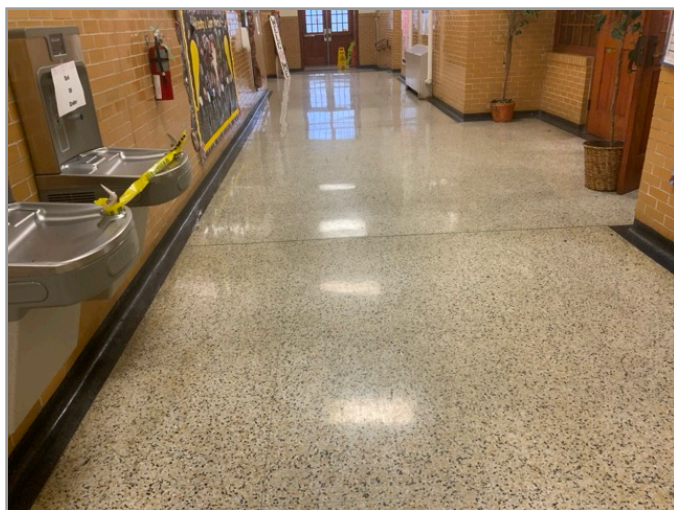
ACCESSIBLE INTERIOR PATH

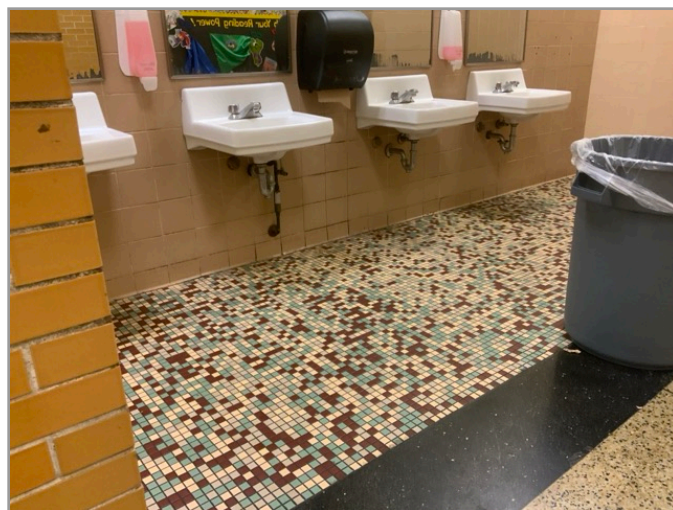
SINK, FAUCET HANDLES AND ACCESSORIES

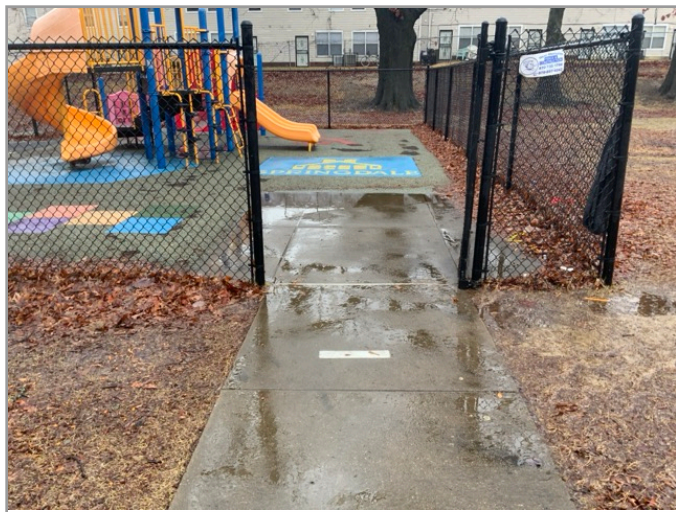
ACCESSIBLE ROUTE TO PLAYGROUND

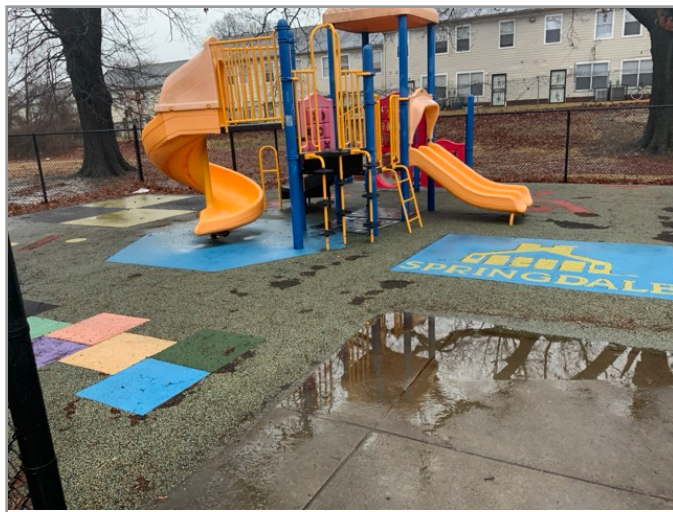
OVERVIEW OF PLAYGROUND
