FACILITY CONDITION ASSESSMENT

Shelby County Board of Education
160 South Hollywood Street
Memphis, Tennessee 38112-4892
Michelle Stuart

Trezevant High School
3350 North Trezevant Street
Memphis, Tennessee 38127

October 22, 2024

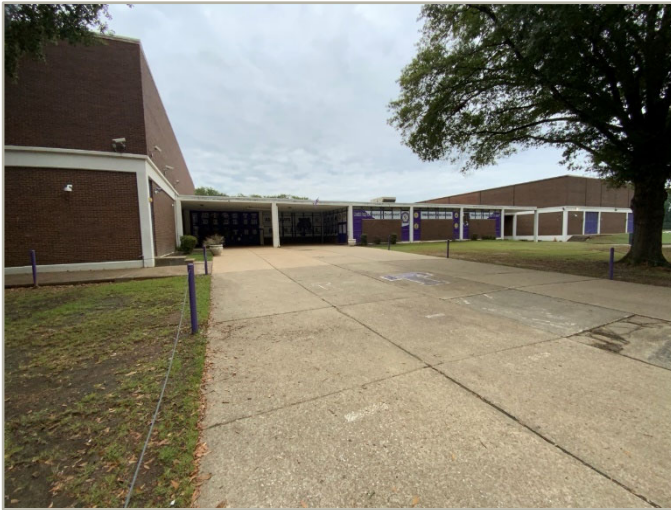
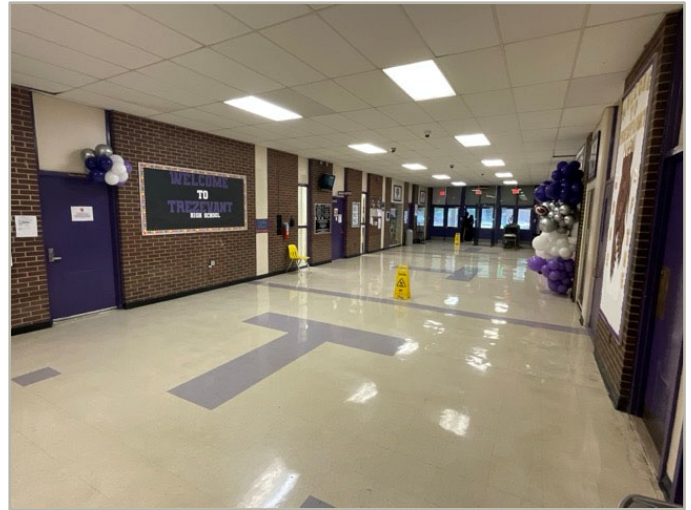
2. Main Building

Fire Alarm	Alarm panel with smoke detectors, alarms, strobes, pull stations, back-up emergency lights, and exit signs	Fair
Equipment/Special	Commercial kitchen equipment and gymnasium equipment	Fair
Accessibility	Presently it does not appear an accessibility study is needed for this building. See Appendix D.	
Key Issues and Findings	There are significant roof leaks throughout the building and roof ponding observed. Window glazing has failed and excessively aged. Interior finishes have deteriorated.

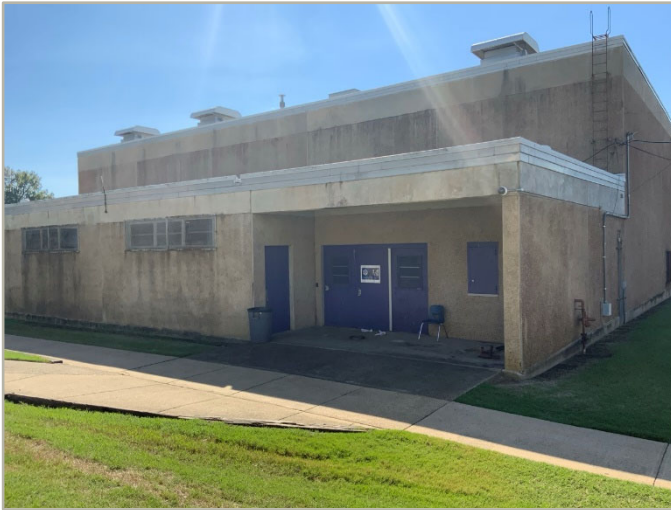
3. Field House

Fire Alarm	Smoke detectors, heat detectors, alarms, strobes, pull stations, back-up emergency lights, and exit signs	Fair
Equipment/Special	Gymnasium equipment	Fair
Accessibility	Presently it does not appear an accessibility study is needed for this building. See Appendix D.	
Key Issues and Findings	Interior finishes have deteriorated

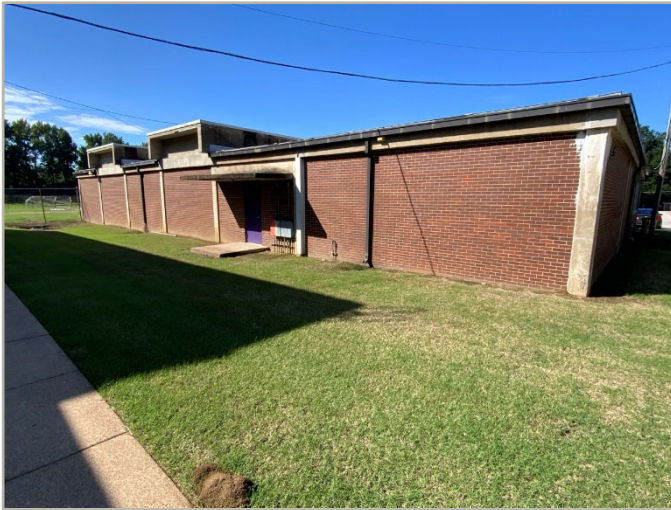
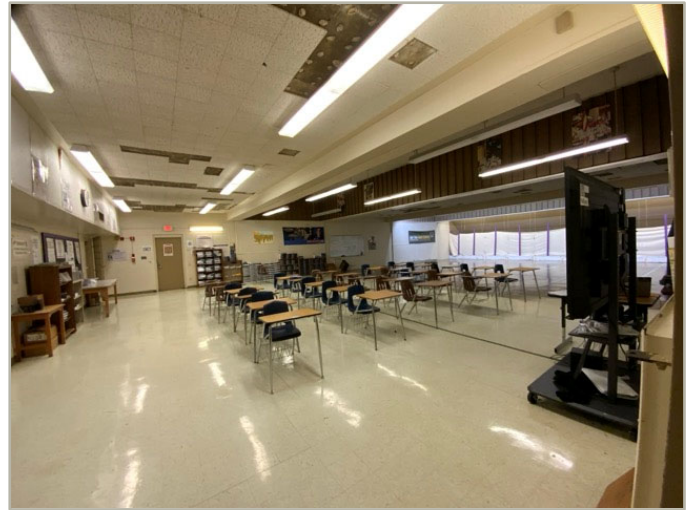
4. ROTC Building

Fire Alarm	Smoke detectors, heat detectors, alarms, strobes, pull stations, back-up emergency lights, and exit signs	Fair
Equipment/Special	None	--
Accessibility	Presently it does not appear an accessibility study is needed for this building. See Appendix D.	
Key Issues and Findings	Missing, falling and damaged ACT

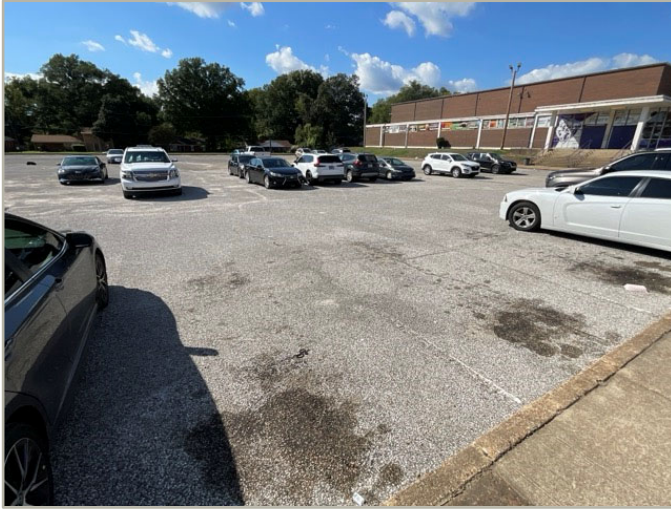
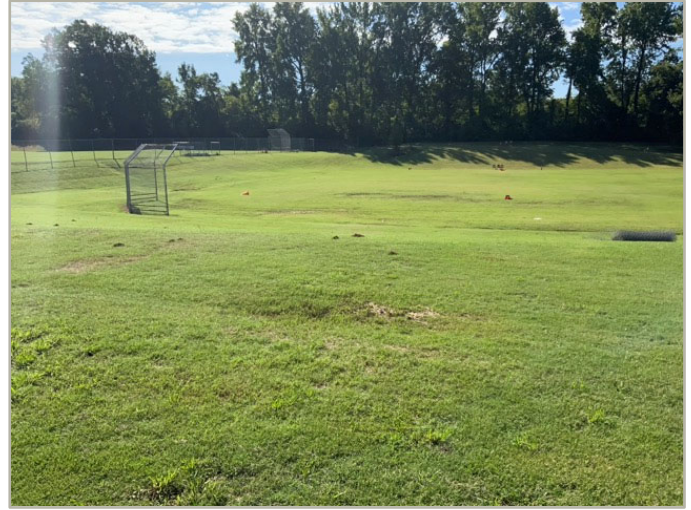
5. Site Summary

System	Description	Condition
Pavement/Flatwork	Asphalt lots with areas of concrete aprons and pavement and adjacent concrete sidewalks, curbs, ramps, and stairs	Poor
Site Development	Property entrance signage; chain link fencing	Fair
Landscaping and Topography	Moderate landscaping features including lawns, trees, bushes, and planters Irrigation not present Moderate site slopes throughout	Fair
Utilities	Municipal water and sewer Local utility-provided electric and natural gas	Fair
Site Lighting	Building-mounted and pole-mounted: LED, CFL	Fair
Ancillary Structures	None	--
Accessibility	Presently it does not appear an accessibility study is needed for the exterior site areas. See Appendix D.	
Key Issues and Findings	Significant cracking and lifting of concrete areas, Cracking, lifting, and potholes throughout asphalt.

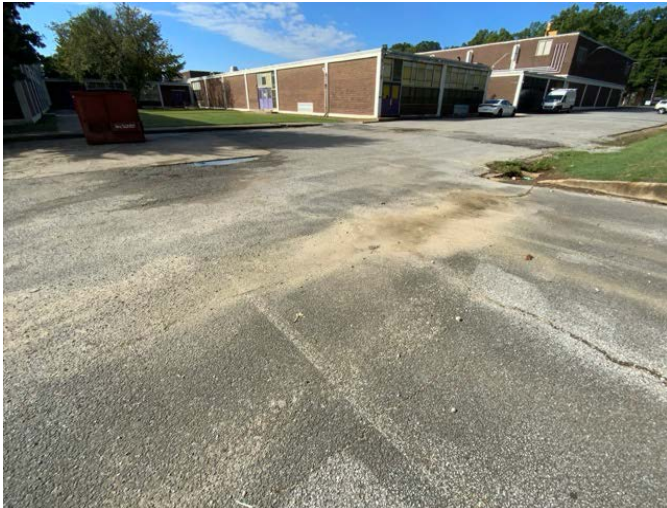
31 - PARKING LOT

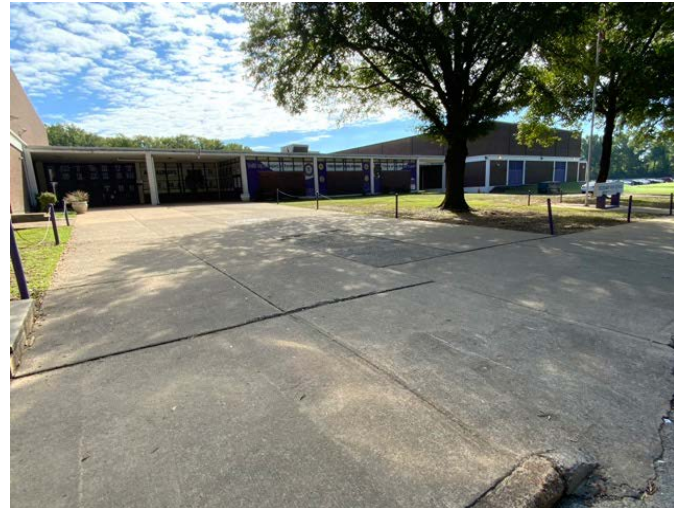
32 - SIDEWALK

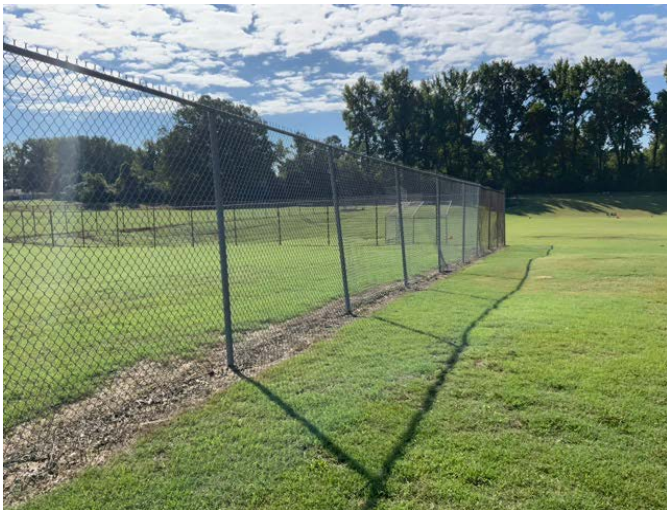
33 - FENCING

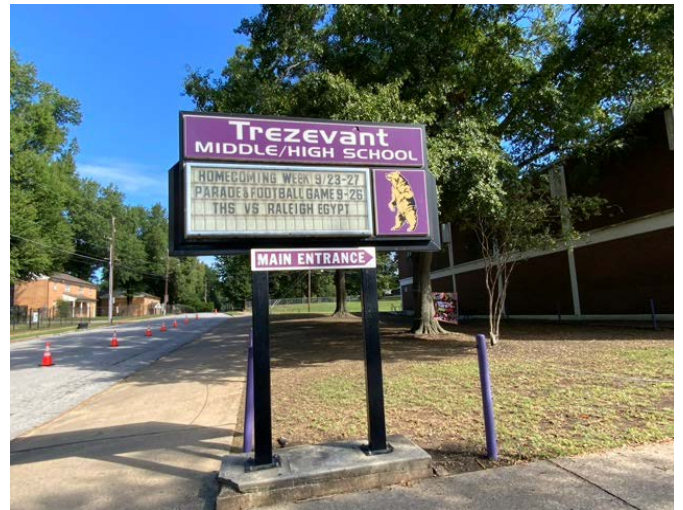
34 - PROPERTY SIGNAGE

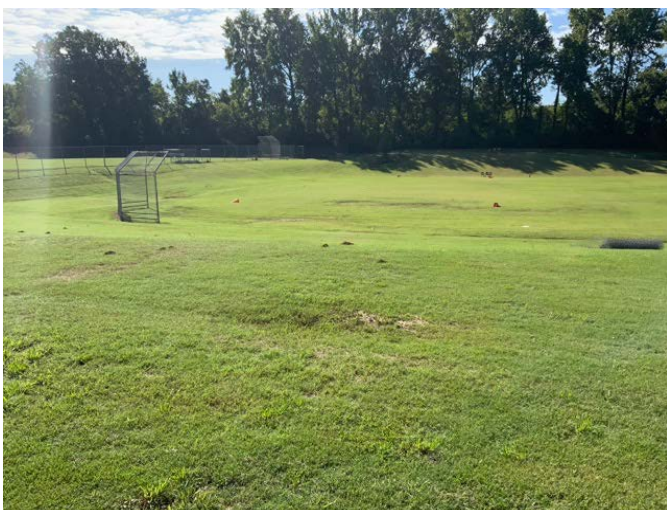
35 - SPORTS FIELD

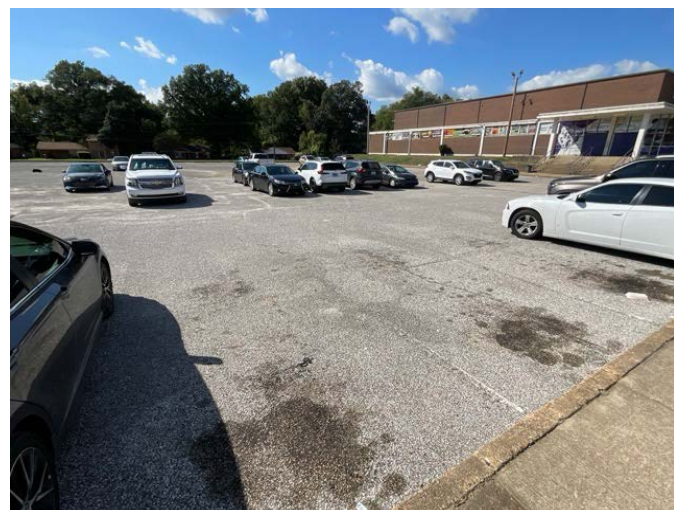
36 - PARKING LOT

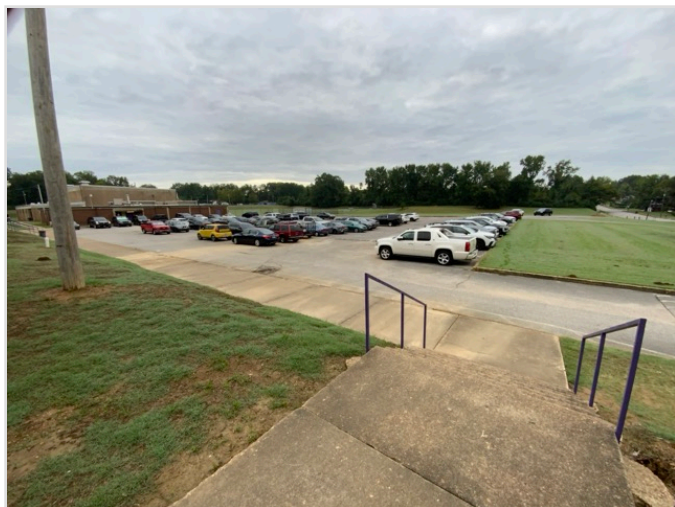
OVERVIEW OF ACCESSIBLE PARKING AREA

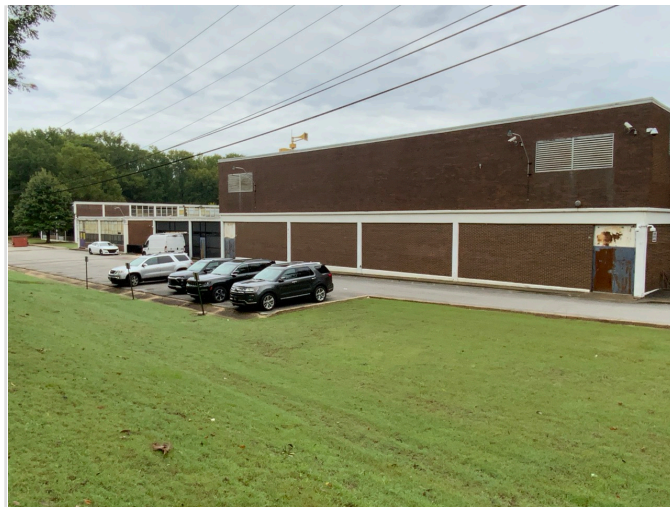
2ND AREA OF ACCESSIBLE PARKING

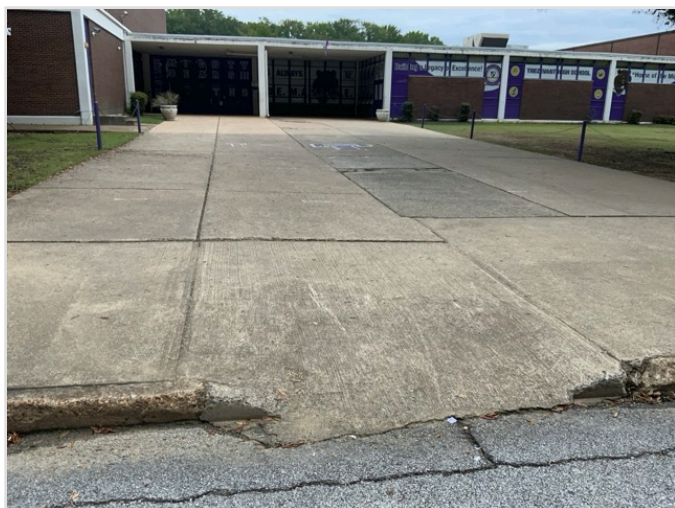
ACCESSIBLE PATH

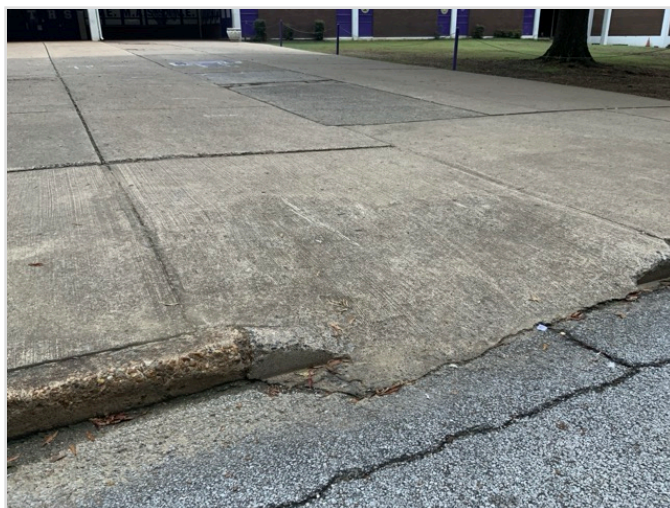
CURB CUT

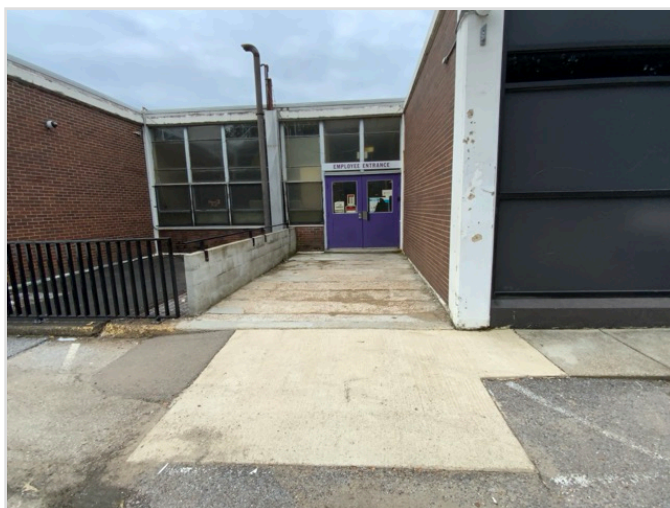
ADDITIONAL ENTRANCE

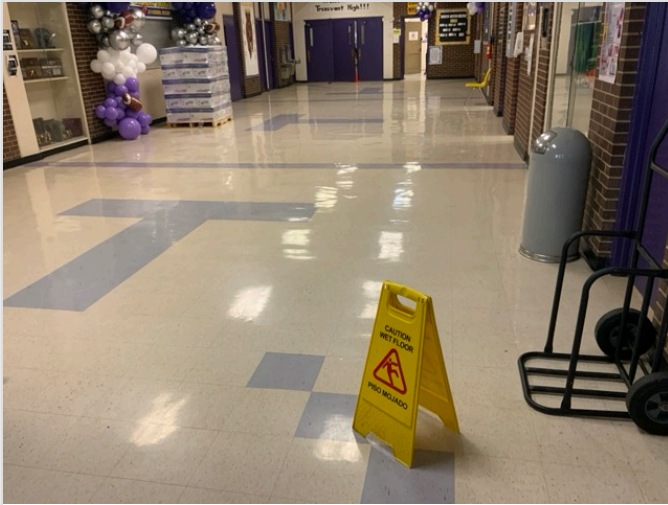
ACCESSIBLE INTERIOR PATH

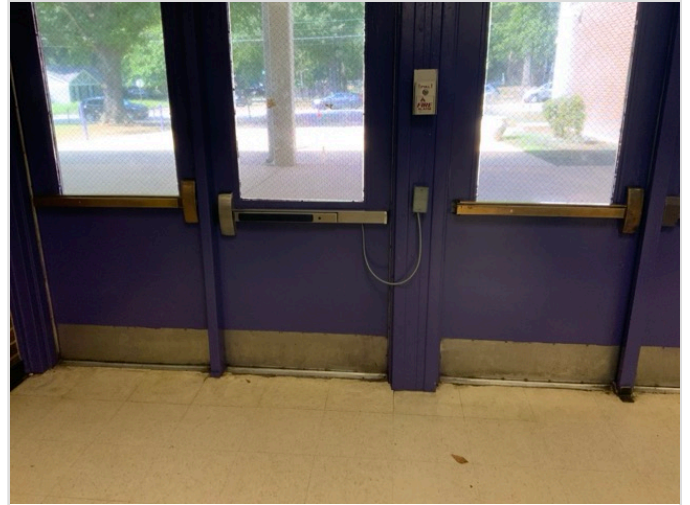
DOOR HARDWARE

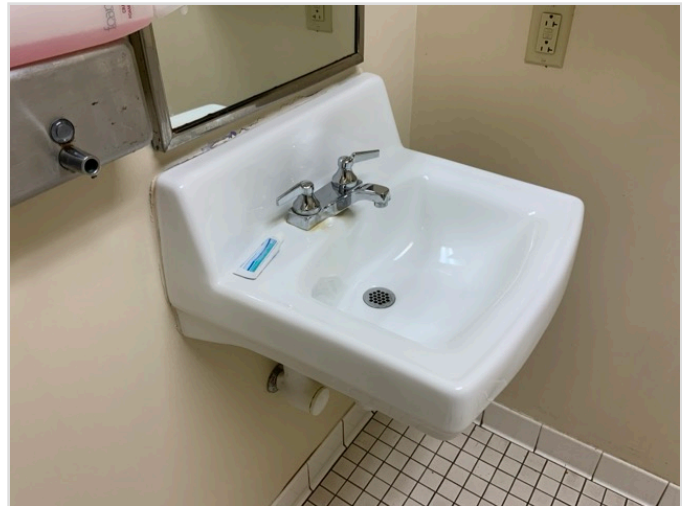
SINK, FAUCET HANDLES AND ACCESSORIES
